TO: Mercedes-Benz Dealer Principals, General Managers, Sales Managers, Service Managers, Parts Managers	FROM: Gregory Gunther, Department Manager, Vehicle Compliance and Analysis, Engineering Services
RE: <b>Service Campaign 2020100001 Launch Notification</b> <b>Check Fuel Tank Filler Hose (G-Class)</b>	DATE: December, 04 2020

Campaign No. 2020100001, December 2020

SUBJECT: **Model G-Class (463 platform)**  
**Model Year 2019-2020**

***Check Fuel Tank Filler Hose***

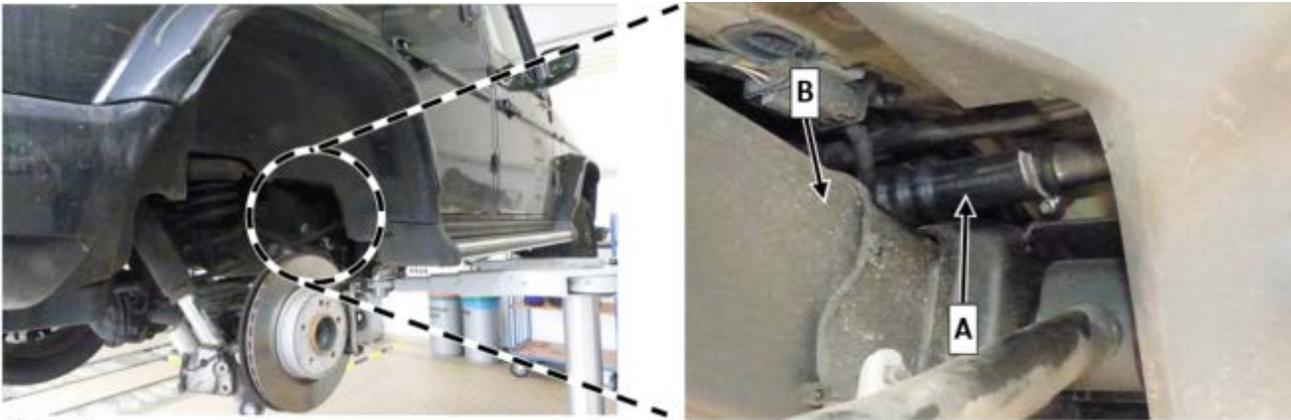
Figure 1

2. Detach right rear wheel and tire assembly.
  - i** For basic data, see **AR40.10-P-1102XG**.
3. Check tank filler hose (**A, Figure 1**) above vehicle frame (**B, Figure 1**) for leaks.

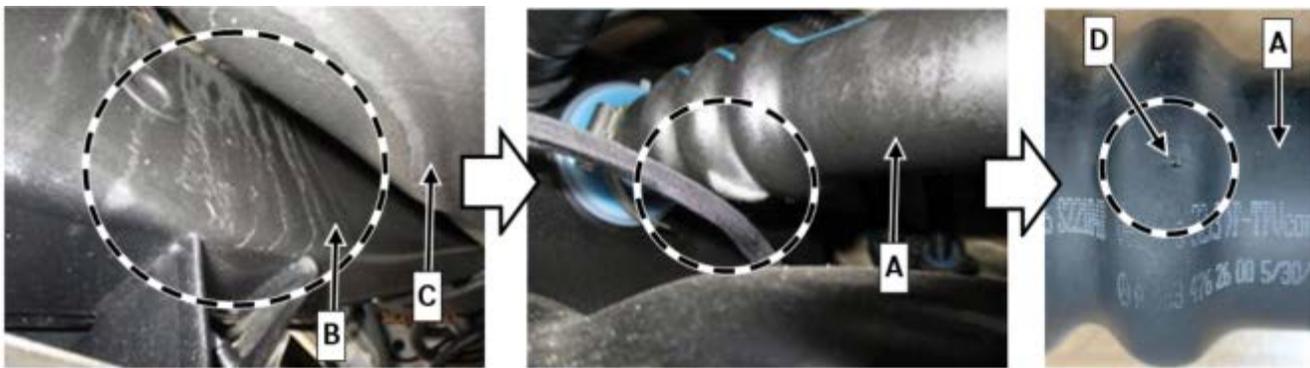
Figure 2

4. Check vehicle frame (**B, Figure 2**) next to fuel tank (**C, Figure 2**) for discolorations caused by fuel.
5. Use a telescopic mirror to check the tank filler hose (**A, Figure 2**) all around for damp areas and discolorations caused by fuel.
  - i** The discolorations caused by fuel are the result of a material fault (**D, Figure 2**) in the tank filler hose (**A, Figure 2**).

- a. Tank filler hose (**A, Figure 2**) **not** leaktight: Carry out **work procedure**.
- b. Tank filler hose (**A, Figure 2**) leaktight: **End measure**.

1. Replace tank filler hose

**i** **Only** if leaks are detected.
