RE: [Service Campaign 2020120009 Launch Notification](#)
Rework Towing Eye
MY20 247 (GLB-Class)

Campaign No. 2020120009, March 2021

SUBJECT: **Model GLB-Class (247 platform)**
Model Year 2020
Rework Towing Eye

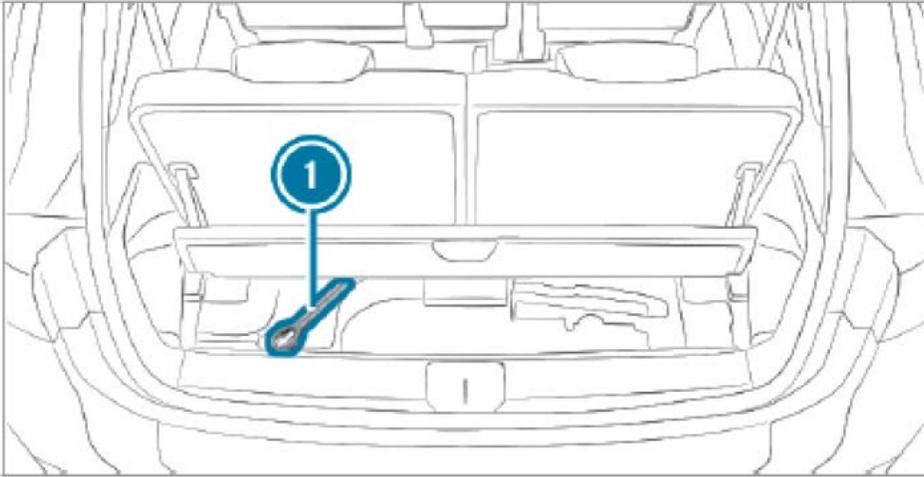
**Figure 1**

1. Locate towing eye storage under the cargo compartment floor. **(Figure 1)**

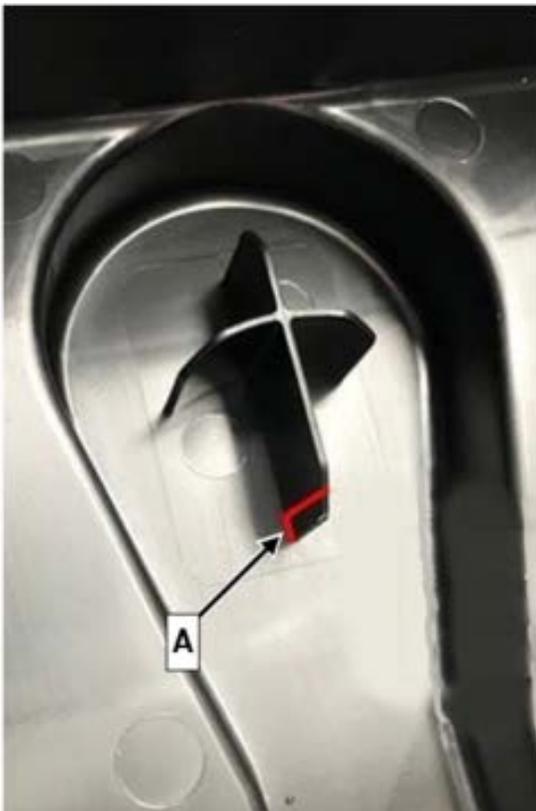
**Figure 2**

Mercedes-Benz AG ("MBAG"), the manufacturer of Mercedes-Benz, has determined that on certain MY 2020 GLB-Class (247 platform) vehicles, the towing eye storage compartment does not meet specification, and the towing eye may be missing. An authorized Mercedes-Benz dealer will rework the towing eye storage compartment on the affected vehicles by shortening the retaining rib and install a new towing eye.

2. Shorten retaining rib **(A, figure 2)** in the stowage compartment of the towing eye, as shown in red, by 3 mm.
3. Place new towing eye **(B, figure 3)** into stowage compartment.
