# Service Campaign Bulletin

Campaign No. 2021030025, May 2021

SUBJECT: **Model AMG GT-Class (290 platform)**  
**Model Year 2019-2020**

**Replace information label and supplementary booklet for filling capacity of AC system**

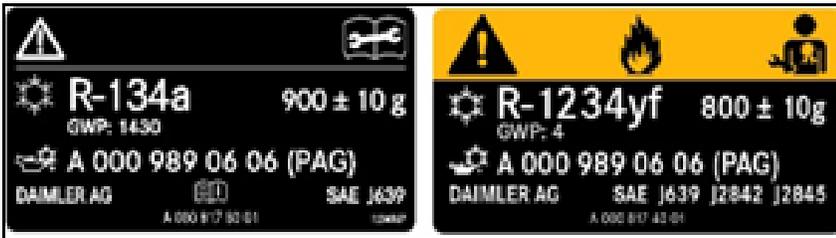
Figure 1

Mercedes-Benz AG ("MBAG"), the manufacturer of Mercedes-Benz, has determined that on certain Model Year ("MY") 2019-2020 AMG GT-Class (290 platform), an incorrect information label with directions on filling the refrigerant circuit was installed on the inside of the hood during production. It is therefore possible that the refrigerant circuit may be filled incorrectly during a workshop visit. In addition, the information provided in the operator's manual for the air conditioning system may be incorrect. An authorized Mercedes-Benz dealer will replace the information label and the operator's manual for the air conditioning system in the affected vehicles.

1. Replace air conditioning system information label on the inside of the hood (Figures 1 and 2).
  - i Remove old information label from hood (**bonding position 3.2, Figure 2**).
  - i Remove residual adhesive of old information label and clean bonding surface.
  - i Apply new information label (**bonding position 3.2, Figure 2**).
