RE: **Service Campaign 2021050008 Launch Notification**
Replace Seals on the Capacitor and Receiver Drier of the Air Conditioning System
MY20-21 118 (CLA-Class)

Campaign No. 2021050008, May 2021

SUBJECT: **Model CLA-Class (118 platform)**
Model Year 2020-2021

Replace Seals on the Capacitor and Receiver Drier of the Air Conditioning System

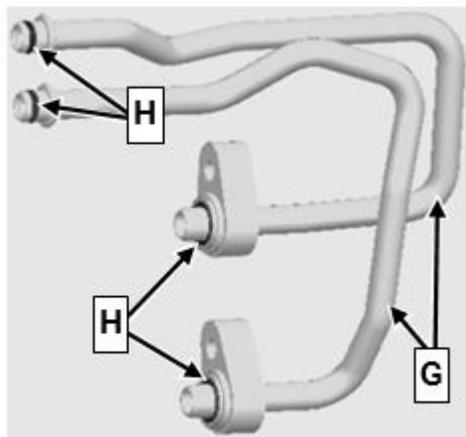
Figure 4

Mercedes-Benz AG (“MBAG”), the manufacturer of Mercedes-Benz vehicles, has determined that on certain Model Year (“MY”) 2020-2021 CLA-Class (118 platform) vehicles, the seals on the capacitor and receiver drier of the air conditioning system do not correspond to our currently valid specification. It is possible that cracks may form on the seals, which may result in refrigerant loss. An authorized Mercedes-Benz dealer will replace the seals on the capacitor and receiver drier of the air conditioning system.

9. Replace sealing rings (**H, Figure 4**) of refrigerant lines (**G, Figure 4**).

Wet new sealing rings with compressor oil (**specification 362.1**).
