Service Campaign Bulletin

Campaign No. 2021070028, August 2021

SUBJECT: **Model CLA-Class vehicles (118 platform)**
Model year 2020-2021

Replace Seals at Condenser and Receiver Drier of Air Conditioning System

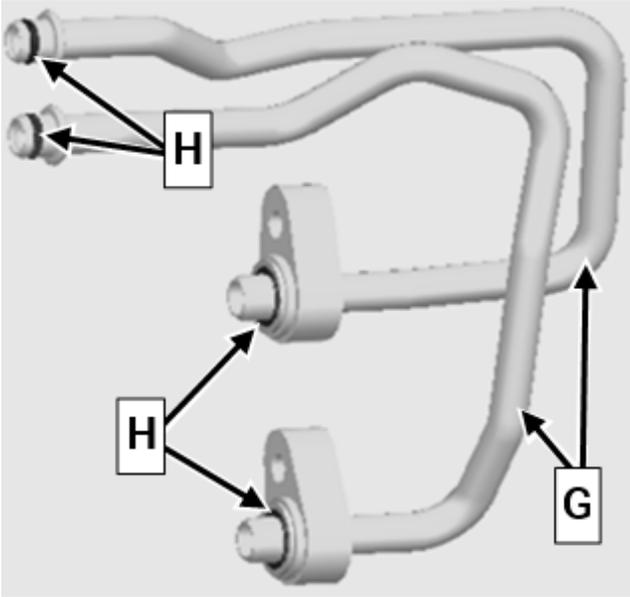
Figure 4

Mercedes-Benz AG ("MBAG"), the manufacturer of Mercedes-Benz, has determined that on certain MY 2020-2021 CLA-Class (118 platform) vehicles, the seals on the condenser and receiver drier of the air conditioning system do not correspond to current specifications. Over time, the seals may develop cracks, which may result in refrigerant loss. This, in rare cases, could lead to a failure of the air conditioning system. An authorized Mercedes-Benz dealer will replace the associated seals of the air conditioning system.

9. Replace sealing rings (**H, Figure 4**) of refrigerant lines (**G, Figure 4**).
- i** Wet new sealing rings with compressor oil (**specification 362.1**).
 - i** For basic data, see **BB00.40-P-0362-01A**.
