# Service Campaign Bulletin

Campaign No. 2021090006, September 2021

SUBJECT: **Model CLA-Class (118 platform)**  
**Model Year 2021**

## **Check Spare Wheel Well for Moisture**

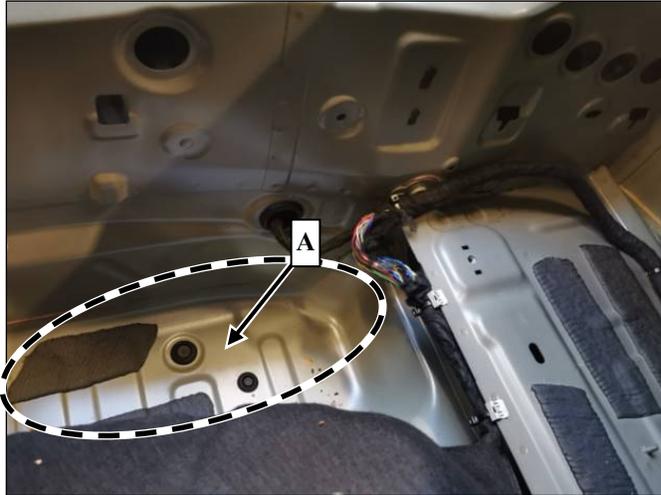
Figure 1

1. Open trunk lid
2. Lift cover of spare wheel well.
3. Check area of spare wheel well (A, Figure 1) for moisture/water.

- a. **Moisture/water present** in spare wheel well: Carry out **work procedure**.
- b. **Moisture/water not present** in spare wheel well: **End measure**.

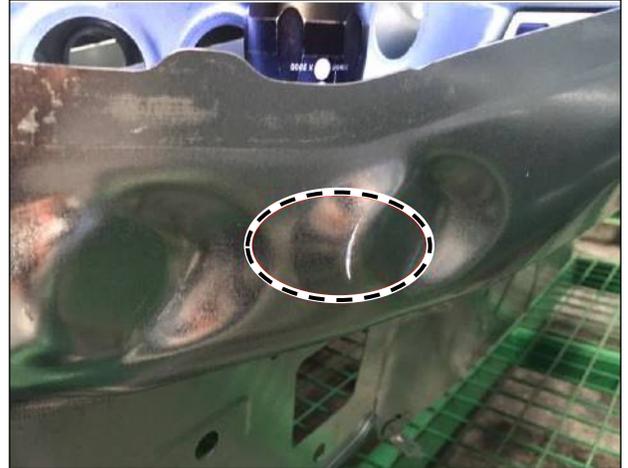
Figure 3

Mercedes-Benz AG (“MBAG”), the manufacturer of Mercedes-Benz vehicles, has determined that on certain MY 2021 CLA-Class (118 platform) vehicles, the left rear section under the spare wheel well may not correspond to current specifications and may have developed a crack. This might allow water to enter into the spare wheel well. MBUSA will conduct a service campaign. An authorized Mercedes-Benz dealer will check the spare wheel well for moisture on the affected vehicles and rework the respective area, if necessary.

1. Remove rear bumper.  
i For basic data, see AR88.20-P-2200MFA.
2. Remove left rear radar sensor mount (B, Figure 2).
3. Drill off crack on left in rear-end center section (Figure 3), weld shut, blend paint, and apply a cavity protection agent.  
i Important: Inner area of cavities/flanges in rear-end center section
