Vehicle Compliance & Analysis

IMPORTANT SERVICE CAMPAIGN LAUNCH

SUBJECT: Model EQS-Class (297 platform)

Retrofit Damping on Front Axle and Replace Engine Lining

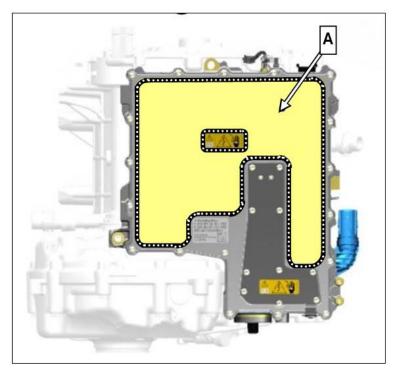
Figure 1

Mercedes-Benz AG ("MBAG"), the manufacturer of Mercedes-Benz, has determined that on certain MY 2022 EQS-Class (297 platform) vehicles, the damping on the front axle and rear engine compartment lining do not correspond to current specifications. Thus, it is possible the electronic drivetrain transmission may output noise into the cabin. An authorized Mercedes-Benz dealer will retrofit the front axle damping and replace the rear engine compartment lining.

- 1. Perform power disconnect of high-voltage on-board electrical system.
 - i For basic data, see AR47.70-P-1000EQS.
- 2. Remove rear engine compartment cover (B, Figure 2).
 - i For basic data, see AR61.20-P-1105EQS.
- 3. Retrofit damping (A, Figure 1) in area of power electronics control unit (N147/4) on front axle drive module.
- Before installing the damping, the surface of the power electronics on the front axle drive module must be cleaned.
- 4. Replace rear engine compartment cover (B, Figure 2).
