News Channel Update | Vans Customer Service and Parts

Campaign No. 2022060004 July, 2022

SUBJECT: **Model 907 Model Year 2021
Retrofit Door Control Module**

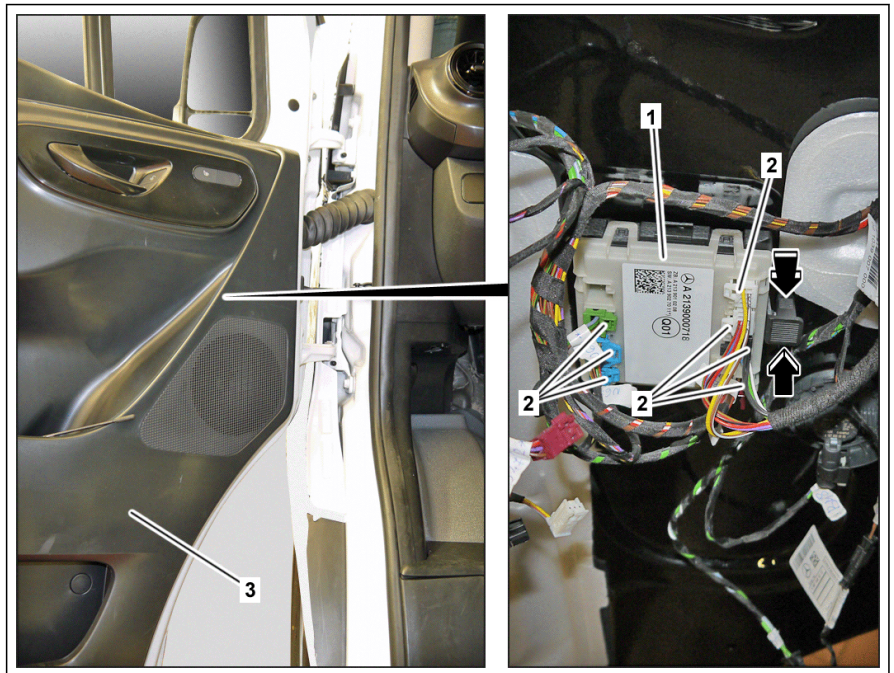
D72.29-1129-76

Shown on left front door

- 1 Control unit
- 2 Electrical connectors
- 3 Door trim

◀	Check		
1	Check whether vehicle is affected by measure.	If the vehicle already has a door module, close the campaign using 02-0001 op Code for inspection only. 0.1hr	SM72.29-D-0016SG SM72.29-D-0016-01AAB
↕	Remove		
2 AR	Remove door trims (3) of right and left front door.	<p>i</p> <p>When removing, check whether all retaining clips or covers, screws, etc. are present, If not present, ↓ determine and order required parts using XENTRY Parts Information.</p>	AR72.10-D-6575TS
↕	Install		
3 AR	Retrofit control units (1) of both front doors.	<p>i</p> <p>Clip control units (1) into holders and lock (arrows).</p>	AR72.29-D-1001TS
4	Connect electrical connectors (2).	<p>i</p> <p>The number of electrical connections (2) may vary depending on vehicle equipment.</p>	
5 AR	Install door trims (3) of right and left front door.		AR72.10-D-6575TS
