| Re: Service Campaign Notification Model 907 (Sprinter) Model Year 2021 Retrofit Door Control Module | DATE: July, 2022 |

Service Campaign Bulletin

Campaign No. 2022060004 July, 2022

SUBJECT: **Model 907 Model Year 2021**
Retrofit Door Control Module

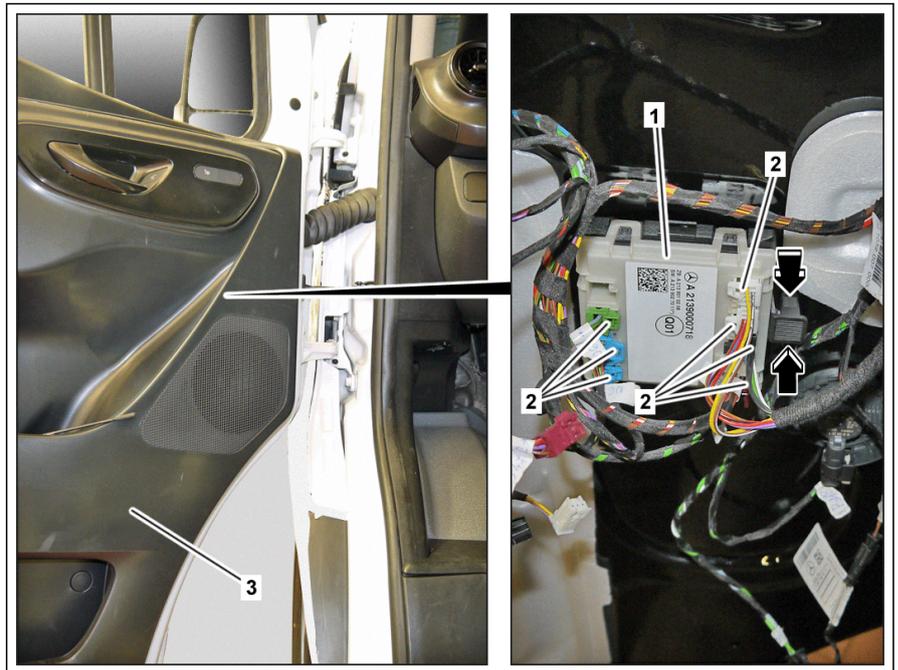
D72.29-1129-76

MBAG, the manufacturer of Mercedes-Benz Sprinter vehicles, determined that due to supplier constraints, certain door control modules were not available during production. Vehicles without door control units may not lock, or allow operation of the windows.

Shown on left front door

- 1 Control unit
- 2 Electrical connectors
- 3 Door trim

| 3 | Retrofit control units (1) of both front doors. | <p> Clip control units (1) into holders and lock (arrows).</p> | AR72.29-D-1001TS |
| 4 | Connect electrical connectors (2). | <p> The number of electrical connections (2) may vary depending on vehicle equipment.</p> | |

| | Commissioning of control units | | |
|---|--|--|---|
| 8 ↖ AD | Commission control units (1) of front doors. | It is absolutely essential to precisely follow the operation steps as described in the vehicle diagnosis system. | AD00.00-D-2000-06TS |
