Campaign No. 2021070026

Version 3.0

SUBJECT: **Model 907 Sprinter, Model Year 2020  
Software Update**

MBAG has determined that on certain Sprinter vehicles (platform 907), the Engine Control Unit (ECU) software and Transmission Control Unit (TCU) software does not correspond to current series production specifications.

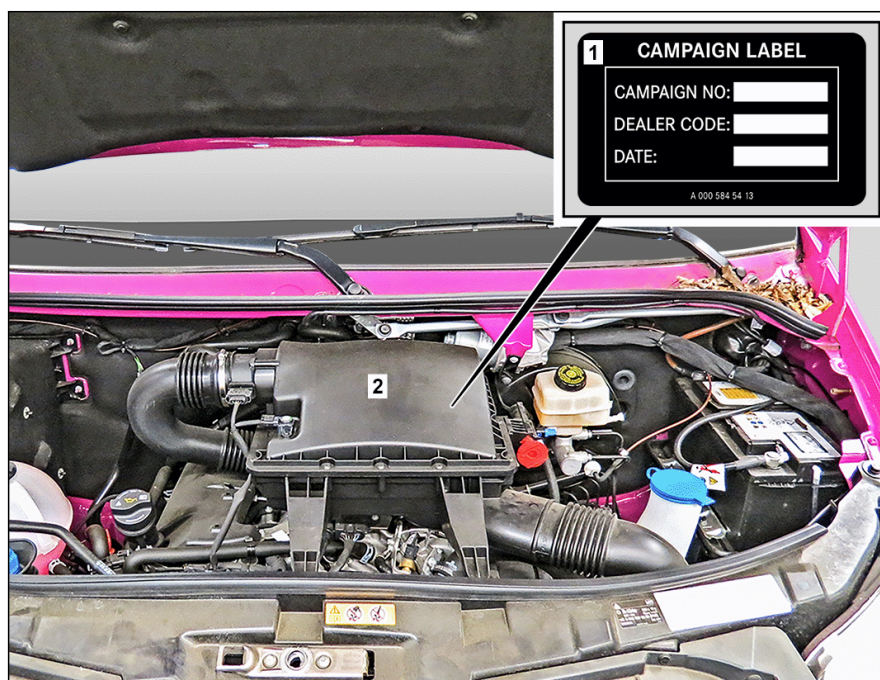
D54.21-A036-76

- 1 Campaign label
- 2 Air cleaner housing

AR	Remove charger from vehicle.		AR54.10-D-1127TS
7	Fill out campaign label (1) and attach to air filter housing (2).	<p>Only applies for vehicles in State of California.</p> <p>
