# News Channel Update | Vans Customer Service and Parts

TO: Mercedes-Benz Dealer Principals, General Managers, Sales Managers, Service Managers, Parts Managers	FROM: Anthony Washington, Department Manager, Regulations and Certifications
Re: Service Campaign Notification Model 907 (Sprinter) Model Year 2022 Retrofit PTC Heater	DATE: August, 2022

Campaign No. 2022070014 August, 2022

SUBJECT: Model 907 Model Year 2022 Retrofit PTC Heater

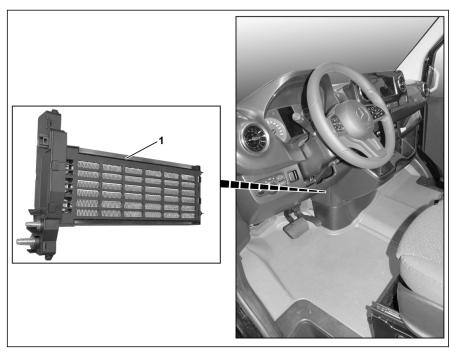
#### 1 PTC heater booster

Due to global supply constraints the PTC Heater was not installed at the time of manufacturing on certain Mercedes-Benz Sprinter vehicles. An authorized Mercedes-Benz Sprinter dealer will retrofit the PTC heater in the affected vehicles.
