Campaign No. 2022070018, September 2022

SUBJECT: **Model A-Class and GLB-Class (177 and 247 platform)**
Model Year 2020

Rework upper hinge of left and right rear door

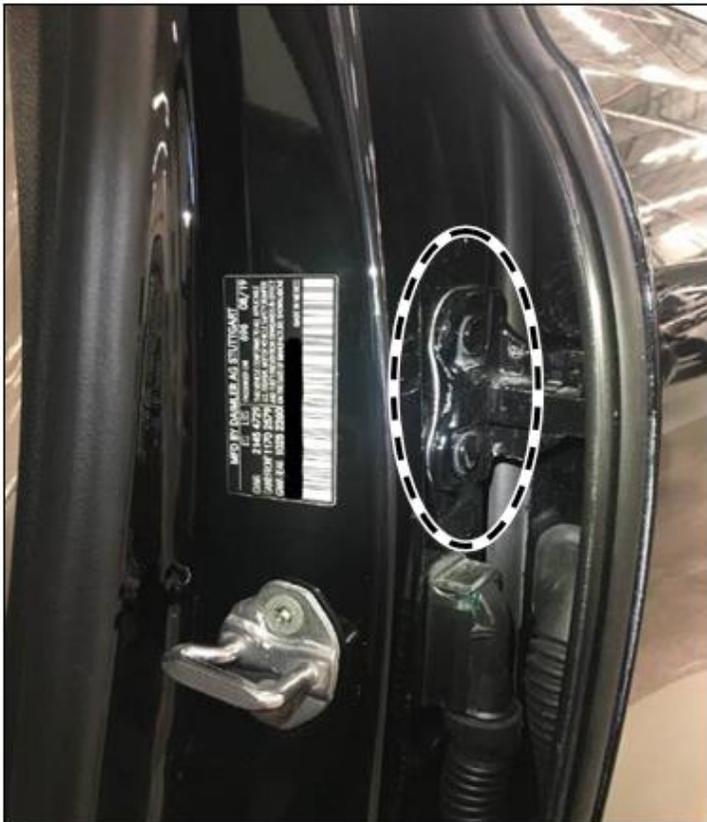
Figure 1

Mercedes-Benz AG ("MBAG"), the manufacturer of Mercedes-Benz, has determined that in certain MY 2020 A-Class and GLB-Class (177 and 247 platform) vehicles, the contact surface of the upper hinges to the B-pillar on the right and left rear doors may have been arched. As a result, water could intrude into the gap between the B-pillar and door hinge, which may result in corrosion. An authorized Mercedes-Benz dealer will rework the upper hinges of the B-pillar on the left and right rear doors.

i **Figure 1** shows the view with opened front door and closed rear door!

1. Clean upper hinge of left rear door on B-pillar (**Figures 1 and 2**).
2. Apply transparent bonding agent/primer in area of transition from B-pillar to upper hinge of left rear door (**Figures 1 and 2**).
3. Clean upper hinge of right rear door on B-pillar (**Figures 1 and 2**).
4. Apply transparent bonding agent/primer in area of transition from B-pillar to upper hinge of right rear door (**Figures 1 and 2**).
5. Apply transparent seam seal thinly in area of transition from B-pillar to upper hinge of left rear door (**Figures 1 and 2**).
i Excess seam seal must be removed!
6. Apply transparent seam seal thinly in area of transition from B-pillar to upper hinge of right rear door (**Figures 1 and 2**).
i Excess seam seal must be removed!

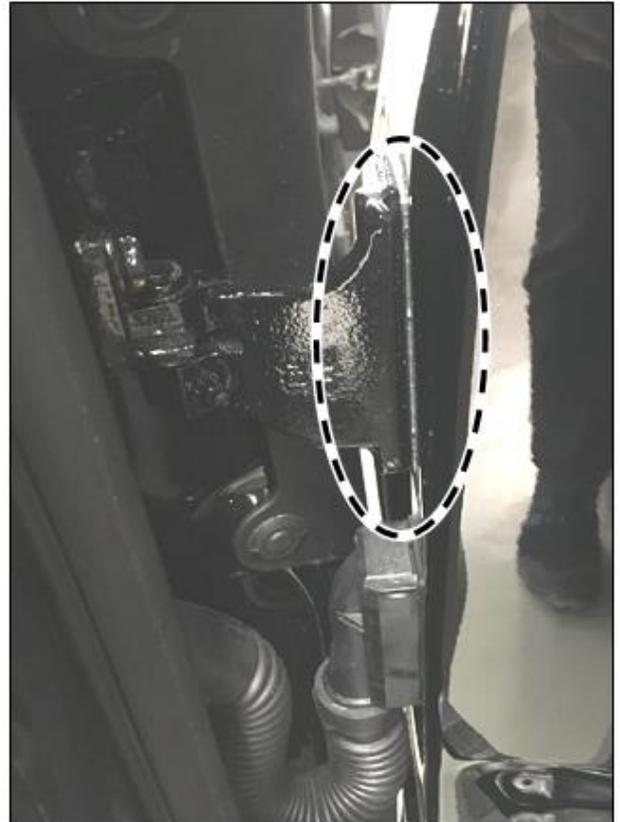
Figure 2

i **Figure 2** shows the view with opened front and rear doors!
