TO: Mercedes-Benz Dealers, General Managers, Sales Managers, Service Managers, Parts Managers	FROM: Anthony Washington, Department Manager, Regulations and Certifications
Re: Service Campaign Notification Model 907 Sprinter Model Years 2019-2021 <u>*UPDATED*</u> Replace Front Door Check	DATE: June, 2023

Campaign No. 2022100014 November, 2022

SUBJECT: Model 907 Sprinter Model Years 2019-2021 Replace Front Door Check

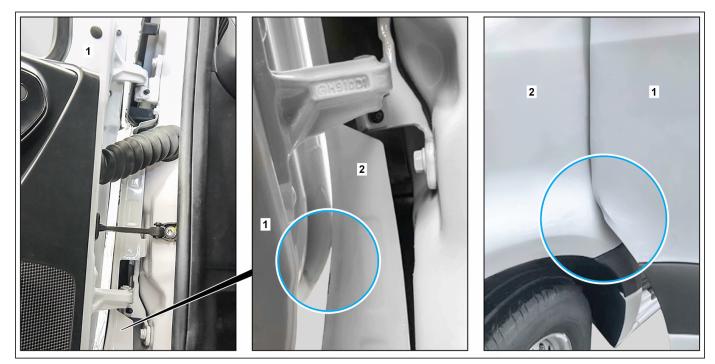
D72.10-A009-79

Example for damage at front door and fender

Front door 1

2 Fender

On affected vehicles, increased loads on the door check (3) may cause damage at the front door (1) or fender (2).

2	Chaok fonder (2) for domost]
3	Check fender (2) for damage.	i Only damage resulting from contact with the corresponding front door (1) is to be taken into consideration.	
		See the example picture above with regard to this.	
		If fender (2) is damaged,	
⊯≊AR		replace fender (2). Remove/install front fender	AR88.10-D-1005TS
		i Before replacing fender (2), take representative pictures of the affected areas and file in a tamperproof manner with the repair order.	
4	Check reinforcement (1.1) of front door (1).	i Check whether cracks are visible at reinforcement (1.1).	
		Take representative pictures of the affected areas and file in a tamperproof manner with the repair order.	
		If cracks are present,	
₩ AR		replace front door (1). Disassembling and assembling front door	AR72.10-D-0510TS
		i Before replacing front door (1), take representative pictures of the affected areas and file in a tamperproof manner with the repair order.

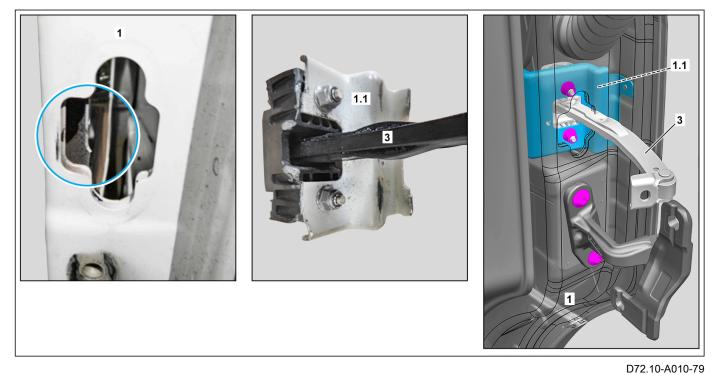
Example for damage at front door reinforcement

Front door 1.1 Reinforcement

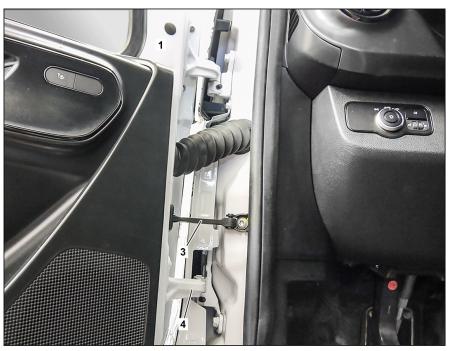
D72.10-A008-76

Shown on driver side

- Front door 1
- 3 Door catch
- 4 Hinge

An authorized Mercedes-Benz dealer will replace the existing door check with an optimized version. If damage is present on front door and fender, the dealer will make necessary repairs.
