TO: Mercedes-Benz Dealer Principals, General Managers, Sales Managers, Service Managers, Parts Managers	FROM: Gregory Gunther, Department Manager, Vehicle Compliance and Analysis, Engineering Services
RE: Service Campaign Launch Notification Check Transmission Bearing Cover MY20-21 GLA-Class and GLB-Class (156/247 platform)	DATE: February 24, 2023

Check Transmission Bearing Cover

SUBJECT: **Model GLA-Class and GLB-Class (156/247 platform)**
Model Year 2020-2021

Replace Transmission Bearing Cover

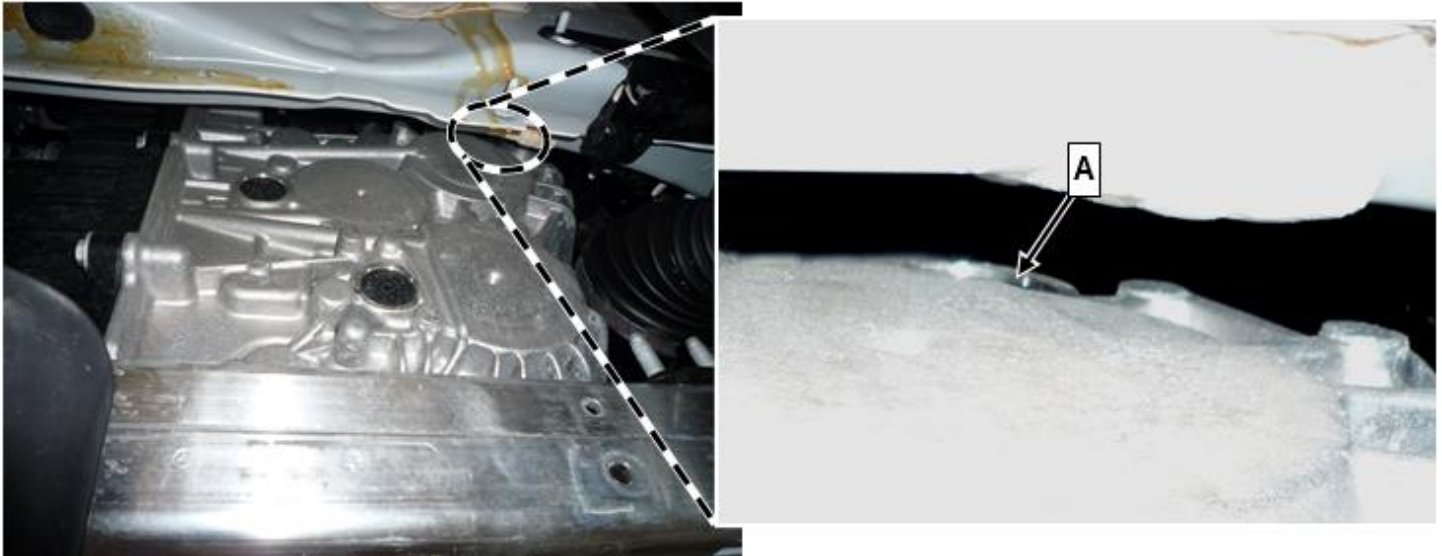
Figure 1

2. Check bearing cap (A, figure 1) on transmission with a mirror.

i A **bright aluminum bearing cap** must be installed here.

- a. Bright aluminum bearing cap **not** installed on transmission: Perform **work procedure**.
- b. Bright aluminum bearing cap installed on transmission: **End measure**.

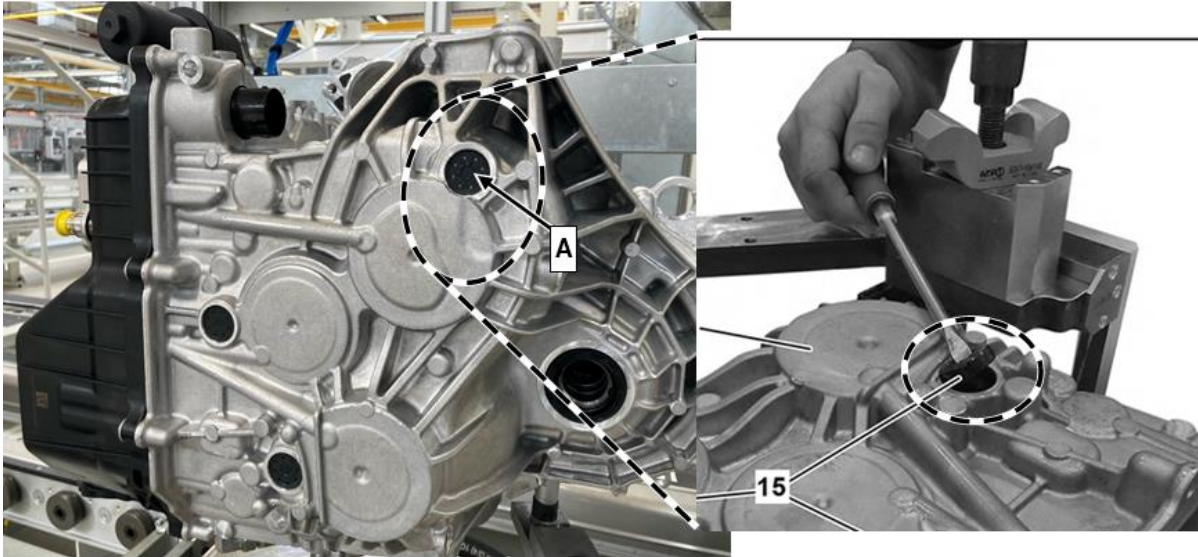
Figure 2

* Select the WIS document according to the vehicle model.
2. Remove bearing cap (A, Figure 2) from transmission using a suitable tool.

The bearing cap will be replaced by a **new aluminum bearing cap**.

3. Insert new aluminum bearing cap up to end stop and hammer in slightly.
 4. Assemble in reverse order.
-
