MY14-20 S-Class (217 and 222 platform)			
Check Front Axle Tension Strut Pilot Bushings	DATE: June 23, 2023		
RE: Service Campaign Launch Notification			
Sales Managers, Service Managers, Parts Managers Compliance and Analysis, Engineering Services			
TO: Mercedes-Benz Dealer Principals, General Managers,	FROM: Gregory Gunther, Department Manager, Vehicle

Campaign No. 2023050005, June 2023

SUBJECT: Model S-Class (217 and 222 platform)

Check Front Axle Tension Strut Pilot Bushings

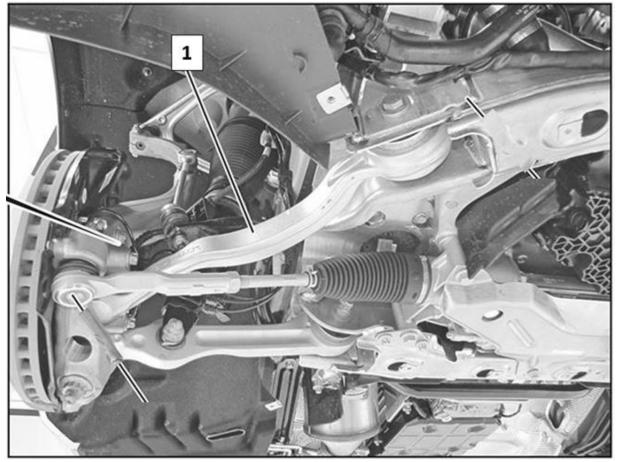
Figure 1

Mercedes-Benz AG ("MBAG"), the manufacturer of Mercedes-Benz vehicles, has determined that on certain Model Year ("MY") 2014-2020 S-Class (217 and 222 platform) vehicles, the incorrect pilot bushings may have been installed in the front axle tension struts. It is possible that noises and an increased wear of the pilot bushings may occur. An authorized Mercedes-Benz dealer will check the pilot bushings on the front axle tension struts, and replace if necessary.

- 1. Remove tension struts (1, Figure 1) of front axle on both sides.

Replace affected tension strut of front axle.
 For basic data, see AR33.15-P-0160LF.

2. Assemble in reverse order.

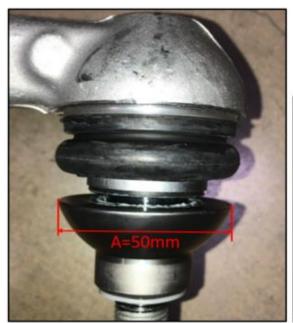
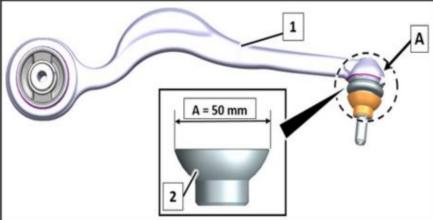
Figure 2

i For basic data, see AR33.15-P-0160LF.
- 2. Check diameter (A, Figure 2) of pilot bushing (2, Figure 2) on both sides.
 - a. Diameter (A) less than 50 mm: Perform work procedure on affected side.
 - b. Diameter (A) greater than or equal to 50 mm: End measure.
