Service Campaign Bulletin

Campaign No. 2023060008, June 2023

SUBJECT: **Model C-Class (206 platform)**
Model Year 2023

Install Rivets on Cross-member above Rear Axle

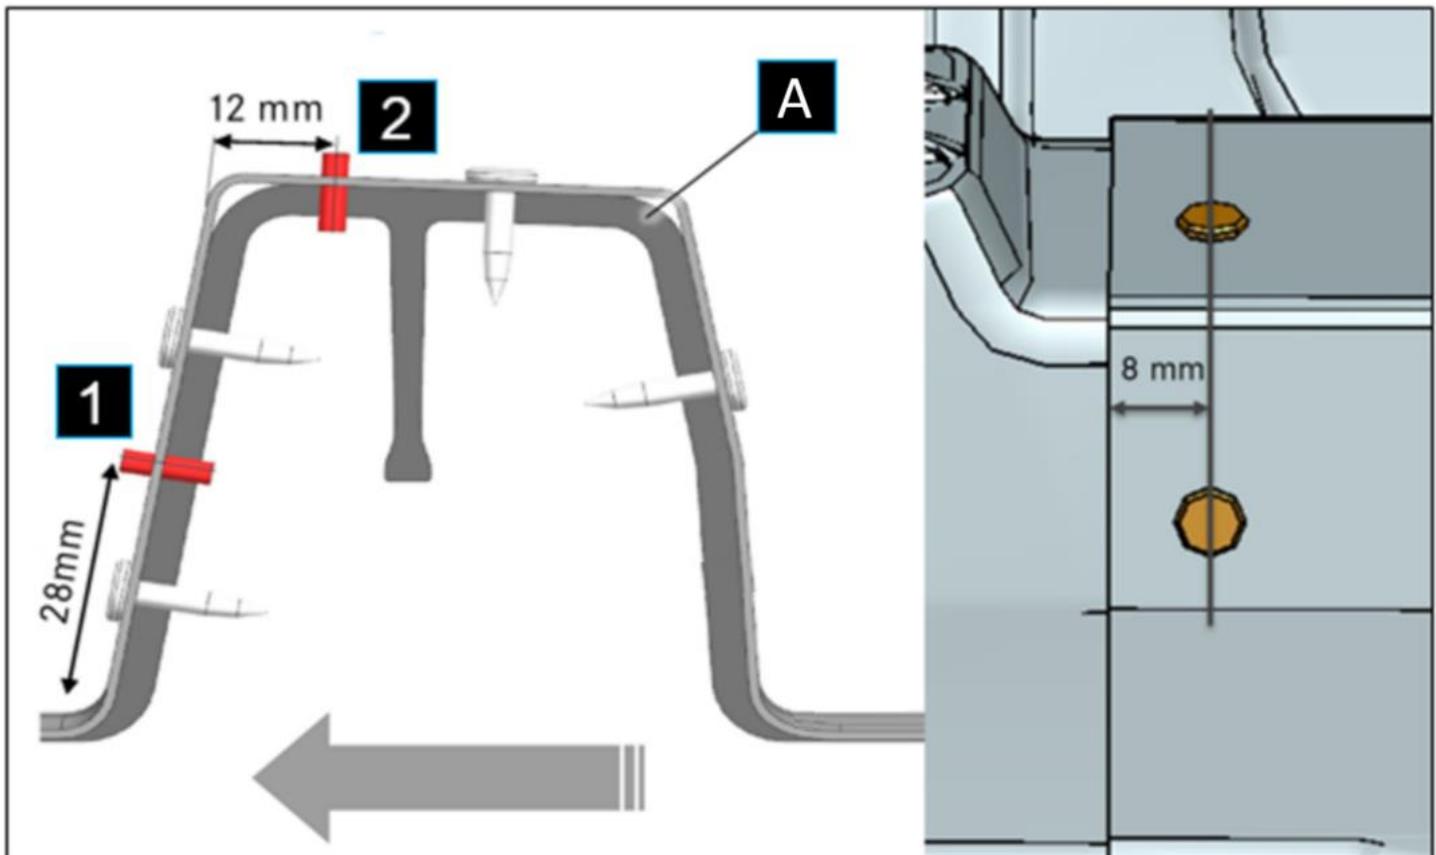
Figure 1

Mercedes-Benz AG (“MBAG”), the manufacturer of Mercedes-Benz vehicles, has determined that on certain Model Year (“MY”) 2023 C-Class (206 platform) vehicles, the adhesive seam on the cross-member in the rear area does not correspond to current specifications. As a result, noise may occur in the rear area of the vehicle while driving and the body may be subjected to greater stress in this area. An authorized Mercedes-Benz dealer will install rivets on the cross-member above the rear axle on the affected vehicles.

1. Remove rear seat cushion padding.
 - i For basic information, see: AR91.12-P-1022WT.
2. Remove seat backrest in rear passenger compartment completely.
 - i For basic information, see: AR91.12-P-1713WT (**except** code 287 (Through-loading feature)).
 - i For basic information, see: AR91.12-P-1723WT (**with** code 287 (Through-loading feature)).
3. Remove trunk lining.
 - i For basic information, see: AR68.30-P-4602WT (**except** code ME10 (Hybrid vehicle (plug-in, PHEV))).
 - i For basic information, see: AR68.80-P-6000WT (**with** code ME10 (Hybrid vehicle (plug-in, PHEV))).
4. Perform power disconnect for high-voltage on-board electrical system.
 - i For basic information, see: AR47.70-P-1010AMC (**with** code ME10 (Hybrid vehicle (plug-in, PHEV))).
5. Mark rivet holes on cross-member (**A, Figure 1**).
 - i Mark positions 1 and 2.
