# WORK DESCRIPTION FOR FIELD MEASURE

Code: 23P6393003

**Check inner right side wall for crack, rework if necessary**

Model 295

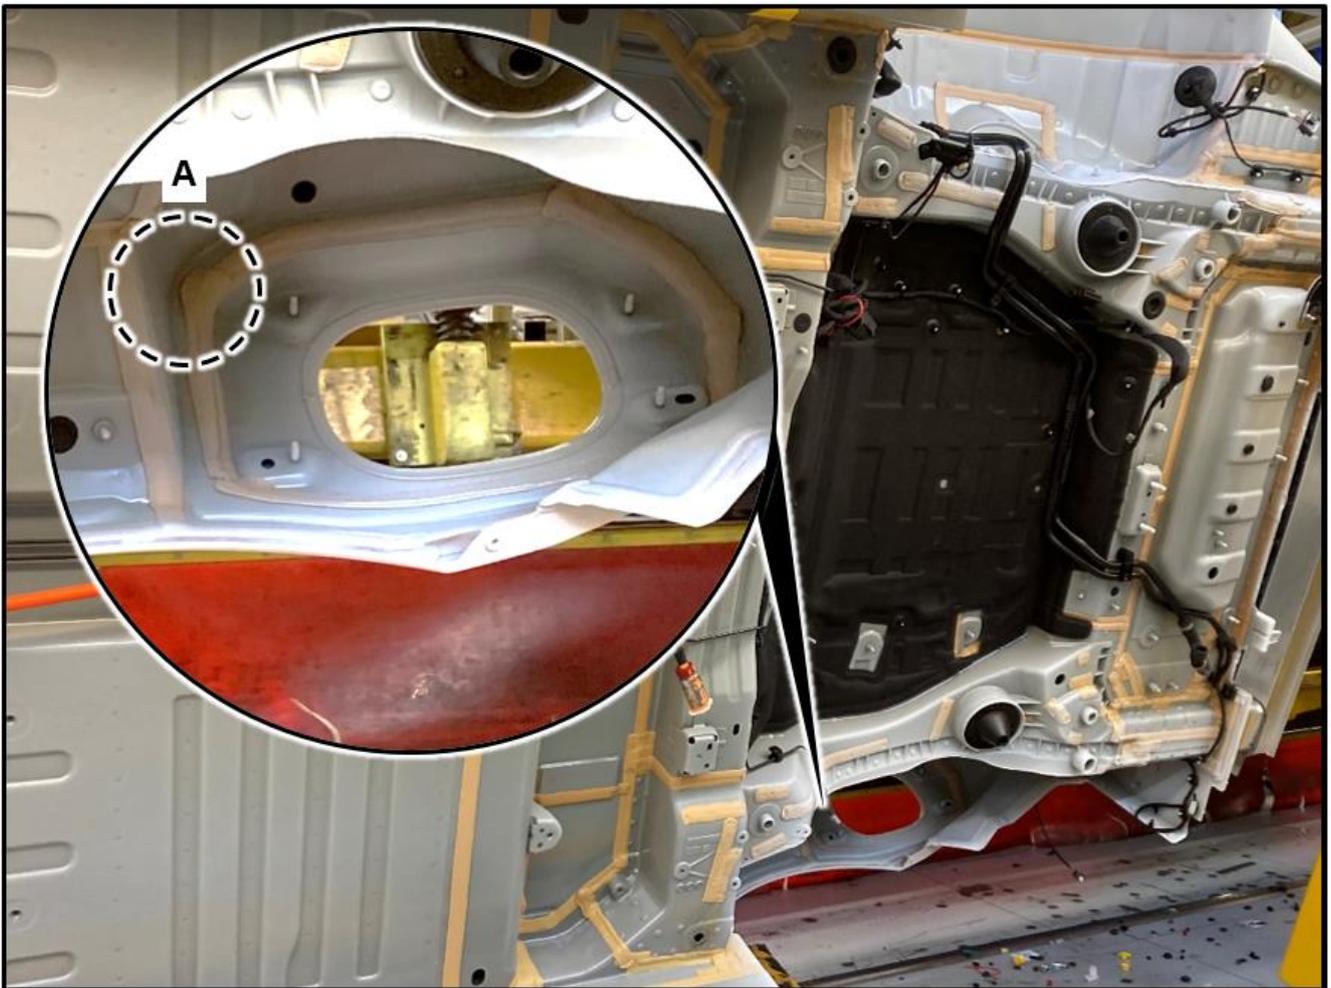
Figure 1

2. Check affected area (A, Figure 1) on inner right side wall for crack.

- a. Area (A, Figure 1) on inner right side wall cracked: Carry out **work procedure**.
- b. Area (A, Figure 1) on inner right side wall **not** cracked: **End measure**.
