WORK DESCRIPTION FOR FIELD MEASURE

Code: 23P6192003

Rework carrier for rear bumper

Model 294

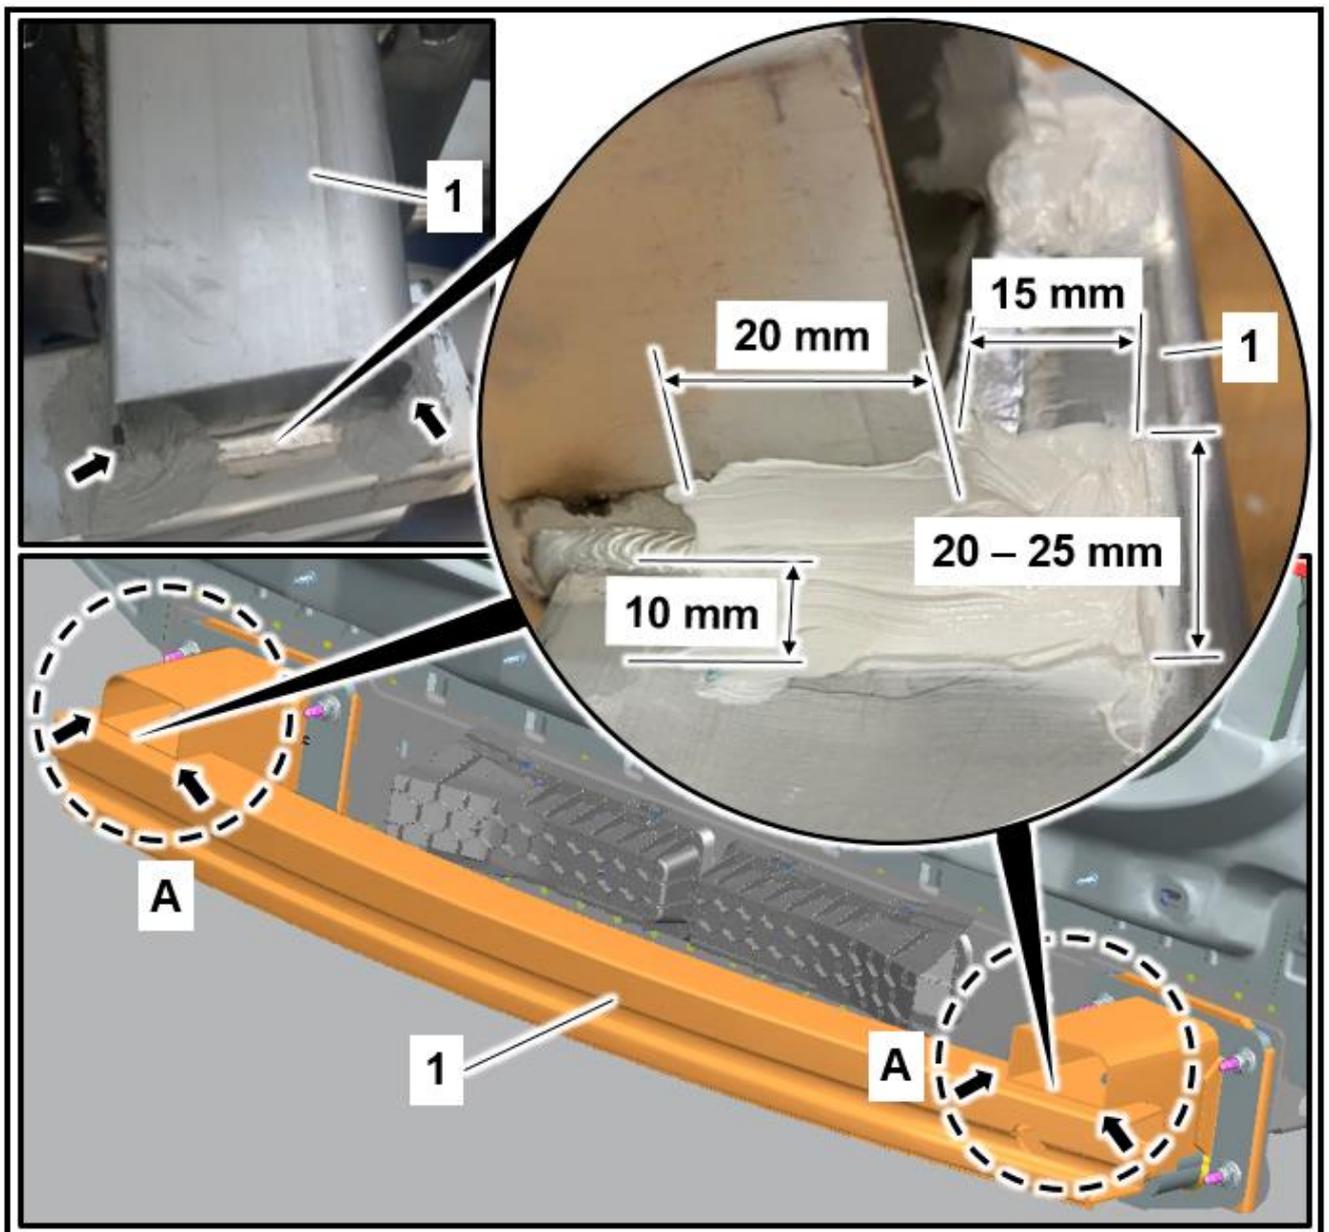
Figure 1

2. Clean affected areas (A, arrows, Figure 1) at weld seams of carrier for rear bumper (1, Figure 1).

3. Apply activator to affected areas (A, arrows, Figure 1) on weld seams of carrier for rear bumper (1, Figure 1).

4. Apply seam seal (transparent) to weld seams of carrier for rear bumper (1, Figure 1) in affected areas (A, arrows, Figure 1) as shown and spread.

i The specified dimensions (Figure 1) must be observed here (in Figure 1, all specified dimensions \pm 10 mm).
