TO: Mercedes-Benz Dealer Principals, General Managers, Sales Managers, Service Managers, Parts Managers	FROM: Gregory Gunther, Senior Manager, Vehicle Compliance and Analysis, Engineering Services
RE: <b>Service Campaign Launch Notification Update Software for Various Control Units – Supplement MY22-23 EQS (297 platform)</b>	DATE: March 8, 2024

Campaign No. 2023070020, August 2023

SUBJECT: **Model EQS (297 platform)**  
**Model Year 2022-2023**

## **Update Software of Several Control Units**

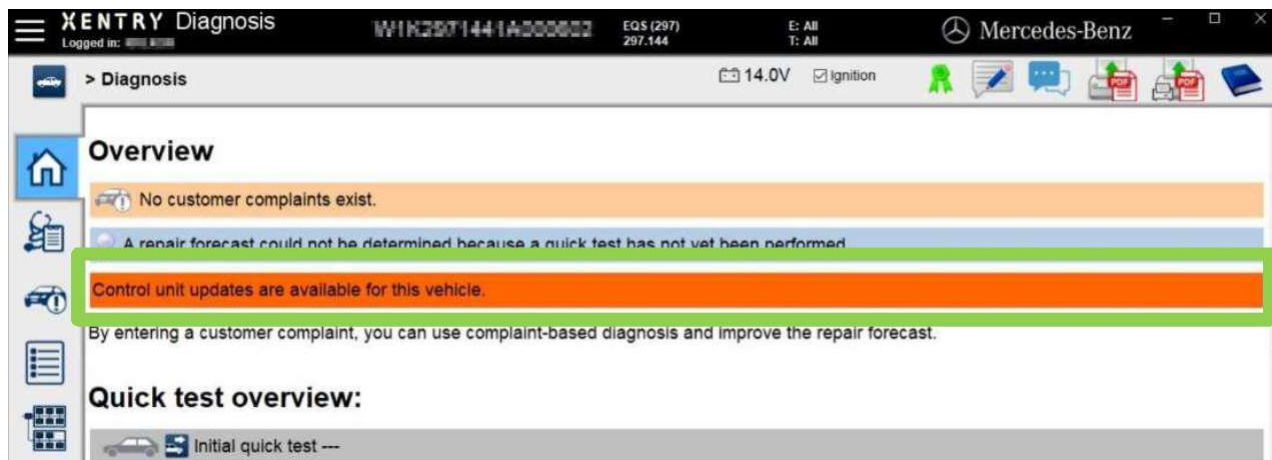
Figure 1

1. Connect XENTRY Diagnosis and verify all the latest ad-ons are installed.
  - i** The cable to the VCI **must** be routed through a rear side window. The front side windows and front doors must be closed. During this process, the front seats are moved to their end positions. The VCI cable must be positioned such that it cannot be pinched.
  - i** Via the **orange** special menu item, start "**Control unit updates are available for this vehicle**" (Figure 1).
  - i** Then follow the user guidance in XENTRY Diagnosis
