<p>TO: Freightliner Dealer Principals, General Managers, Sales Managers, Service Managers, Parts Managers</p>	<p>FROM: Anthony Washington, Senior Manager, Regulations and Certifications</p>
<p>Re: Launch Recall Campaign Notification Model Sprinter 907 Model Years 2021 Replace Fuel Delivery Module</p>	<p>DATE: October, 2023</p>

Campaign No. 2023090004 October, 2023

SUBJECT: **Model 907 Sprinter, Model Year 2021**
Replace Fuel Delivery Module

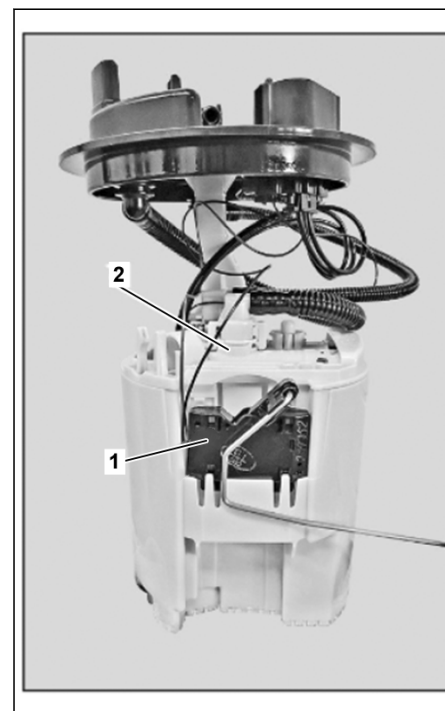
D47.20-A027-03

Mercedes-Benz AG, the manufacturer of Sprinter vans, has determined that on certain Sprinter (907 platform) vehicles the fuel pump impeller might not meet specifications in regards to material characteristics. As a consequence, the impeller might deform and come into contact with the fuel pump housing, leading to a mechanical resistance. In some instances, this could lead to a shutdown of the fuel pump. As a result, the vehicle could lose propulsion, which could increase the risk of a crash or injury.

AR	Replace fuel delivery module (2).	<p>

Dispose of removed component parts that are not reused properly. Observe the applicable legal requirements and specifications of the relevant country.</p> <p>If the new part is not equipped with a fill level sensor (1),</p> <p style="text-align: center;">↓</p> <p>the fill level sensor (1) must then be modified.</p>	AR47.20-D-7000TSC
