TO: Mercedes-Benz Dealer Principals, General Managers, Sales Managers, Service Managers, Parts Managers	FROM: Gregory Gunther, Senior Manager, Vehicle Compliance and Analysis, Engineering Services
RE: <b>Service Campaign Launch Notification</b> <b>Retrofit Headlamp Housing Screws</b> <b>MY22 SL (232 platform)</b>	DATE: January 19, 2024

Campaign No. 2023120019, January 2024

SUBJECT: **Model SL (232 platform)**  
**Model Year 2022**

## **Retrofit Headlamp Housing Screws**

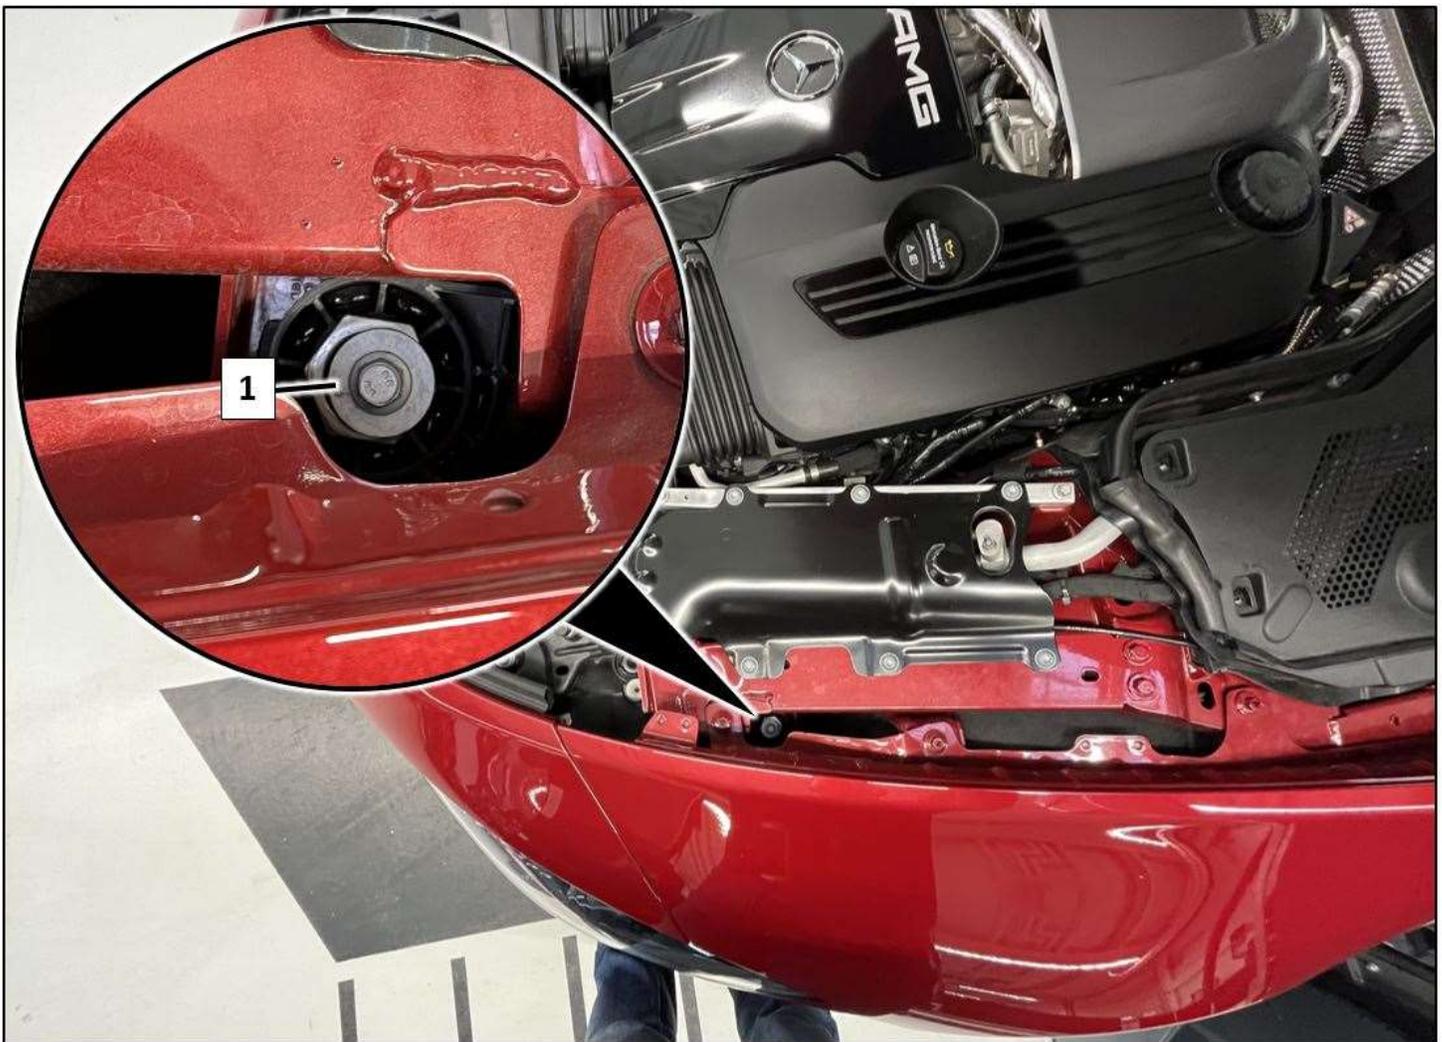
Figure 1: Washer on left headlamp shown

1. Clean and dry bonding area on washer (**1, Figure 1**) of left and right headlamp housing screws. Use a suitable cleaning agent for this purpose. Subsequently dry the bonding area on the washer (**1, Figure 1**) with a lint-free cloth.

**i** The bonding area on the washer (**1, Figure 1**) must be completely free of dust and grease. There may otherwise be problems with adhesion.
