| <b>Re: Launch Recall Campaign Notification</b><br><b>Model 907 Sprinter</b><br><b>Model Years 2019-2022</b><br><b>Inspect Frame Reinforcement v2.0</b> | DATE: April 2024 |

## IMPORTANT RECALL CAMPAIGN INFORMATION

| Campaign No. : | Campaign Desc. : | Inspect Frame Reinforcement |
| 2024010007 | VS3ROHRAH | |

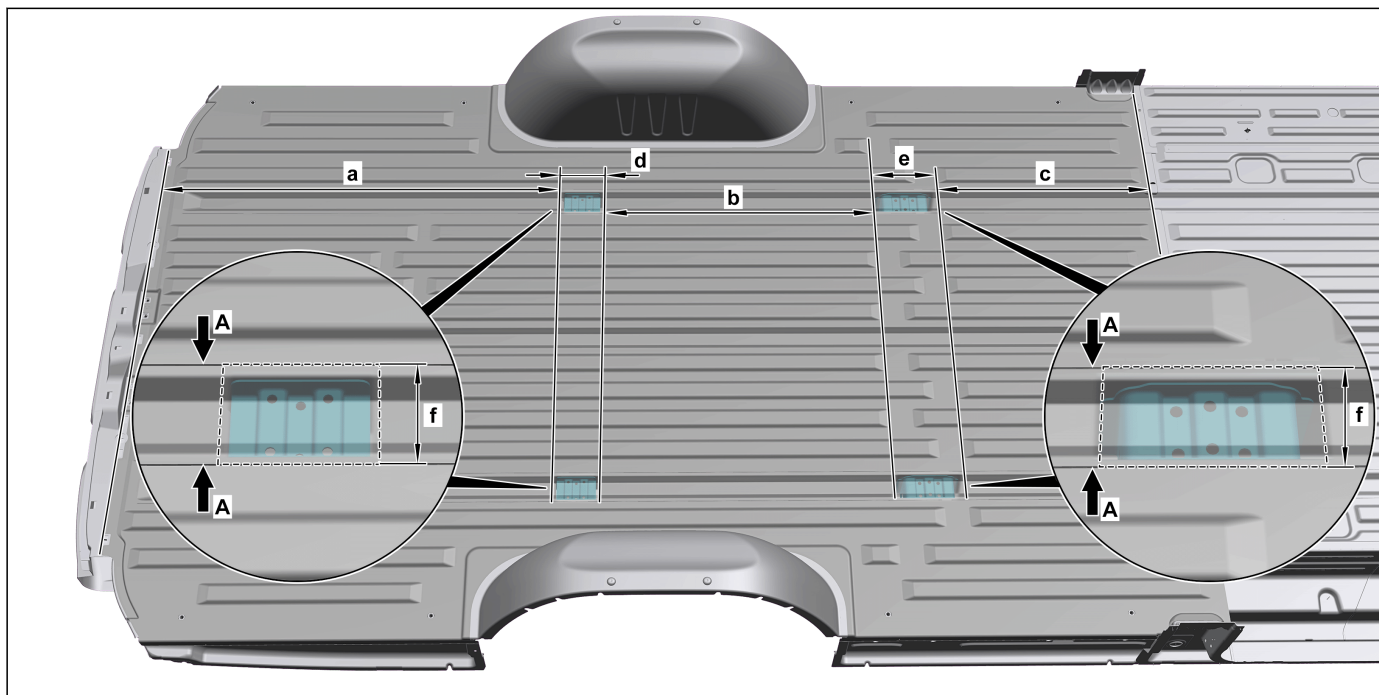
D61.25-A027-79

So that the missing reinforcements can be inserted into the longitudinal members, the vehicle floor must be cut at the corresponding installation locations so that the inside of the longitudinal members is accessible.

# 1 Mark separation lines on vehicle floor.

The width of the cutouts is based on the laser weld seams (arrows A).

Observe dimensions (a, b, c, d, e).

Dimension (a) is approx. 1,175 mm.

Dimension (b) is approx. 808 mm.

Dimension (c) is approx. 638 mm.

Dimension (d) is approx. 120 mm.

Dimension (e) is approx. 190 mm.
