TO: Freightliner Dealer Principals, General Managers, Service Managers, Parts Managers	FROM: Anthony Washington, Senior Manager, Regulations and Certifications
Re: Launch Recall Campaign Notification Model 907 Sprinter Model Years 2019-2021 Inspect Frame Reinforcement v2.0	DATE: April 2024

VERSION 2.0
ADDED INSPECTION STEPS VIA
BOREScope /ENDOSCOPE

Campaign No. :		Campaign Desc. :	Inspect Frame Reinforcement
2024010007		VS3ROHRAH	
This is to notify you of a Recall Campaign to inspect the Frame Reinforcement on approximately 130 MY 2019-2021 Freightliner Sprinter Vans. The recall campaign will be visible on the www.safercar.gov website and may generate questions from customers. All affected VINs will be flagged as "OPEN" in VMI and cannot be sold.			
Background			
Issue	Mercedes-Benz AG ("MBAG"), the manufacturer of Freightliner Sprinter Vans, has determined that on certain Sprinter (907 platform) vehicles, the longitudinal frame members of the body-in-white might not meet specifications. Missing reinforcements might lead to damage in the rear area of the longitudinal frame members. Over time, impairment of driving stability cannot be ruled out. In addition, vehicles equipped with

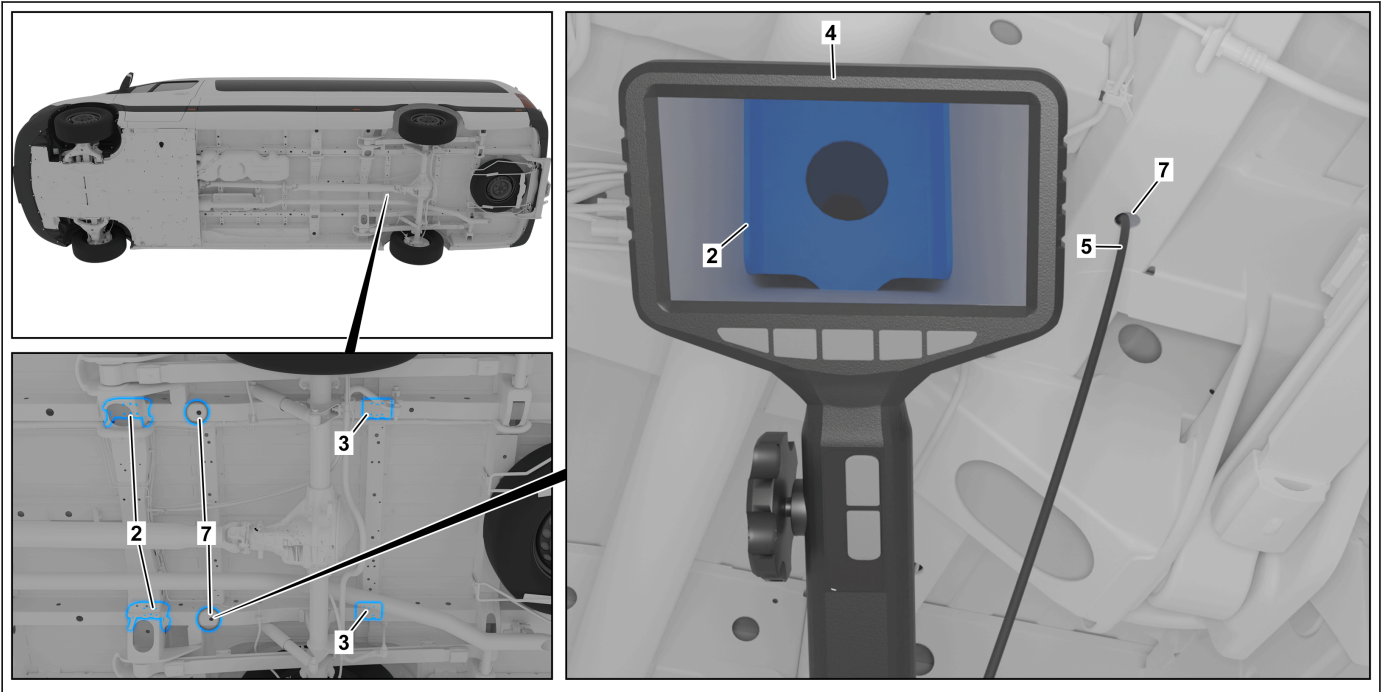
D61.25-A025-79

To do so, insert endoscopic camera (5) into longitudinal members through holes (6, 7) and check on terminal (4) whether reinforcements (2, 3) can be seen in longitudinal members. If reinforcements (2, 3) are present: ↓ Lower vehicle and end measure. If reinforcements (2, 3) are not present: ↓ Lower vehicle and continue with next operation step.

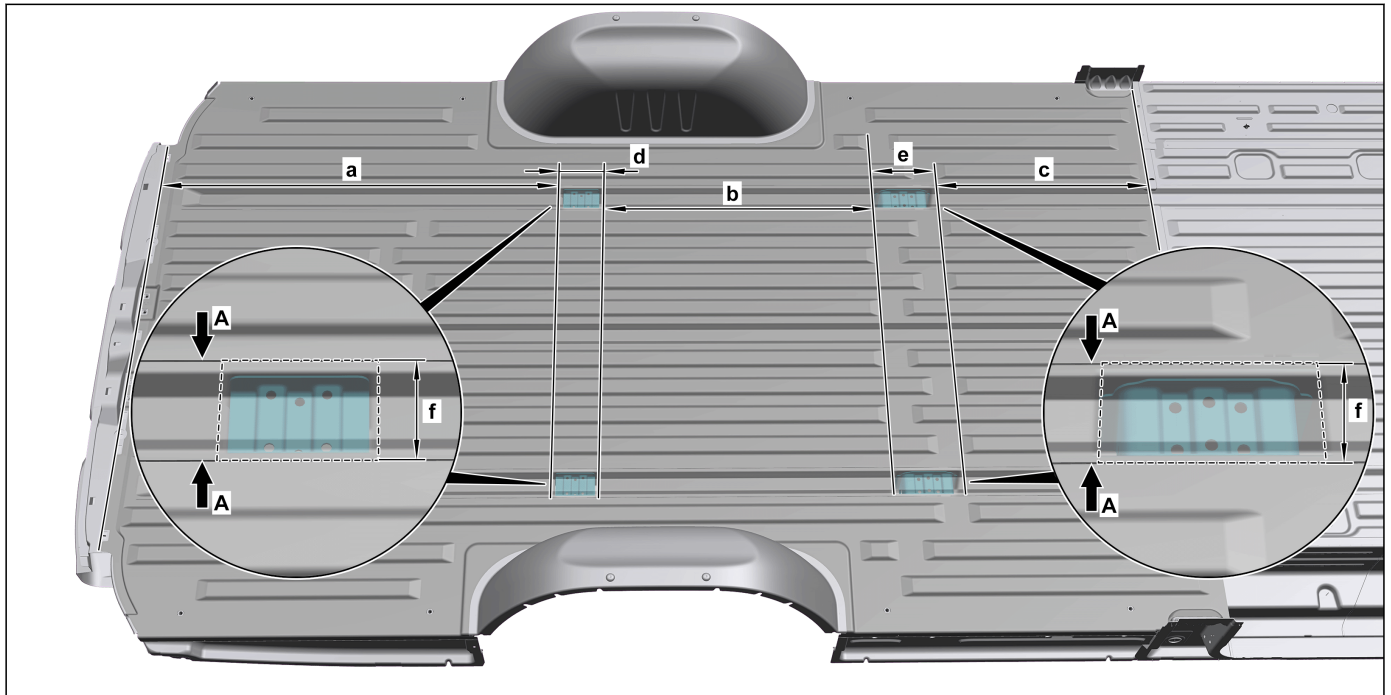
D61.25-A027-79

So that the missing reinforcements can be inserted into the longitudinal members, the vehicle floor must be cut at the corresponding installation locations so that the inside of the longitudinal members is accessible.

1 Mark separation lines on vehicle floor.

The width of the cutouts is based on the laser weld seams (arrows A).

Observe dimensions (a, b, c, d, e).

Dimension (a) is approx. 1,175 mm.

Dimension (b) is approx. 808 mm.

Dimension (c) is approx. 638 mm.

Dimension (d) is approx. 120 mm.

Dimension (e) is approx. 190 mm.
