**Wax Inside of Integral Carrier**

Campaign No. 2024020011, March 2024

SUBJECT: **Model EQE (295 platform)**  
**Model Year 2023 – 2024**

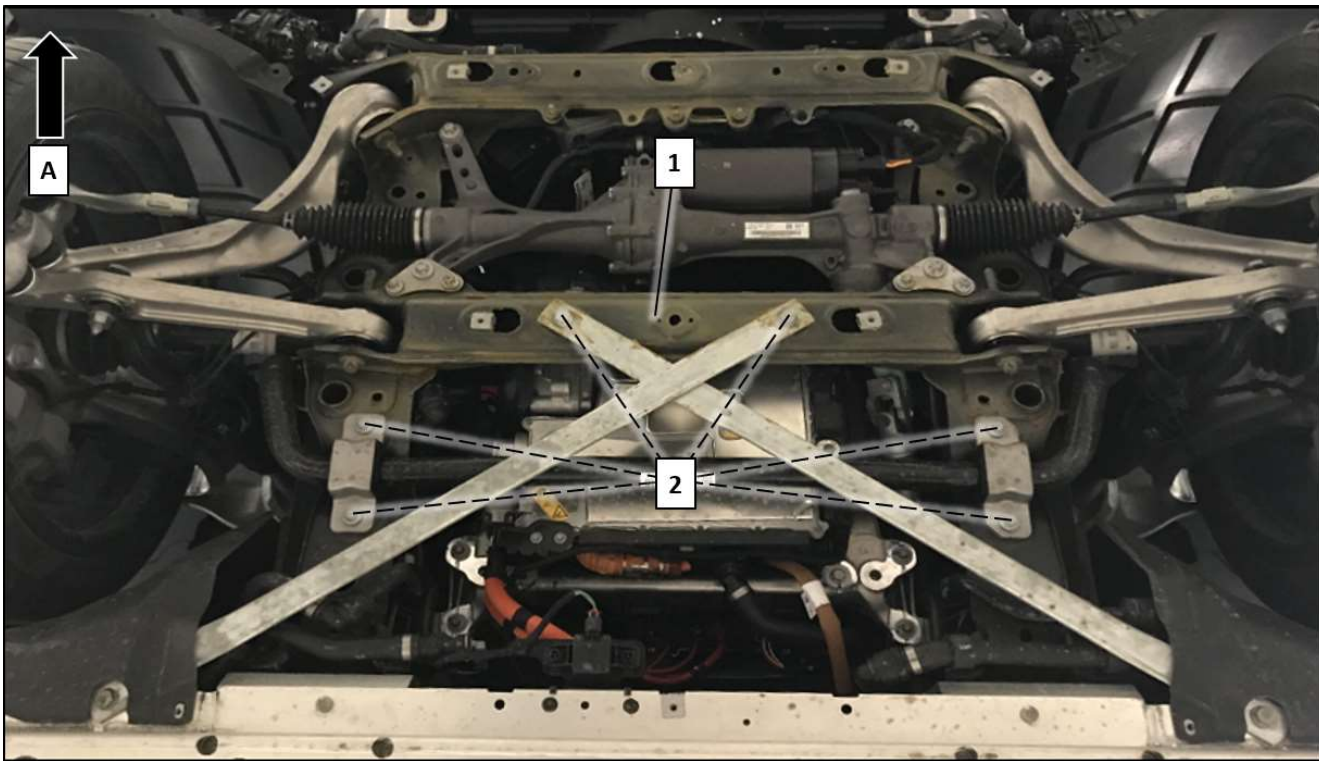
**Figure 1** Vehicle underside in direction of travel (arrow A)

**Issue**  
Mercedes-Benz AG, the manufacturer of Mercedes-Benz vehicles, has determined that on certain MY 2023-2024 EQE Sedan (295 platform) vehicles, the integral carrier may not meet production specifications. It is possible that over the lifetime of the vehicle, corrosion could occur around the six rivet nuts.

2. Wax the inside of the integral carrier (Figures 1 and 2, 1) in the area of the rivet nuts (Figures 1 and 2, 2) with cavity preservation wax.
