TO: Mercedes-Benz Dealer Principals, General Managers, Sales Managers, Service Managers, Parts Managers	FROM: Anthony Washington, Senior Manager, Regulations and Certifications
<b>Re: Launch Recall Campaign Notification</b> <b>Model: Metris (447)</b> <b>Model Years: 2016-2021</b> <b>Replace eCall Communication Module Metris</b>	DATE: April, 2024

<b>Campaign No. :</b>	<b>Campaign Desc. :</b>	<b>Replace eCall Communication Module</b>
<b>2024030014</b>	<b>VS2SIMKOW</b>	
<p>This is to notify you of a Recall Campaign launch to replace the eCall Communication Module on approximately <b>24</b> MY 2016-2021 Metris Vans. The recall campaign will be visible on the <a href="http://www.safercar.gov">www.safercar.gov</a> website and may generate questions from customers. All affected VINs will be flagged as "<b>OPEN</b>" in VMI and cannot be sold until remedied.</p>		
<b>Background</b>		
<b>Issue</b>	<p>Mercedes-Benz AG ("MBAG"), the manufacturer of Mercedes-Benz Metris vans, has determined that due to an interaction between a SIM card security mechanism and the affected SIM profile, the SIM card might inadvertently become disabled. Should this occur, the communication module would not be able

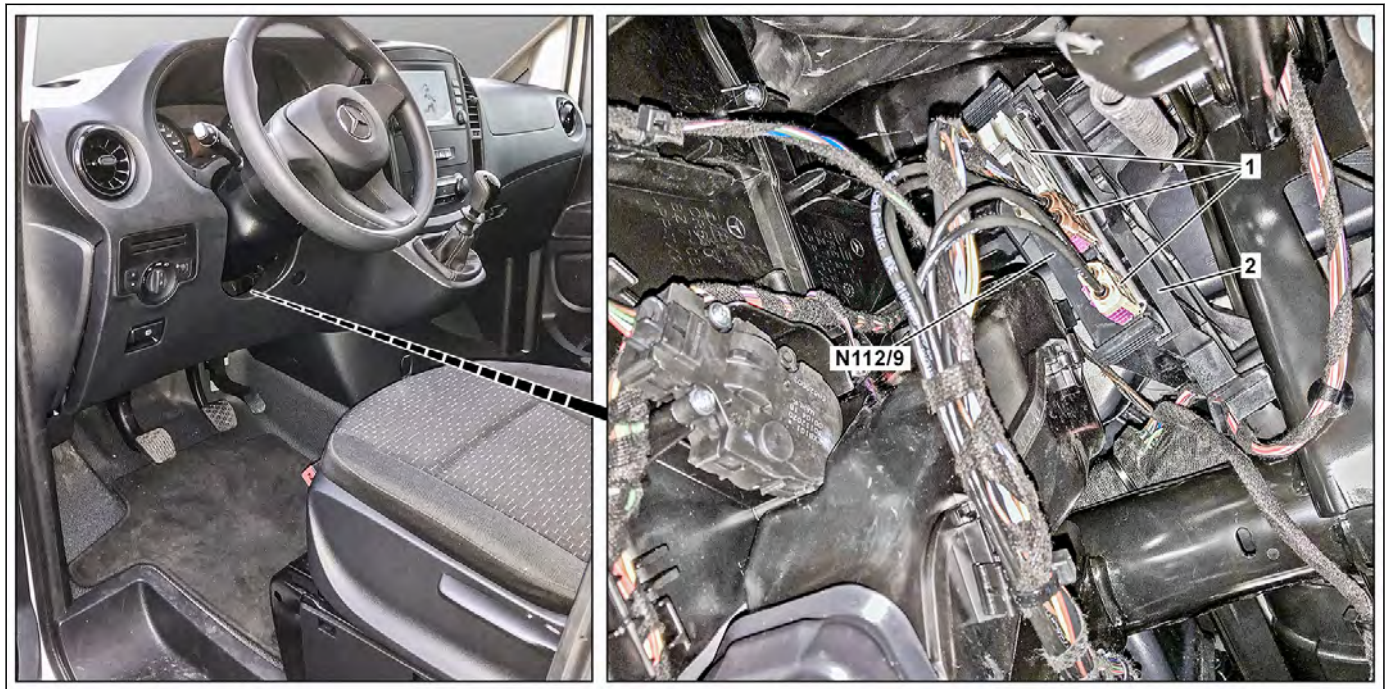
S82.95-A014-79

- 1 Electrical connector
- 2 Bracket

N112/9 HERMES control unit

<b>Install</b>		
10	Install new HERMES control unit (N112/9) on holder (2) and lock.

<b>The new HERMES control unit (N112/9) is commissioned in operation step 14.</b>	
11	Connect electrical connectors (1).

To do so, lock U-shaped striker and pull in electrical connectors (1).	
12	Install air duct on instrument panel.	If installed.
