| <b>Re: Launch Recall Campaign Notification</b><br><b>Model: Sprinter (907)</b><br><b>Model Years: 2019-2021</b><br><b>Replace eCall Communication Module</b> | DATE: April, 2024 |

| Campaign No. : | Campaign Desc. : | Replace eCall Communication Module |
| 2024030013 | VS3SIMKOW | |

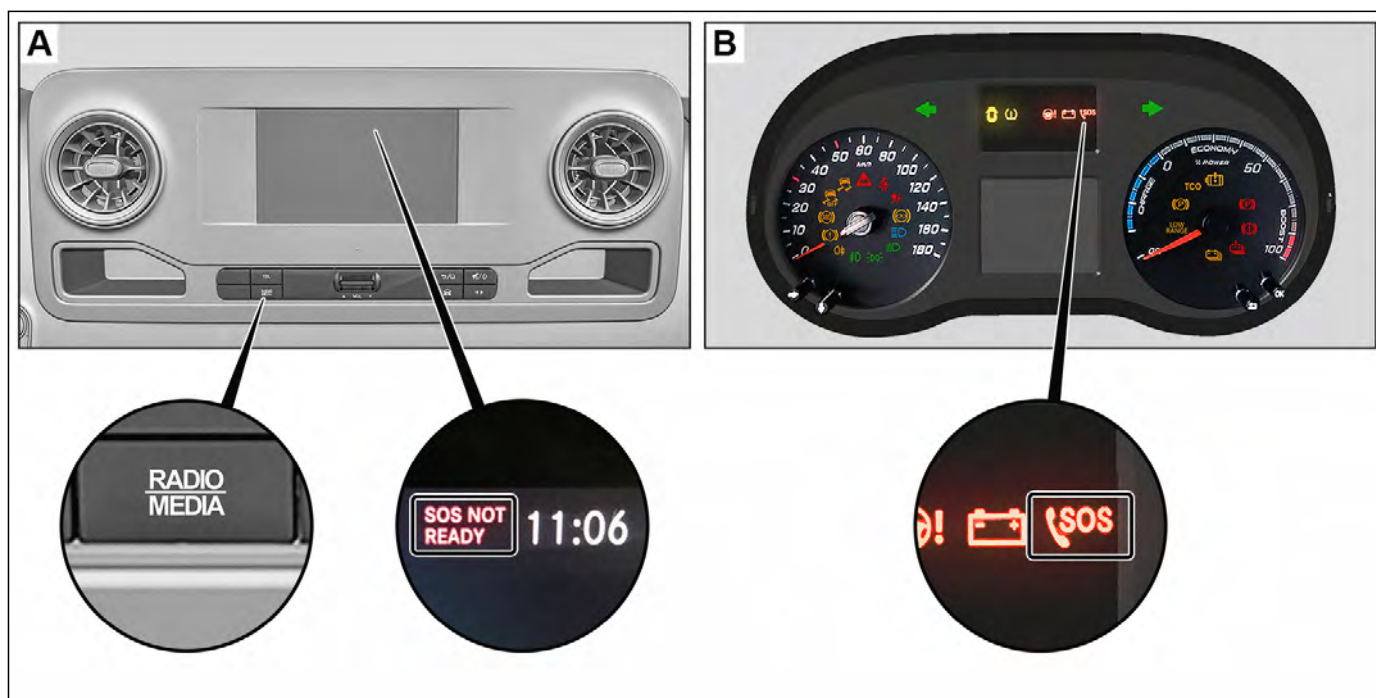
D82.95-A011-79

| 8.1 | Perform function test of emergency call system. | Model 907 with code E3M (MBUX multimedia system with 7-inch touchscreen) or code E4M (MBUX multimedia system with 10.25-inch touchscreen)<br><br><b>See Fig. A.</b><br><br>To do so, press start button once, without touching brake pedal, to switch ignition to position 1. Then set head unit to radio menu and check whether "SOS-NOT READY" appears in display. Press start button a second time, without touching brake pedal, to switch ignition to position 2. Check whether "SOS-NOT READY" disappears automatically in display. | |

| 8.2 | Perform function test of emergency call system. | Model 907 except code E3M (MBUX multimedia system with 7-inch touchscreen) except code E4M (MBUX multimedia system with 10.25-inch touchscreen)<br><br><b>See Fig. B.</b><br><br>To do so, press start button twice, without touching brake pedal, to switch ignition to position 2. Check whether "SOS" warning lamp in instrument cluster goes out automatically. | |
