| RE: <b>Service Campaign Launch Notification</b><br><b>Check Top of Right and Left Fenders at A-Pillar Paneling</b><br><b>MY23 CLA (118 platform)</b> | DATE: May 10, 2024 |

Campaign No. 2024040014, May 2024

## **Check Top of Right and Left Fenders at A-pillar Paneling**

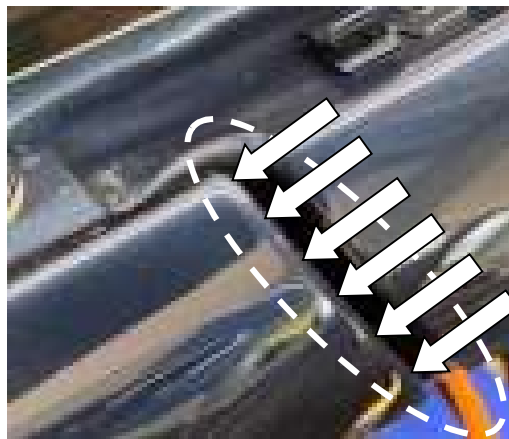
Figure 2

1. Remove drip rail on right and left of windshield.  
i For basic data, see **AR88.80-P-4000MFA**.
2. Unscrew screw (**Figure 1, 1**) on right and left side of vehicle.
3. Lift fender above and check A-pillar paneling (**Figure 2, arrows**) for paint damage (cracking/chipping, deformations or rubbing).

- a. Paint surface (**Figure 2, arrows**) on **right** and/or **left** is damaged: **Carry out Work Procedure.**  
**NOTE:** Document pictures of damage for submission of **TIPS case**.
- b. Paint surface (**Figure 2, arrows**) on **right** and/or **left** is **not** damaged: **End measure.**
