TO: Mercedes-Benz Dealer Principals, General Managers, Sales Managers, Service Managers, Parts Managers	FROM: Gregory Gunther, Department Manager, Vehicle Compliance and Analysis, Engineering Services
RE: Service Campaign Launch Notification Replace Tire Pressure Label MY20-21 167(GLE-Class, GLS-Class)	Date: November 13, 2020

Campaign No. 2020110009, November 2020

SUBJECT: **Model GLE-Class and GLS-Class vehicles (167 and X167 platform)**
Model Year 2020-2021

Replace Tire Pressure Labels

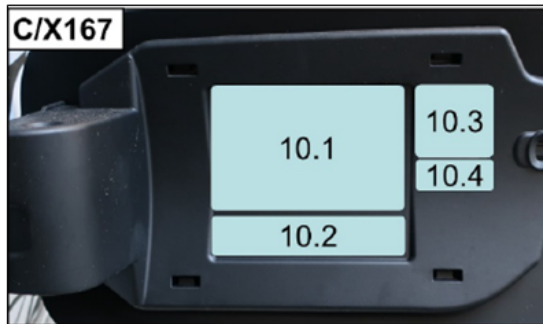
Figure 1

1. Replace tire pressure information label (**figure 1**) on inside of fuel filler flap (**bonding position 10.1, figure 2 or 3**).

100 kPa = 1 bar		lbf/in²		PSI	
245/50 R18	240	35	260	38	
245/40 R20	270	39	310	45	
275/35 R20	270	39	310	45	
245/50 R18	240	35	260	38	
275/45 R18	260	38	300	44	
245/45 R19	240	35	240	35	
275/45 R19	240	35	260	38	
245/45 R19 M&S	240	35	270	39	
	270	39	320	46

i Remove tire pressure information label on inside of fuel filler flap, remove any residual adhesive, and clean bonding surface.

i The tire pressure information label must be determined in accordance with the equipment code for the vehicle identification number via the parts process in the XENTRY Portal!

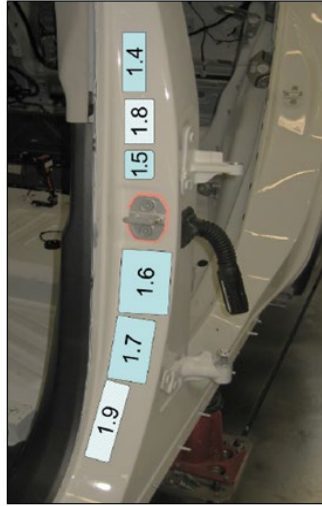
Figure 4

2. Replace additional tire pressure label (**figure 4**) at left B-pillar (**bonding position 1.7, figure 5**).

i Remove additional tire pressure label at left B-pillar, remove any residual adhesive, and clean bonding surface.

i The additional tire pressure label must be determined in accordance with the equipment code for the vehicle identification number via the parts process in the XENTRY Portal!

i Air pressure data in VeDoc system must be taken from new additional tire pressure label (**figure 4**).

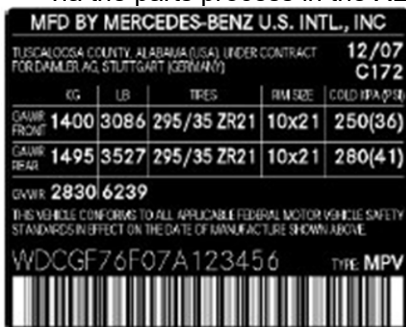
Figure 7

2. Replace identification plate (figure 7) at left B-pillar (bonding position 1.6, figure 5).
 i Only order and replace identification plate after the change in the VeDoc system, as this will be printed based on the updated data in VeDoc!
 i Remove identification plate at left B-pillar, remove any residual adhesive, and clean bonding surface.
 i The identification plate must be determined in accordance with the equipment code for the vehicle identification number via the parts process in the XENTRY Portal!

If needed, only order and replace identification plate (Work procedure B) after the change in the VeDoc system, as this will be printed based on the updated data in VeDoc!
