TO: Mercedes-Benz Dealer Principals, General Managers, Sales Managers, Service Managers, Parts Managers	FROM: Gregory Gunther, Department Manager, Vehicle Compliance and Analysis, Engineering Services
RE: <b>Emission Recall Campaign Notification</b> <b>Check Activated Carbon Filter</b> <b>MY18-19 C/E-Class (205/238 platforms)</b>	DATE: February 12, 2021

## Check Activated Carbon Filter

Campaign No. 2020090018, February 2021

SUBJECT: **Model C/E-Class vehicles (205, 238 platform)**  
**Model Year 2018-2019**  
**Check Activated-Carbon Filter**

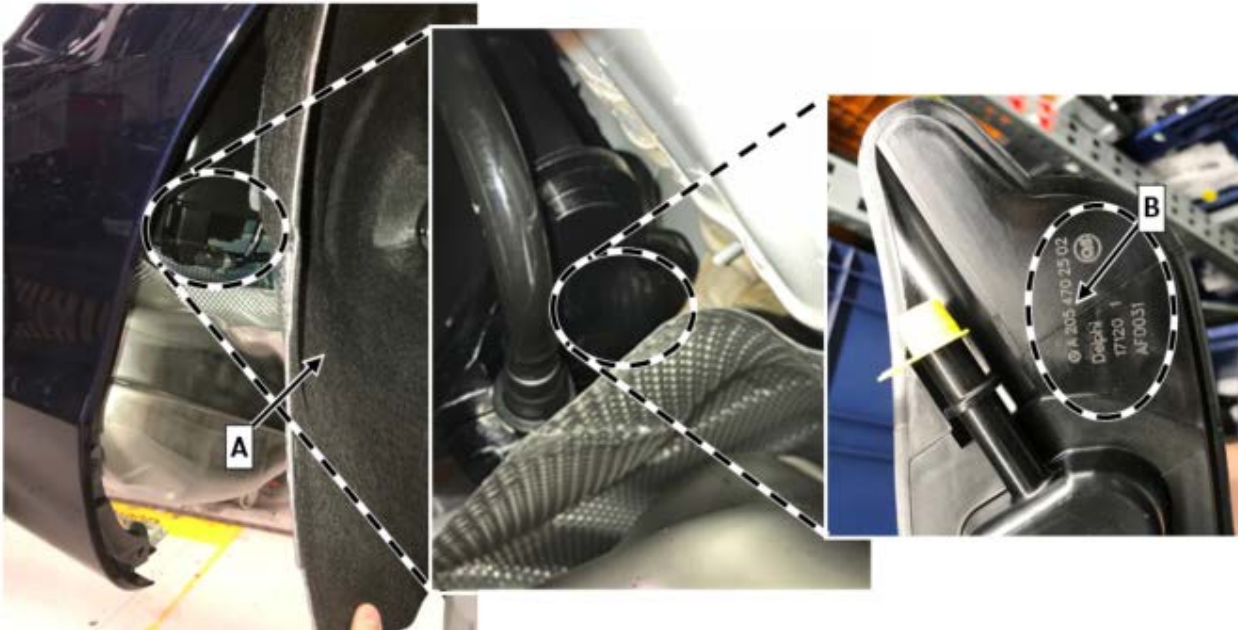
Figure 1

1. Remove right rear wheel and partially release fender skirt (**A, figure 1**) so that the part number on the activated charcoal canister can be read off.

2. Read off part number of activated charcoal canister (**B, figure 1**) in lower area of activated charcoal canister.

**i** Activated charcoal canisters with the part number **A 205 470 04 59** must be replaced!

- a. **A 205 470 04 59** installed: Carry out **work procedure**.
- b. **A 205 470 04 59** *not* installed: **End measure**.

1. Replace activated charcoal canister.

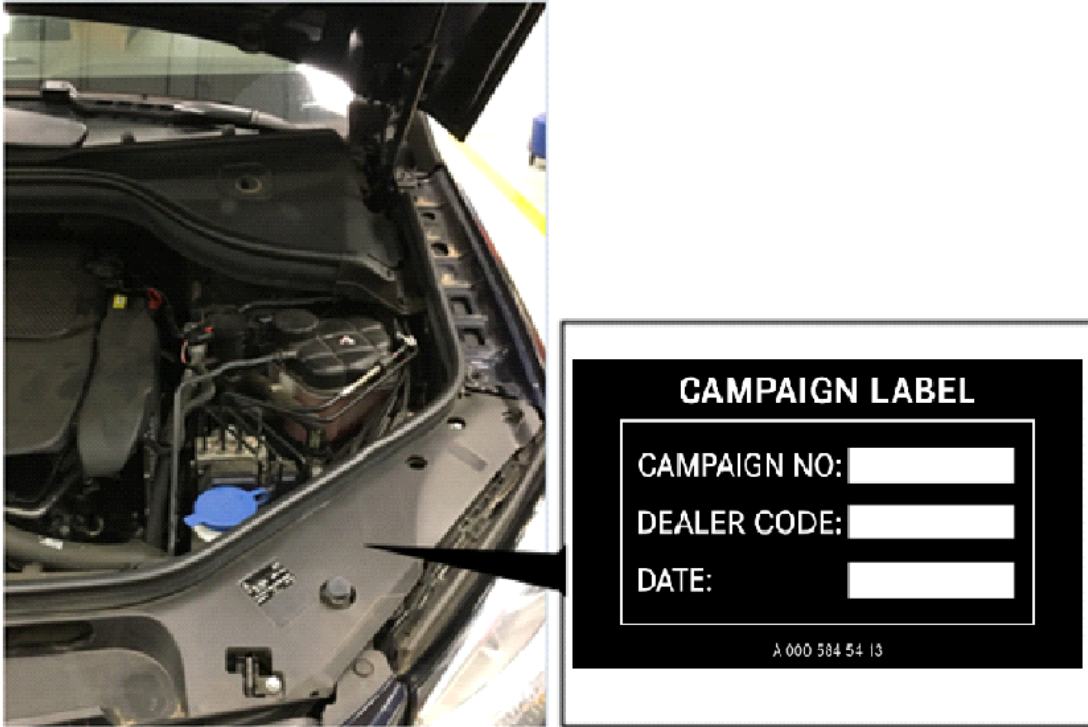
**Figure 2**

**i** **Proof of Correction Certificate and Label must be completed for (Check/test procedure) and/or (Work procedure).** Apply Proof of Correction Label (A 000 584 54 13) to area identified in Figure 2. Fill in Campaign 200918 your dealer code, and the date of the repair, using a black permanent marker.

**i** Note: Clean bonding surface prior to affixing label.
