Campaign No. 2022070004, August 2022

SUBJECT: **Model E-Class, S-Class & AMG GT (213, 217, 222, 223 and 290 platform)
Model Year 2018 - 2024**

Replace Braided Hose of Low-Pressure Fuel Line

Replace braided hose of right low-pressure fuel line

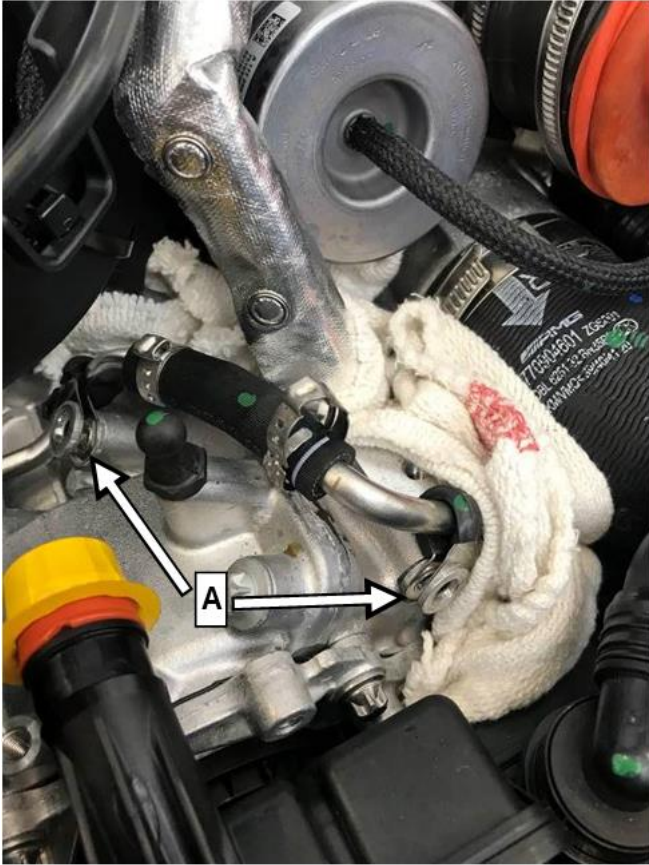
Figure 2

4. Unscrew fastening clamps of low-pressure line (**Figure 2, A**) upstream and downstream of the braided hose.

i The fastening clamps (**Figure 2, A**) should not be removed.

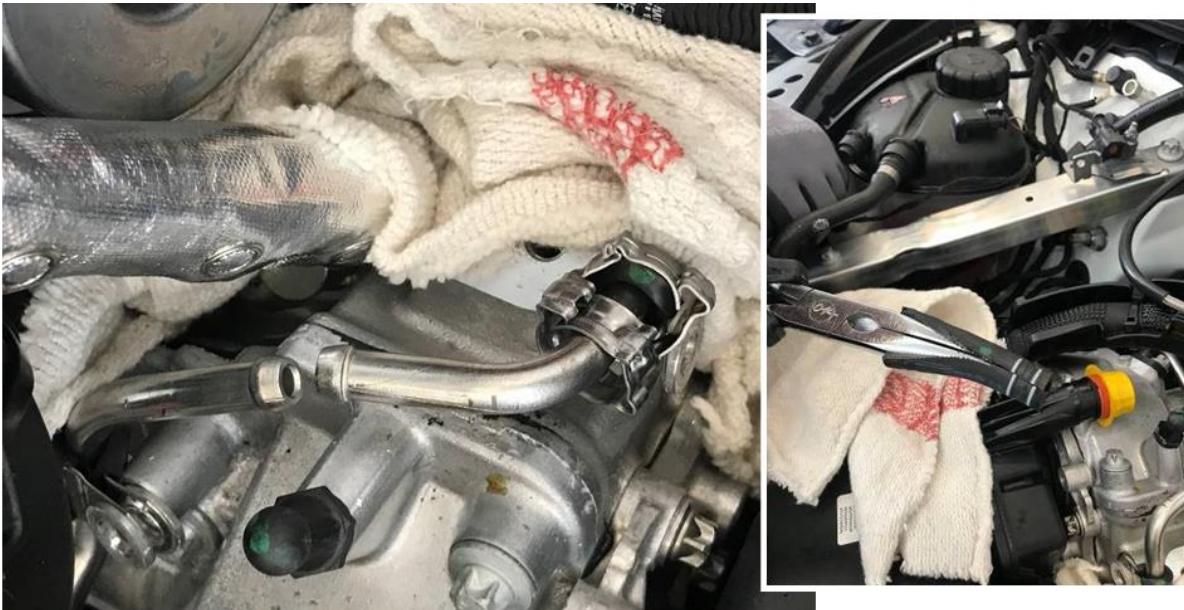
Figure 3

5. Open CLIC clamps on the braided hose and take off (**Figure 3, Left**). Carefully cut through the braided hose along its length and remove from the metal line (**Figure 3, Right**).

i This makes it easier to remove the braided hose from the metal line.

i Cover work environment with a rag so that the remaining fuel is collected.

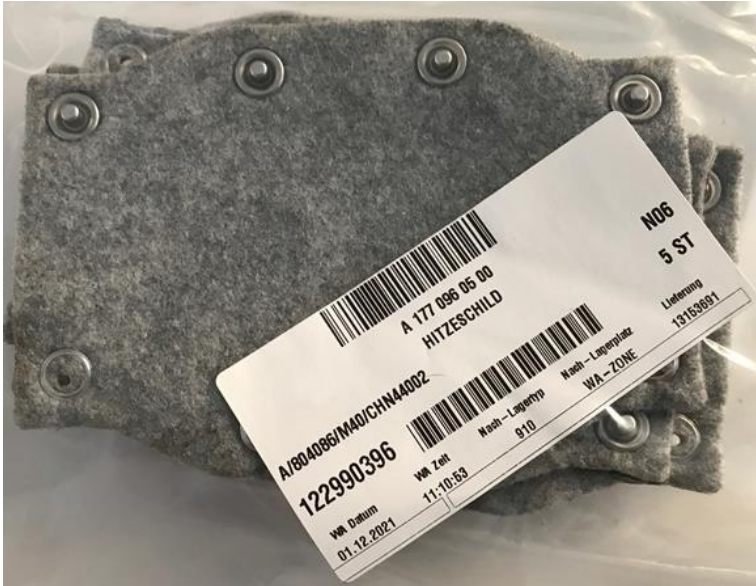
Figure 5

7. Install heat shield over the new braided hose.

i Close snap fasteners.
