Campaign No. 2022070004, August 2022

SUBJECT: **Model S-Class (217 and 222 platform)**  
**Model Year 2018 - 2021**

## **Replace Braided Hose of Low-Pressure Fuel Line**

## Replace braided hose of right low-pressure fuel line Model 217 and 222

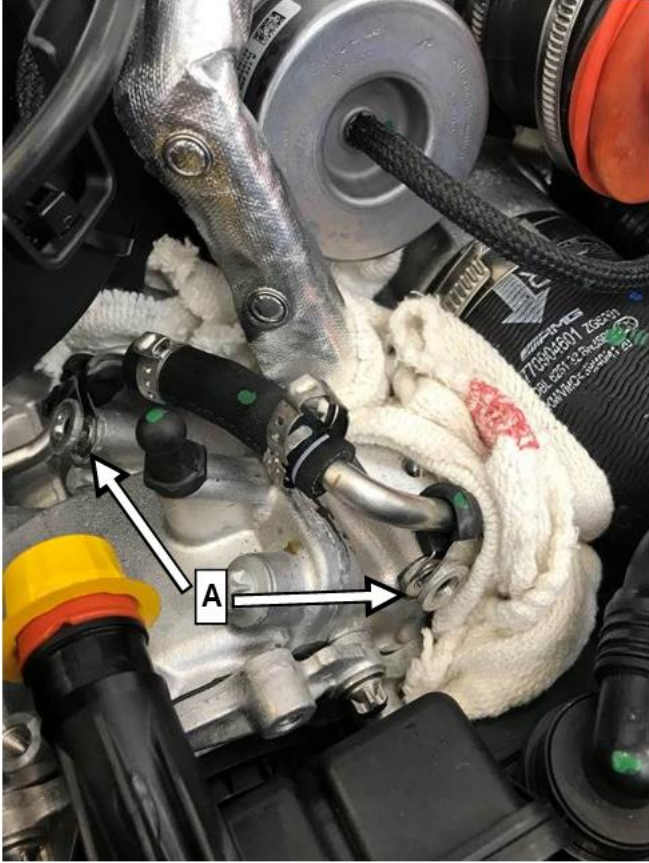
Figure 2

4. Unscrew fastening clamps of low-pressure line (**A, Figure 2**) upstream and downstream of the braided hose.

**i** The fastening clamps (**A, Figure 2**) should not be removed.

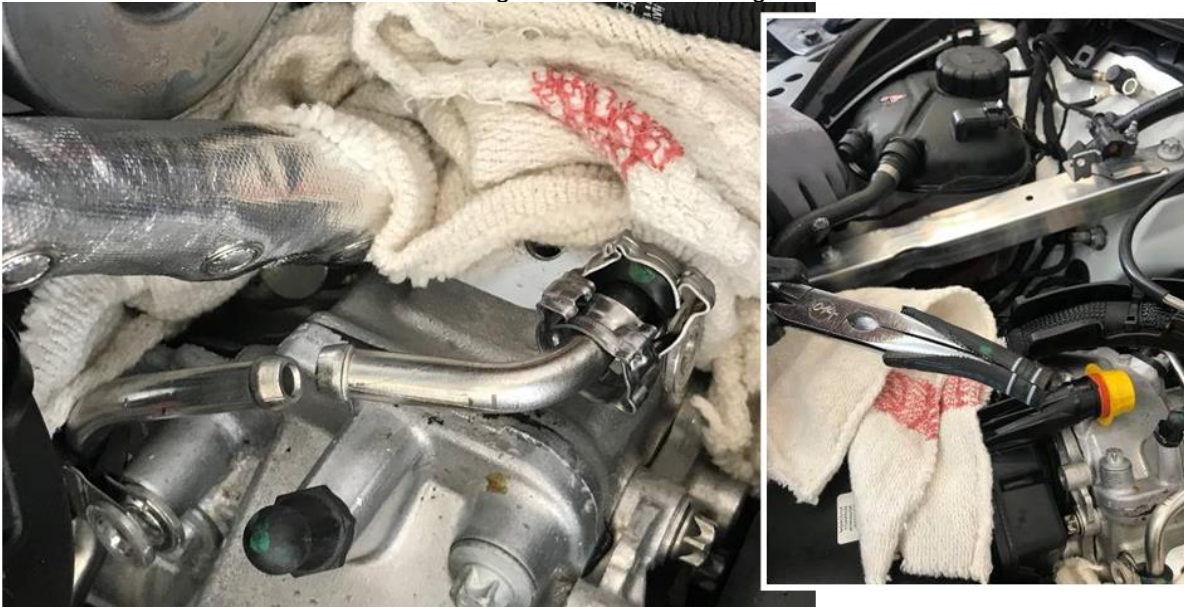
**Figure 3**

5. Open CLIC clamps on the braided hose and take off (**figure 3, left**). Carefully cut through the braided hose along its length and remove from the metal line (**figure 3, right**).

**i** This makes it easier to remove the braided hose from the metal line.

**i** Cover work environment with a rag so that the remaining fuel is collected.

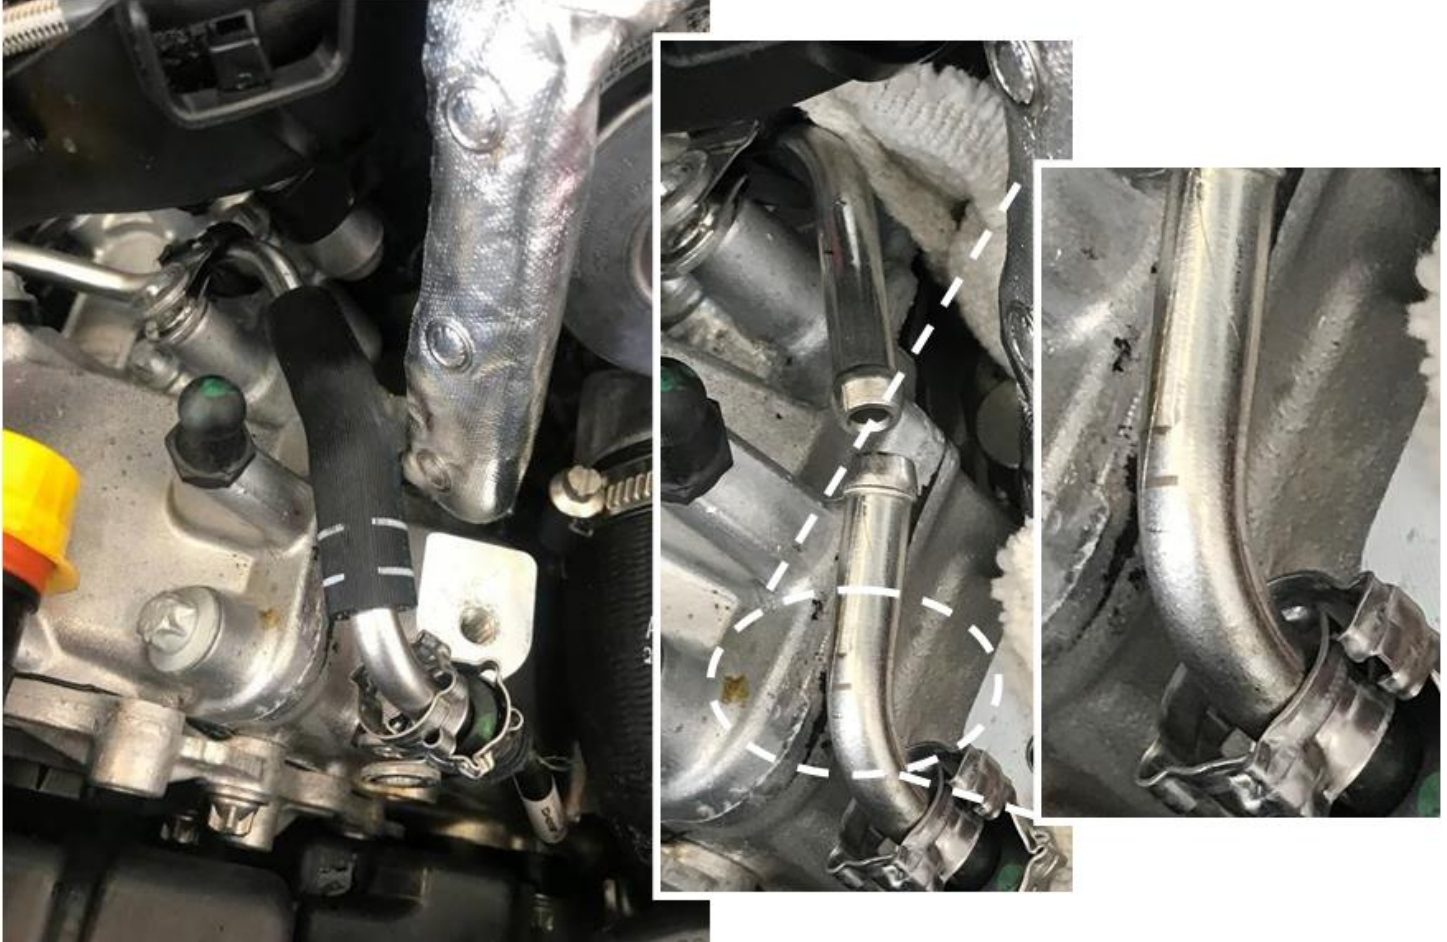
**Figure 4**

6. Slide on new braided hose, position, and fasten with new CLIC clamps.

**i** Position braided hose on metal line based on markings (**figure 4, middle and right**).

**i** Slide CLIC clamps onto line before the fabric hose.

**i** Metal lines must not be bent during assembly!

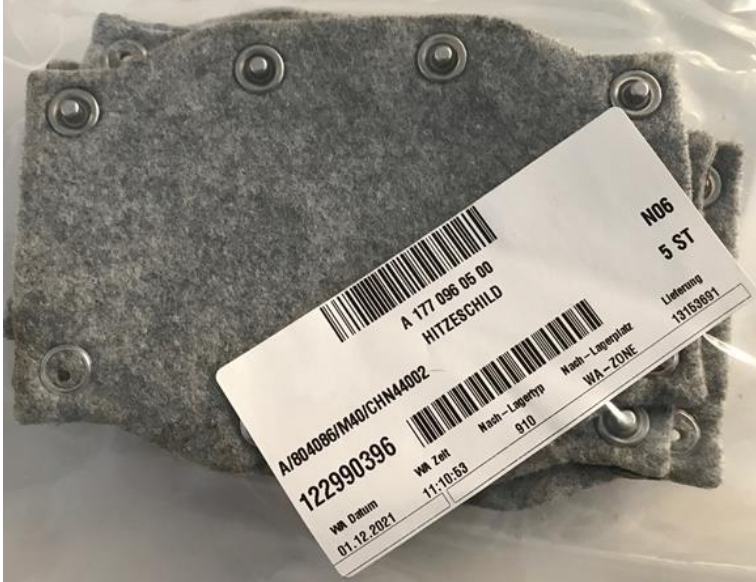
Figure 5

7. Install heat shield over the new braided hose.

**i** Close snap fasteners.
