Service Campaign Bulletin

Campaign No. 2022090008 October, 2022

SUBJECT: **Model 447 Metris Model Year 2021 Inspect
Clamps on Heating Circuit Hose Lines**

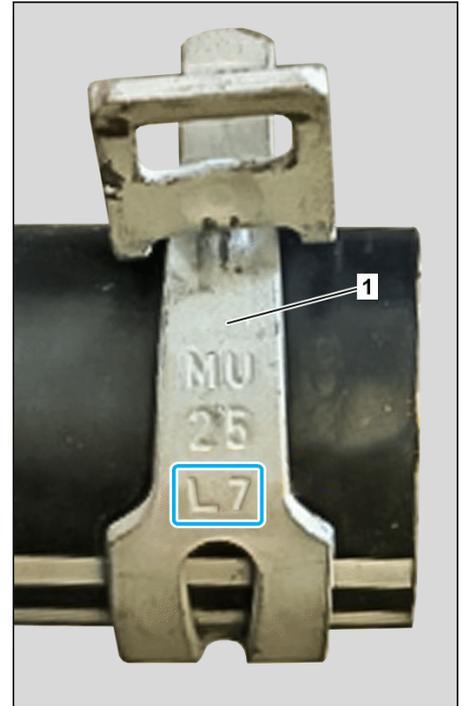
S83.20-A004-73

Shown here is a faulty clamp (1)

1 Clip

If at least one clamp (1) has the identifier "L7", the entire affected component part must be replaced.</p> <p>Otherwise, leak tightness of the heating circuit is not guaranteed.</p>	Page 14
<p>3.2</p> <p>

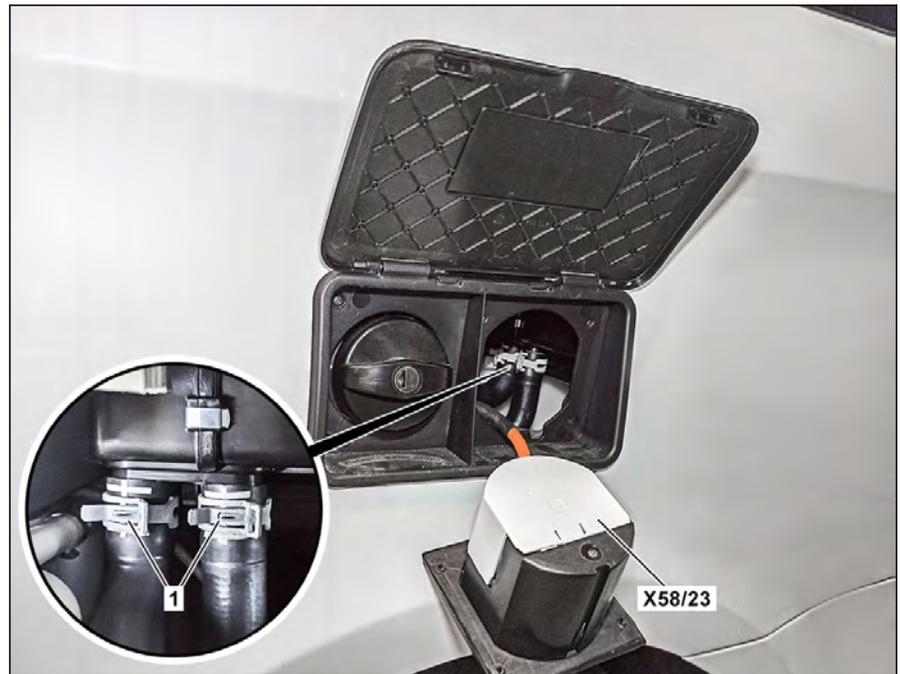
S83.20-A035-76

Model 447 with code ZK7 (MARCO POLO equipment line)

1 Clamps

X58/23 230 V feed socket

Use a suitable endoscope camera to check the clamps (1).</p> <p>The test is performed through the body cutout for the 230 V feed socket (X58/23).</p>	<p>Page 17</p> <p>WS01.00-P-0097B</p>

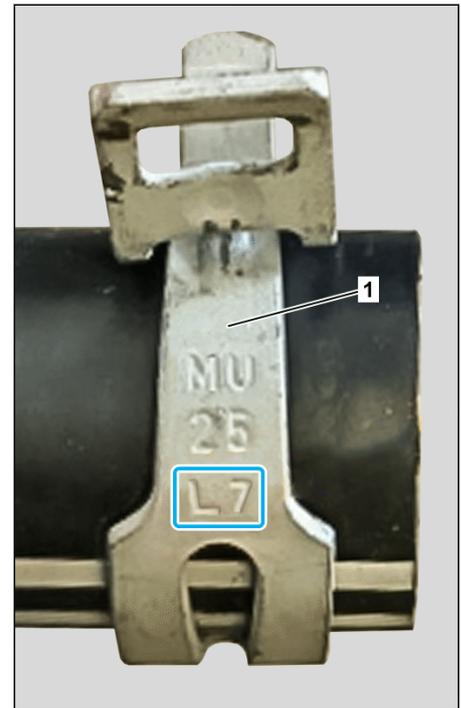
S83.20-A004-73

Shown here is a faulty clamp (1)

1 Clip

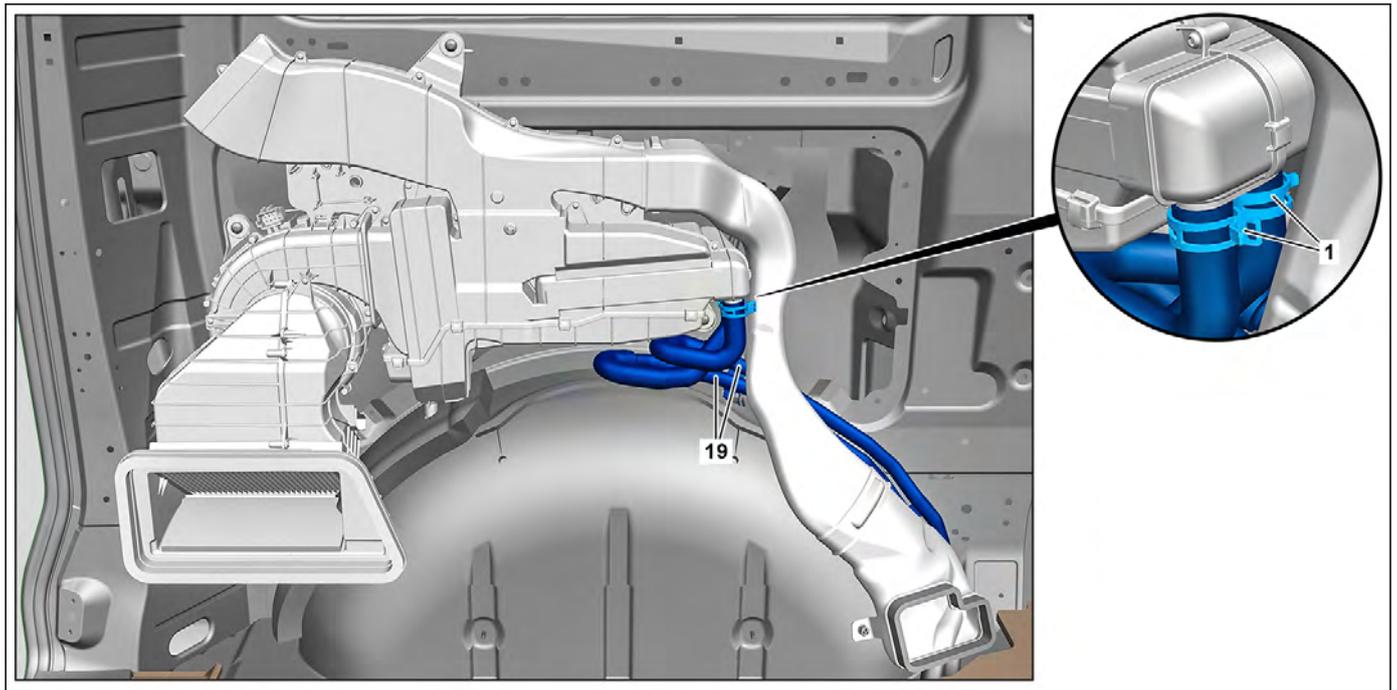
S83.20-A033-79

Model 447 with code IN1 + (H13/HZ7)

1 Clamps

19 Coolant hoses including heating circuit coolant lines in rear area

If at least one clamp (1) has the identifier "L7", the entire affected component part must be replaced.</p> <p>Otherwise, leak tightness of the heating circuit is not guaranteed.</p> <p>

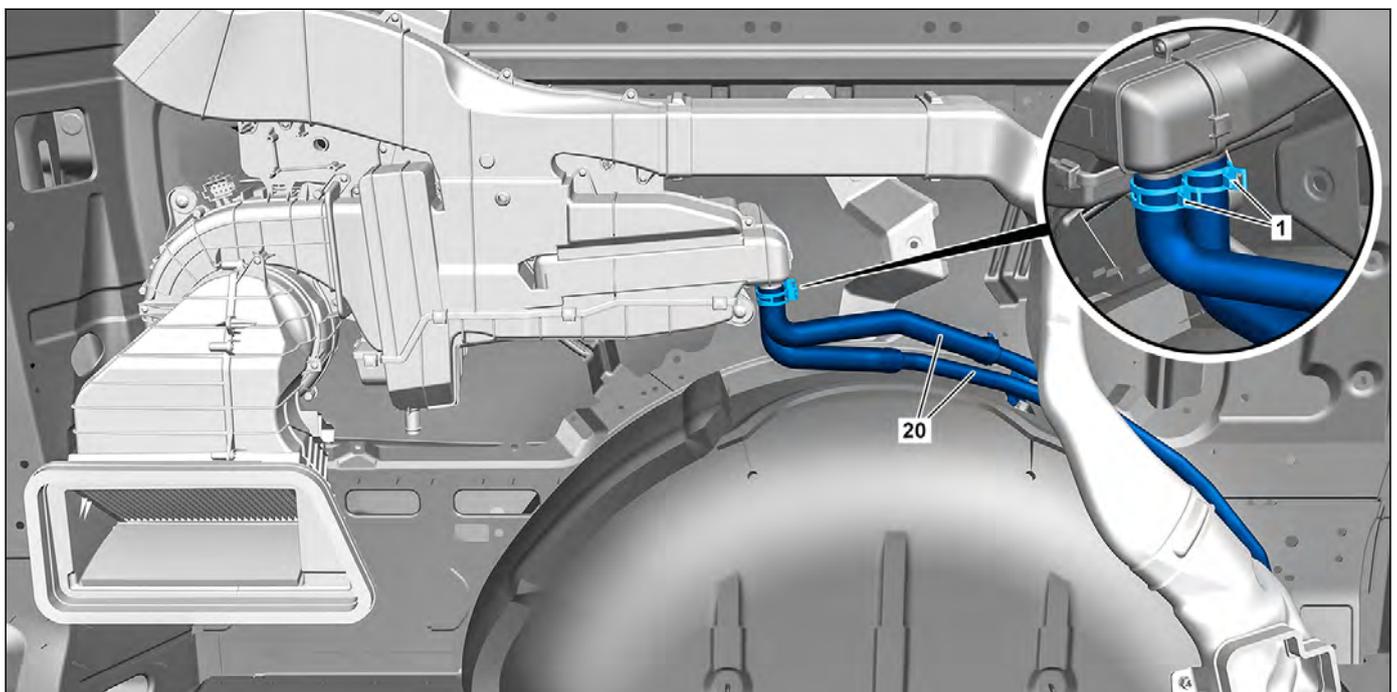
S83.20-A034-79

Model 447 with code (IN2/IN3) + (H13/HZ7)

1 Clamps

20 Coolant hoses including heating circuit coolant lines in rear area

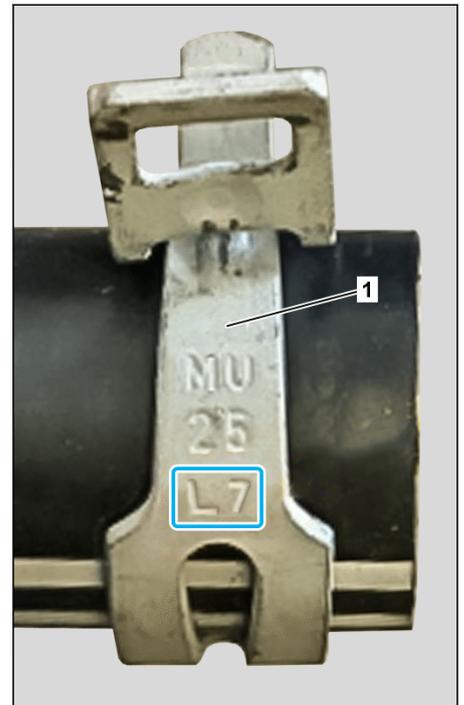
S83.20-A004-73

Shown here is a faulty clamp (1)

1 Clip

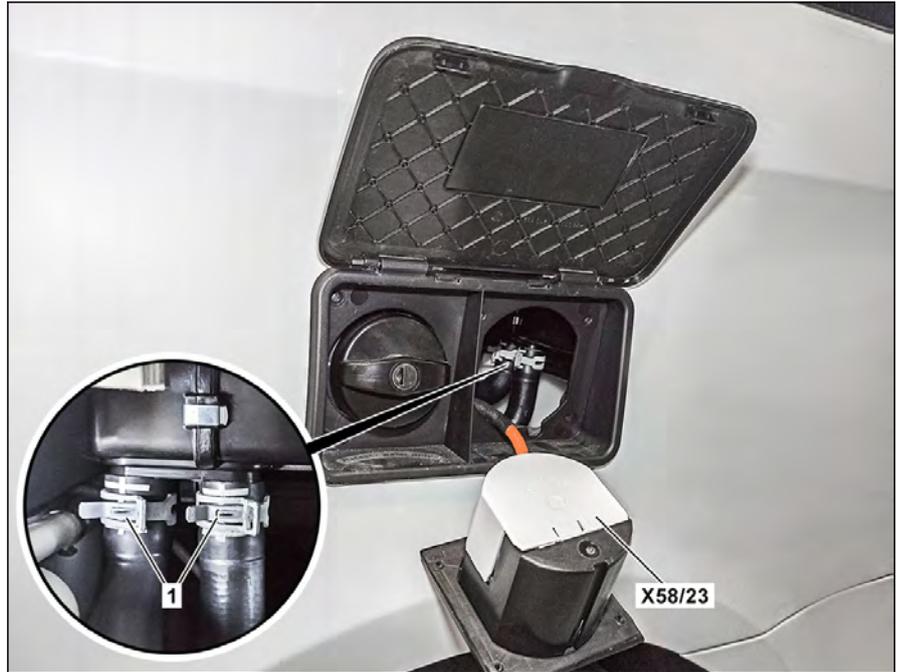
S83.20-A035-76

- 1 Clamps
- X58/23 230 V feed socket

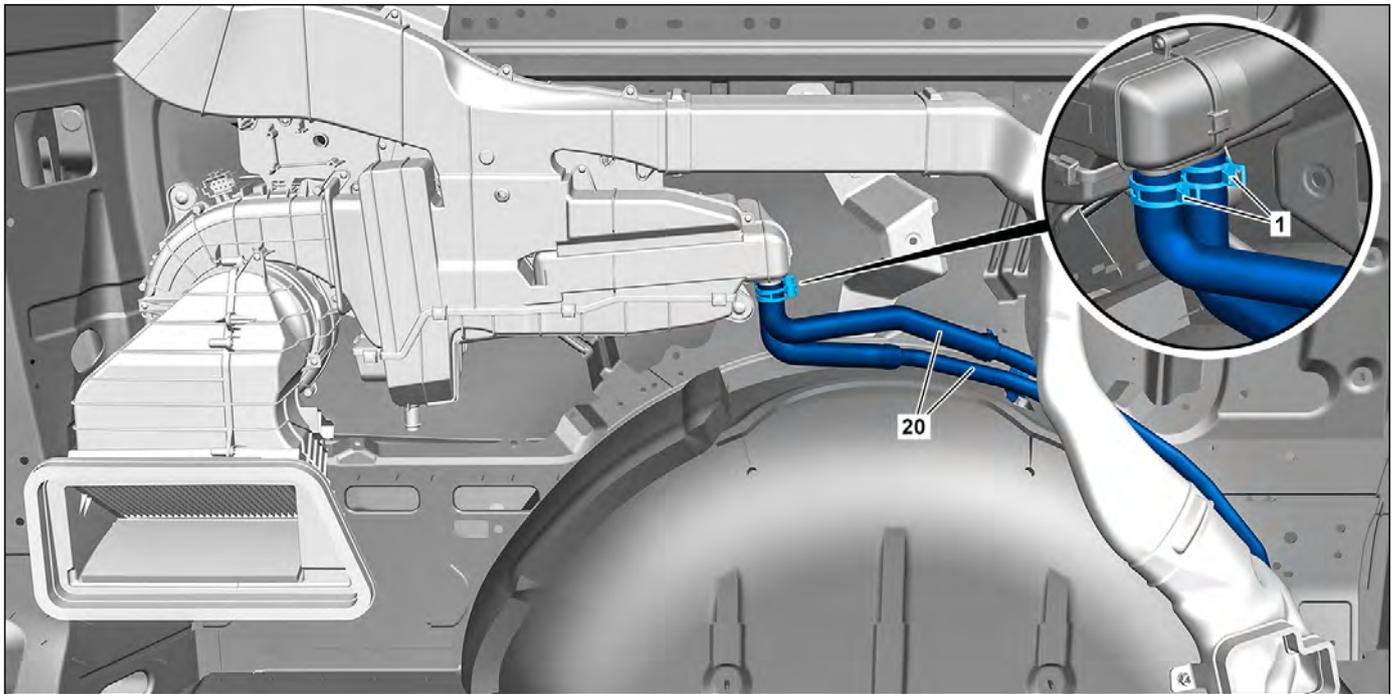
S83.20-A034-79

Model 447 with code IN2 + (H13/HZ7)

- 1 Clamps
- 20 Coolant hoses including heating circuit coolant lines in rear area

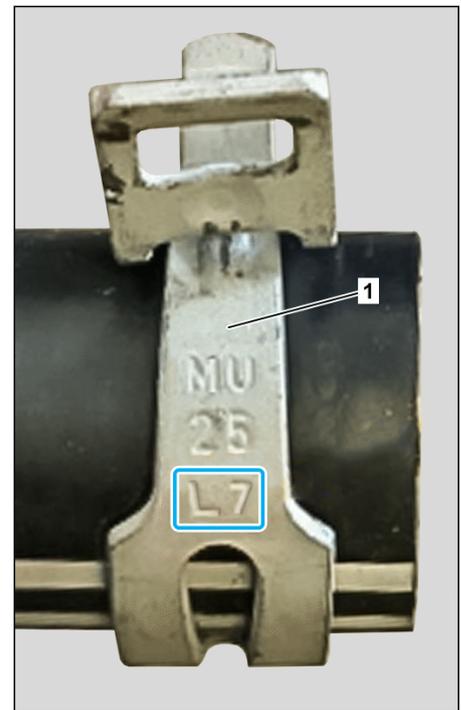
S83.20-A004-73

Shown here is a faulty clamp (1)

1 Clip

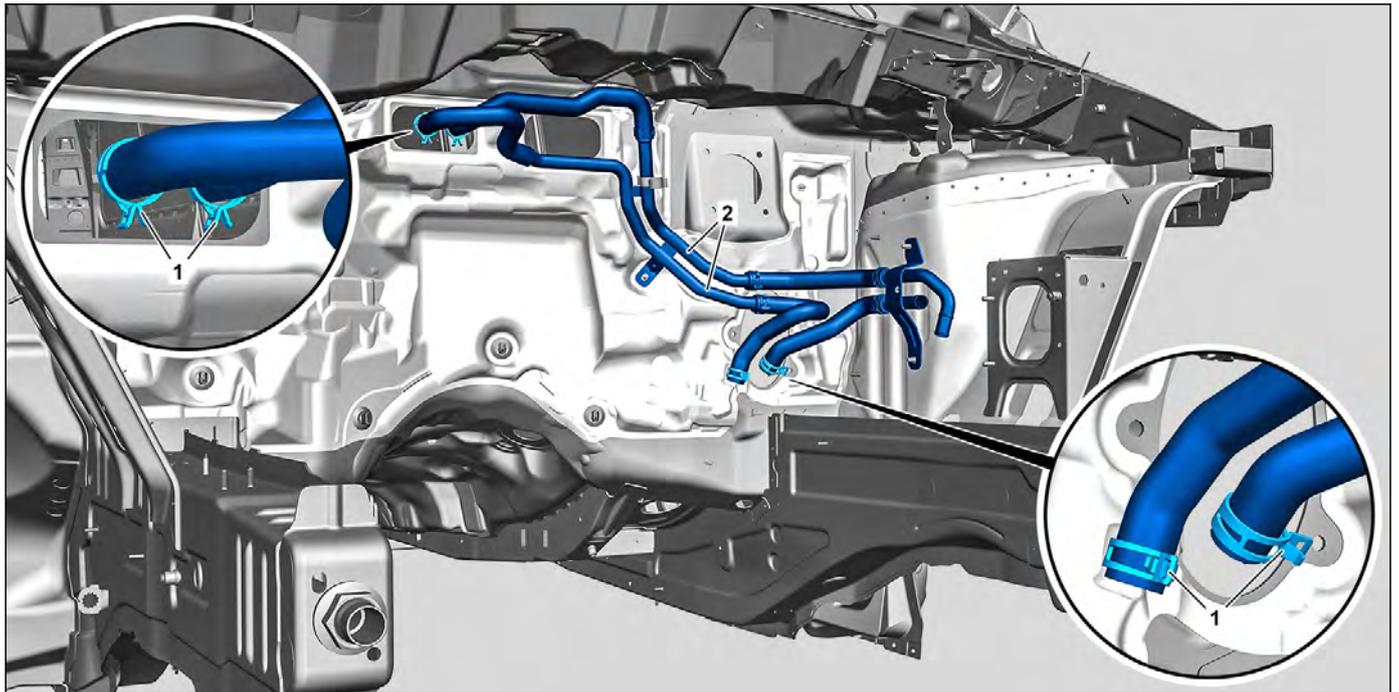
S83.20-A018-79

Model 447 with code H12

- 1 Clamps
- 2 Coolant hoses including heating circuit coolant lines in engine compartment at firewall

If at least one clamp (1) has the identifier "L7", the entire affected component part must be replaced.</p> <p>Otherwise, leak tightness of the heating circuit is not guaranteed.</p> <p>

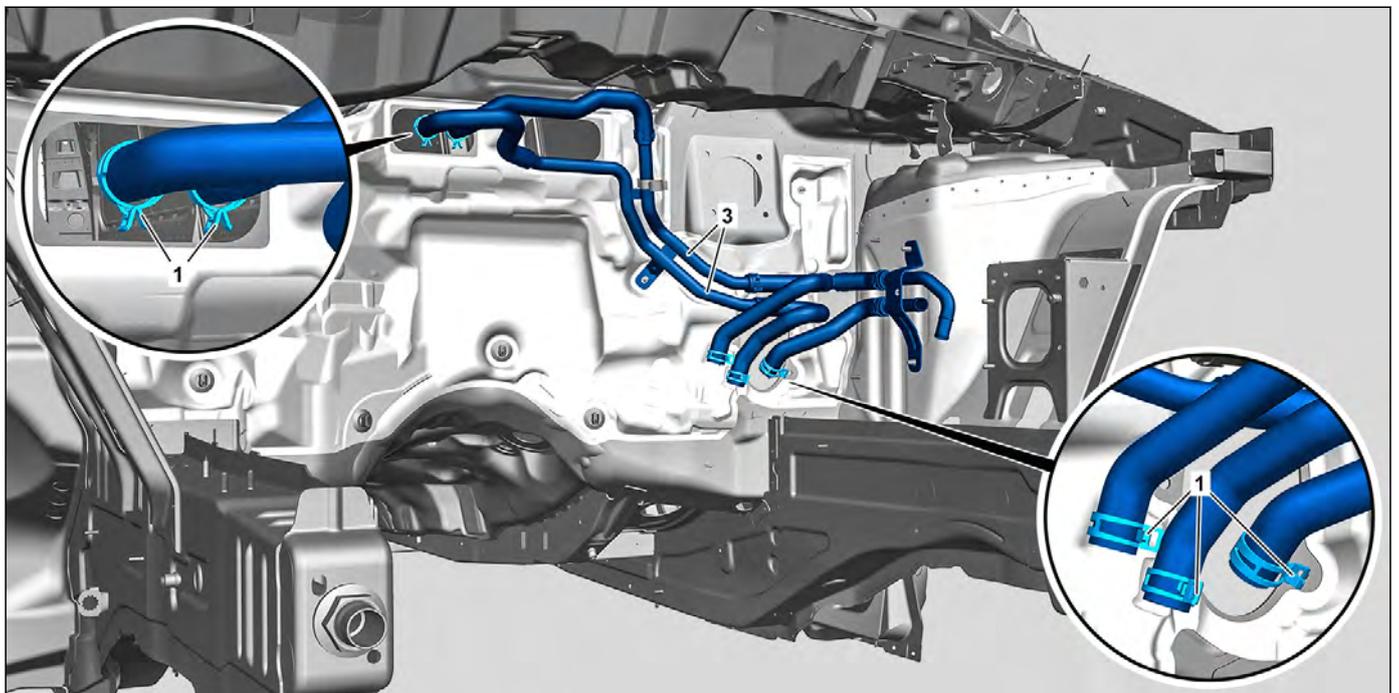
S83.20-A019-79

Model 447 with code H12 + (H13/HZ7)

- 1 Clamps
- 3 Coolant hoses including heating circuit coolant lines in engine compartment at firewall

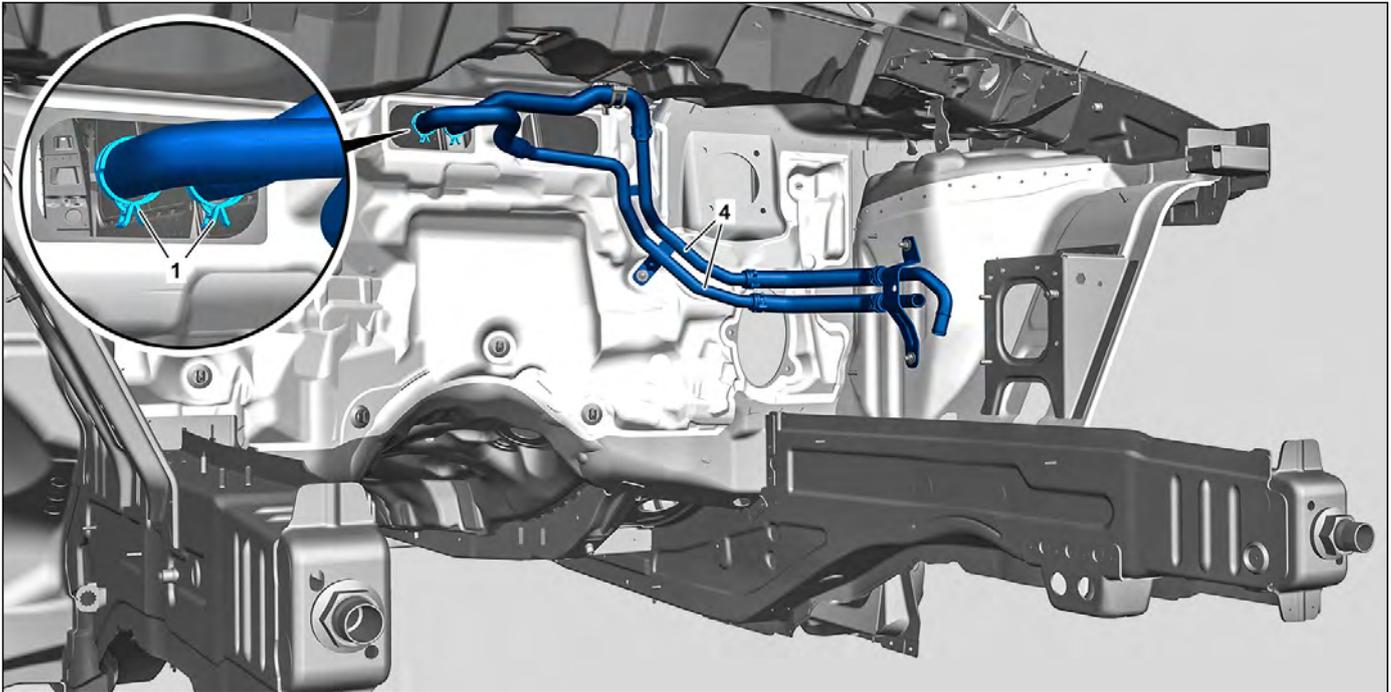
S83.20-A020-79

Model 447 with standard equipment

- 1 Clamps
- 4 Coolant hoses including heating circuit coolant lines in engine compartment at firewall

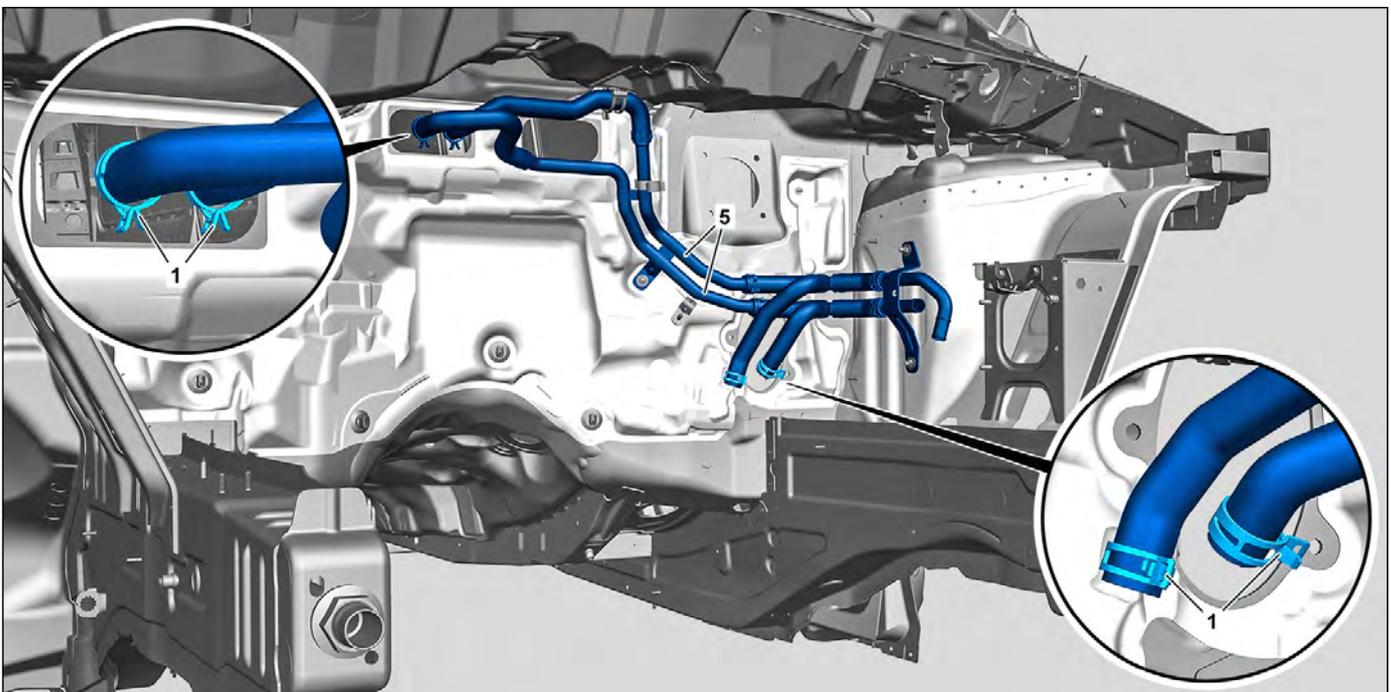
S83.20-A021-79

Model 447 with code H13/HZ7

- 1 Clamps
- 5 Coolant hoses including heating circuit coolant lines in engine compartment at firewall

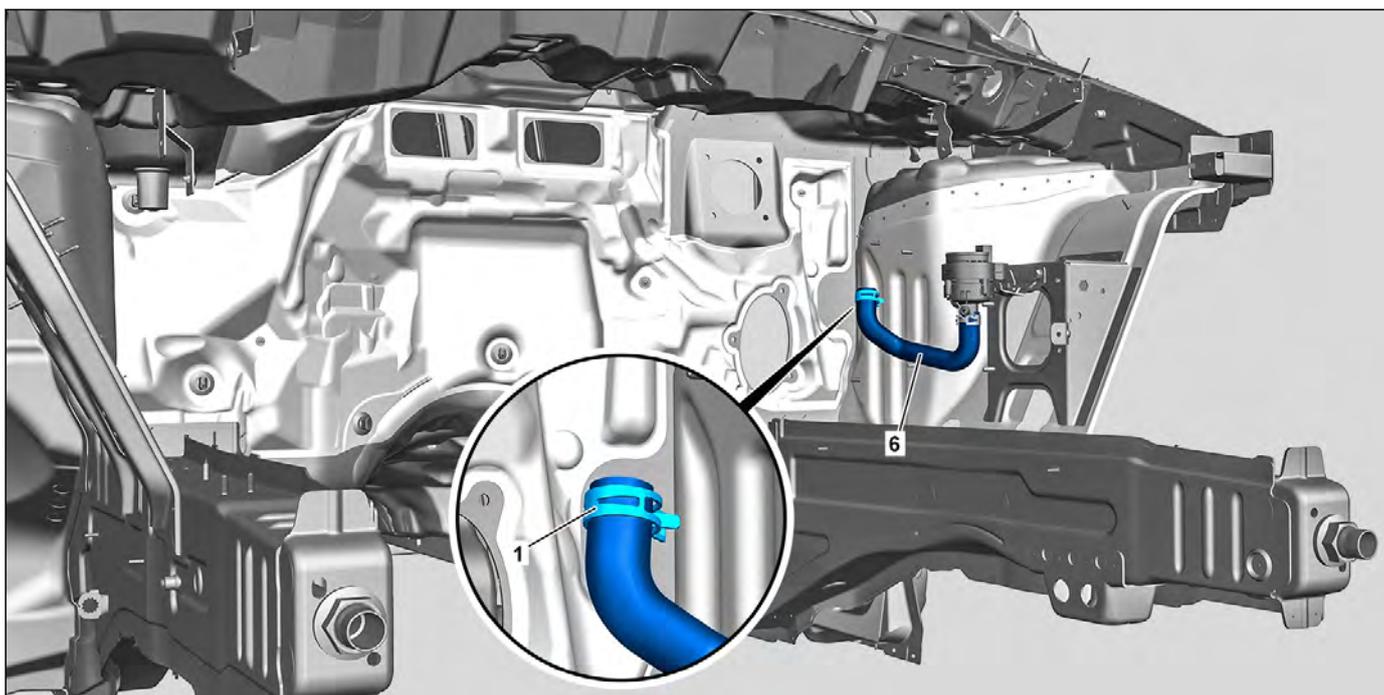
S83.20-A022-79

Model 447.6 with code (HH4/F48) + (MG3/MG4/MG7), model 447.7 with code (H13/HZ7/HH4/F48) + (MG3/MG4/MG7), model 447.8 with code (H13/HZ7/HH4/F48) + (MG3/MG4/MG7)

1 Clip

6 Heating circuit molded hose in engine compartment at left wheel well

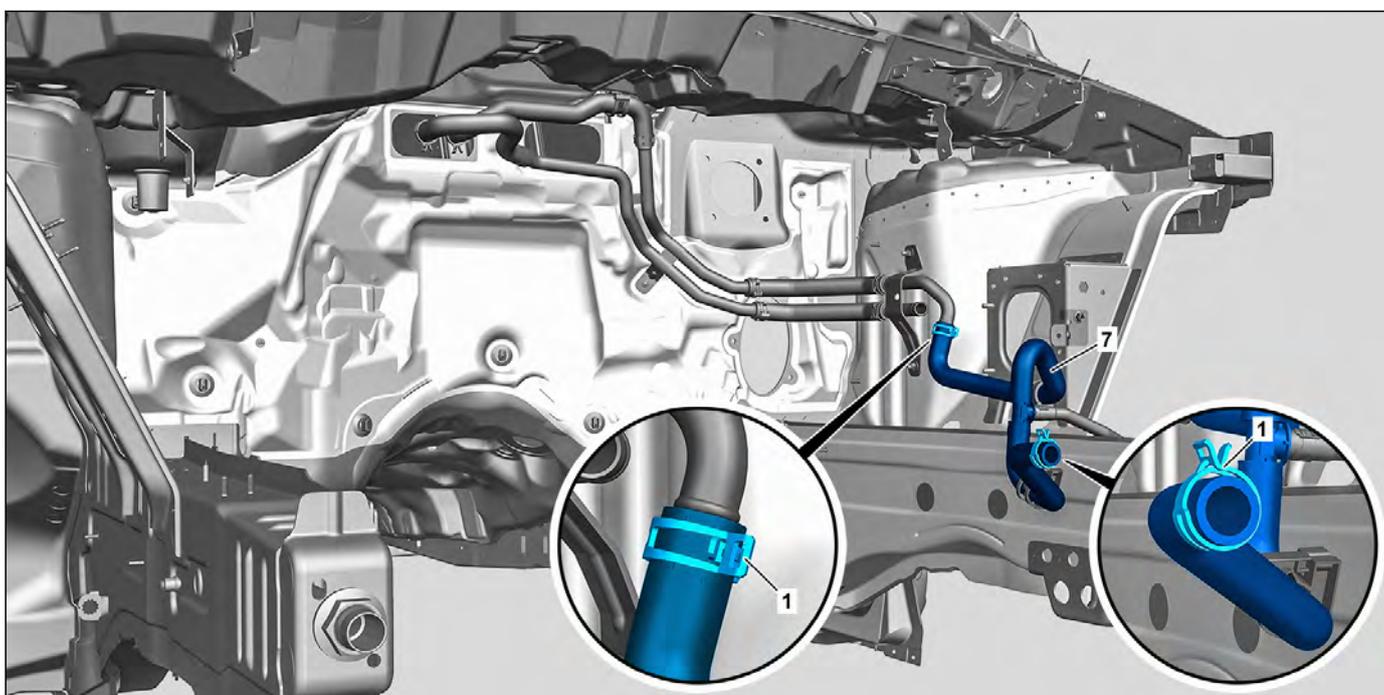
S83.20-A023-79

Model 447 with code F48 + (MG3/MG4/MG7)

1 Clip

7 Heating circuit molded hose in engine compartment at left wheel well

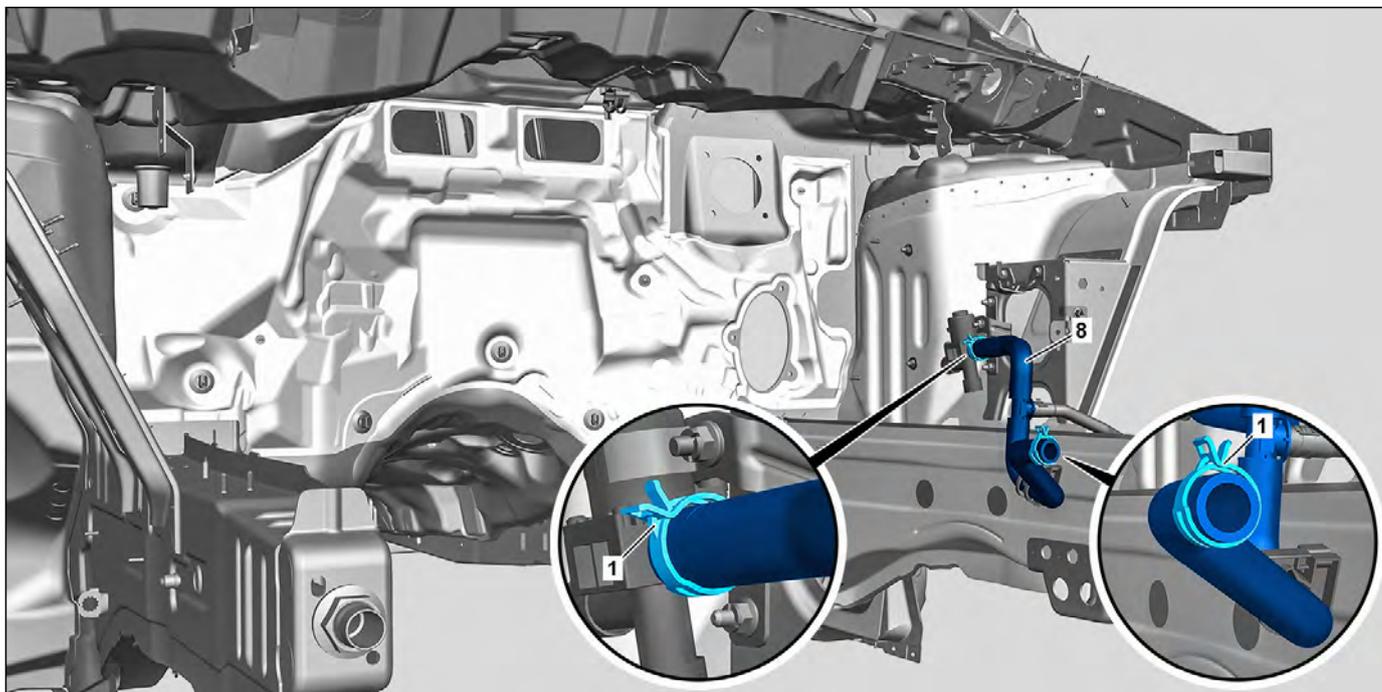
S83.20-A024-79

Model 447 with code H12 + F48 + (MG3/MG4/MG7)

1 Clip

8 Heating circuit molded hose in engine compartment at left wheel well

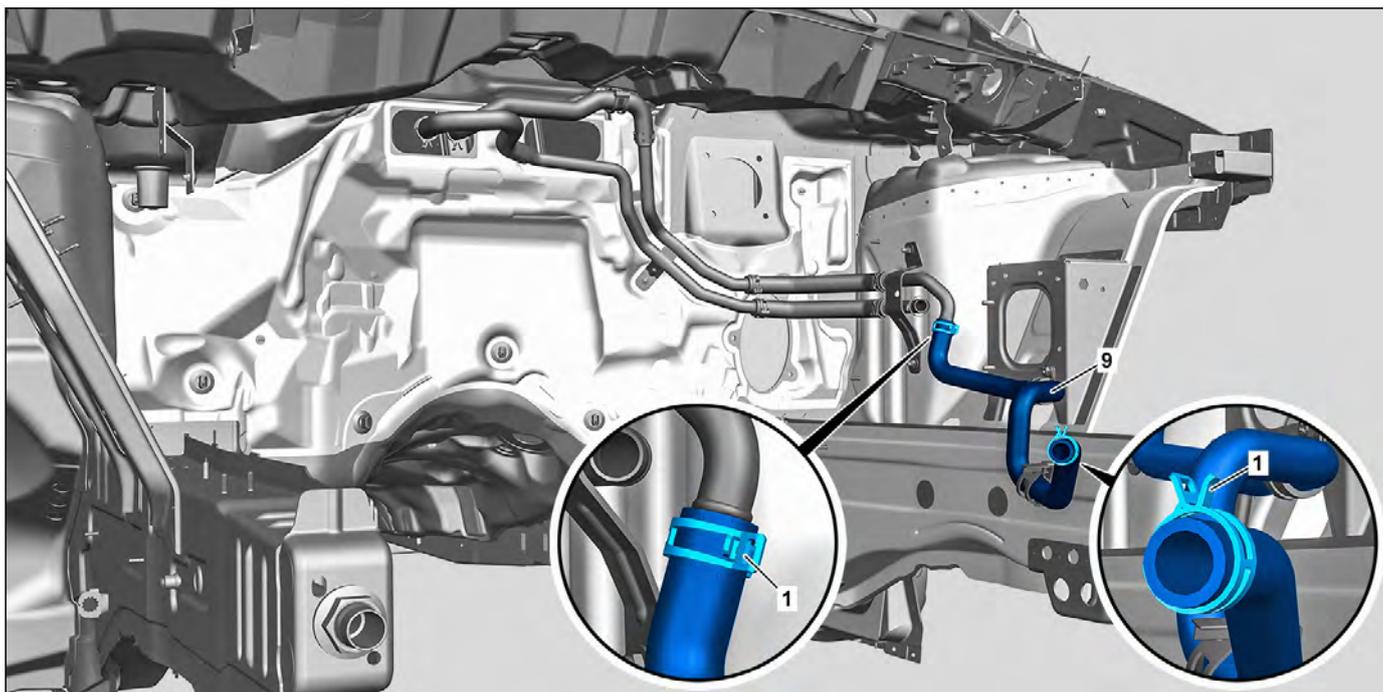
S83.20-A025-79

Model 447 with code MM1

1 Clip

9 Heating circuit molded hose in engine compartment at left wheel well

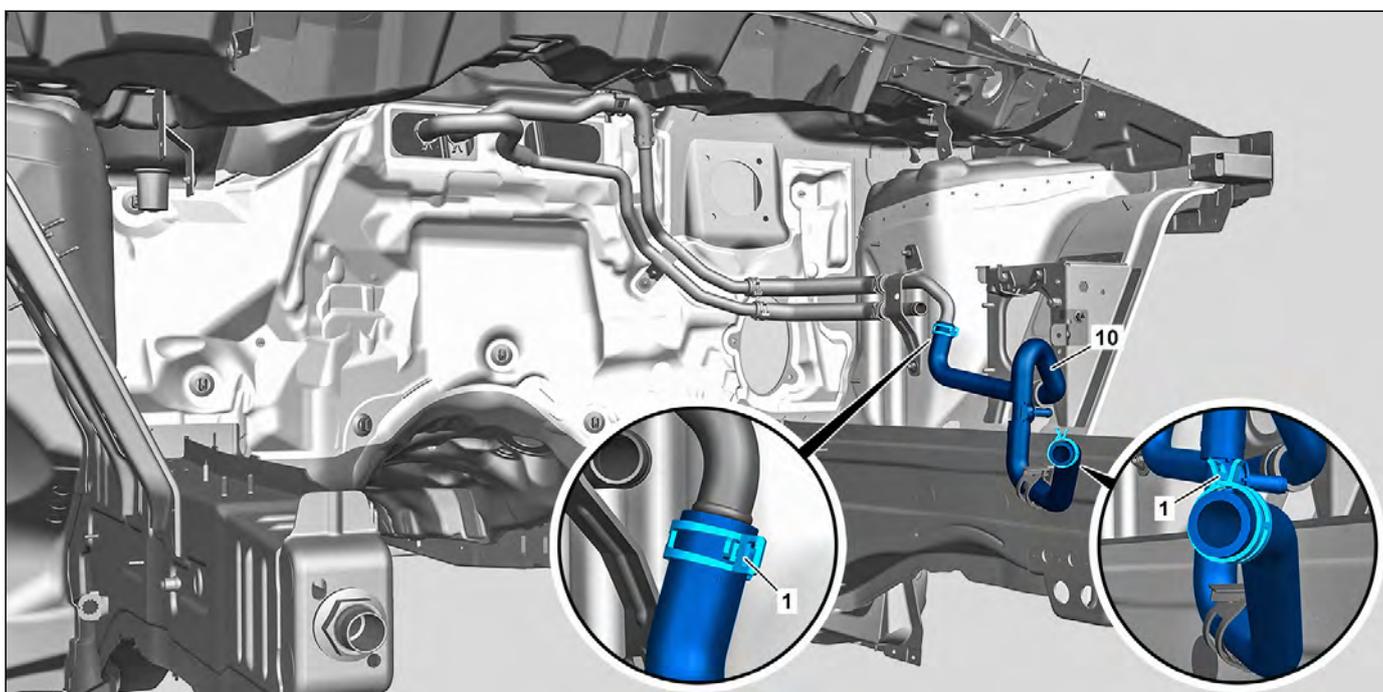
S83.20-A026-79

Model 447 with code F48 + MM1

1 Clip

10 Heating circuit molded hose in engine compartment at left wheel well

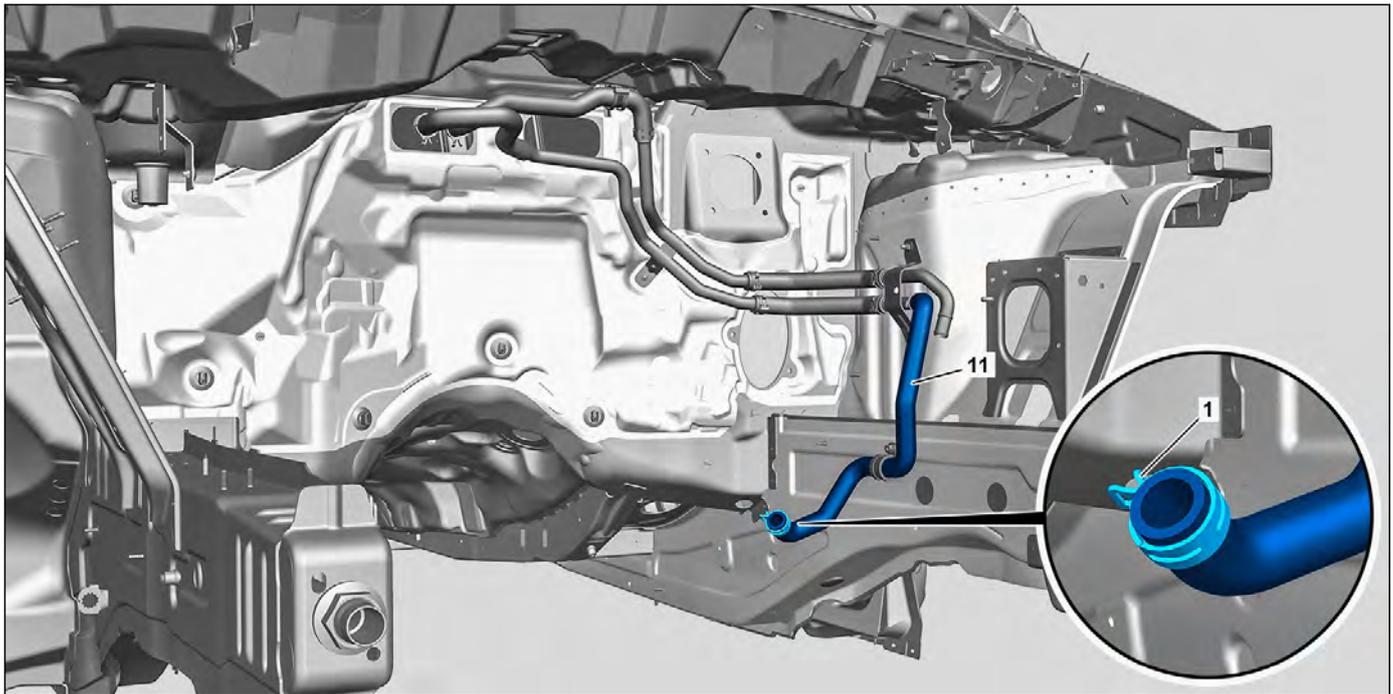
S83.20-A027-79

Model 447 with code MM1

1 Clip

11 Heating circuit molded hose in engine compartment at left wheel well

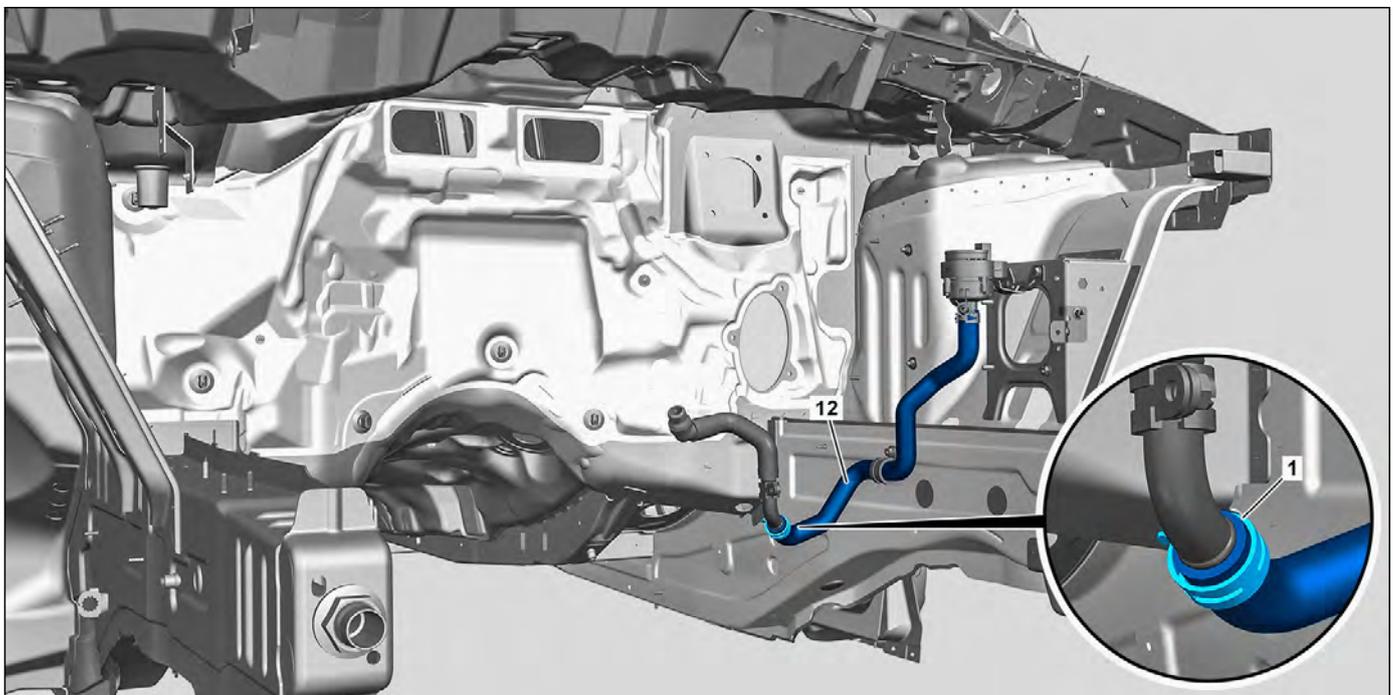
S83.20-A028-79

Model 447.6 with code MM1 + (HH4/F48), model 447.7/8 with code MM1 + (F48/HH4/HZ7/H13)

1 Clip

12 Heating circuit molded hose in engine compartment at left wheel well

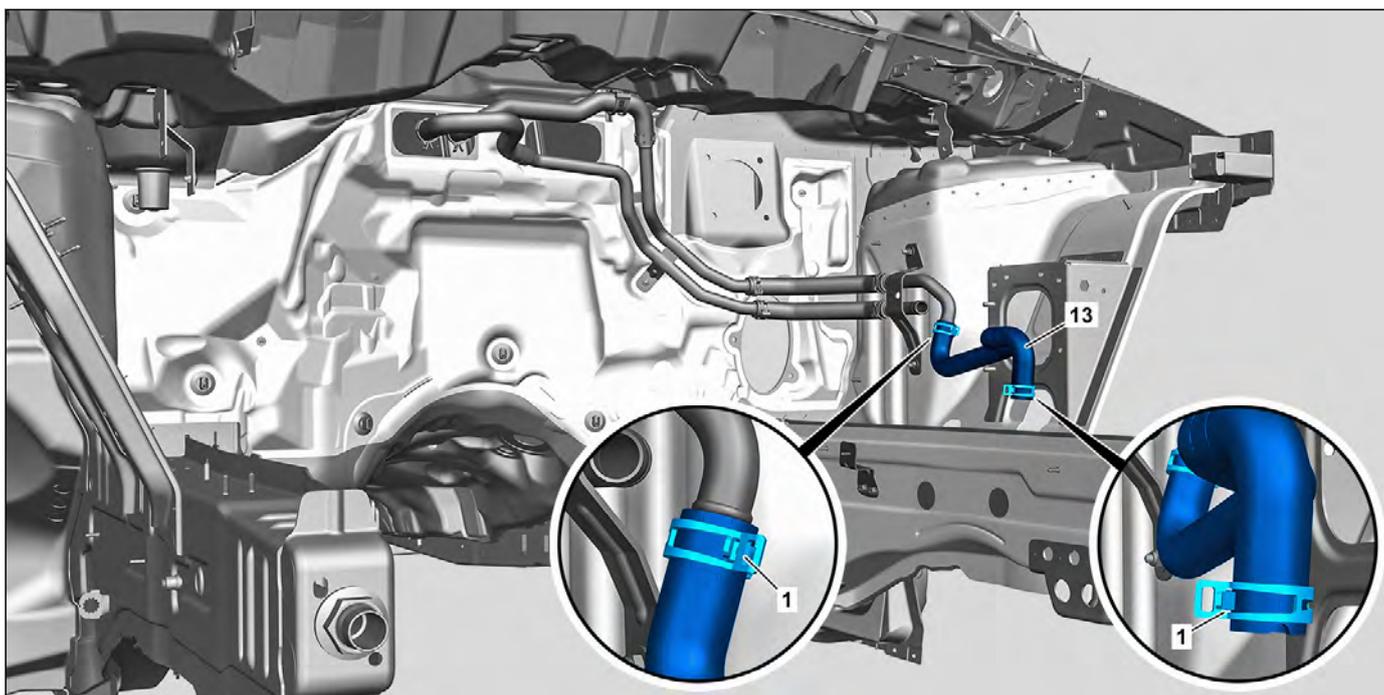
S83.20-A029-79

Model 447 with code MX1/MX2/MX4/MX8

1 Clip

13 Heating circuit molded hose in engine compartment at left wheel well

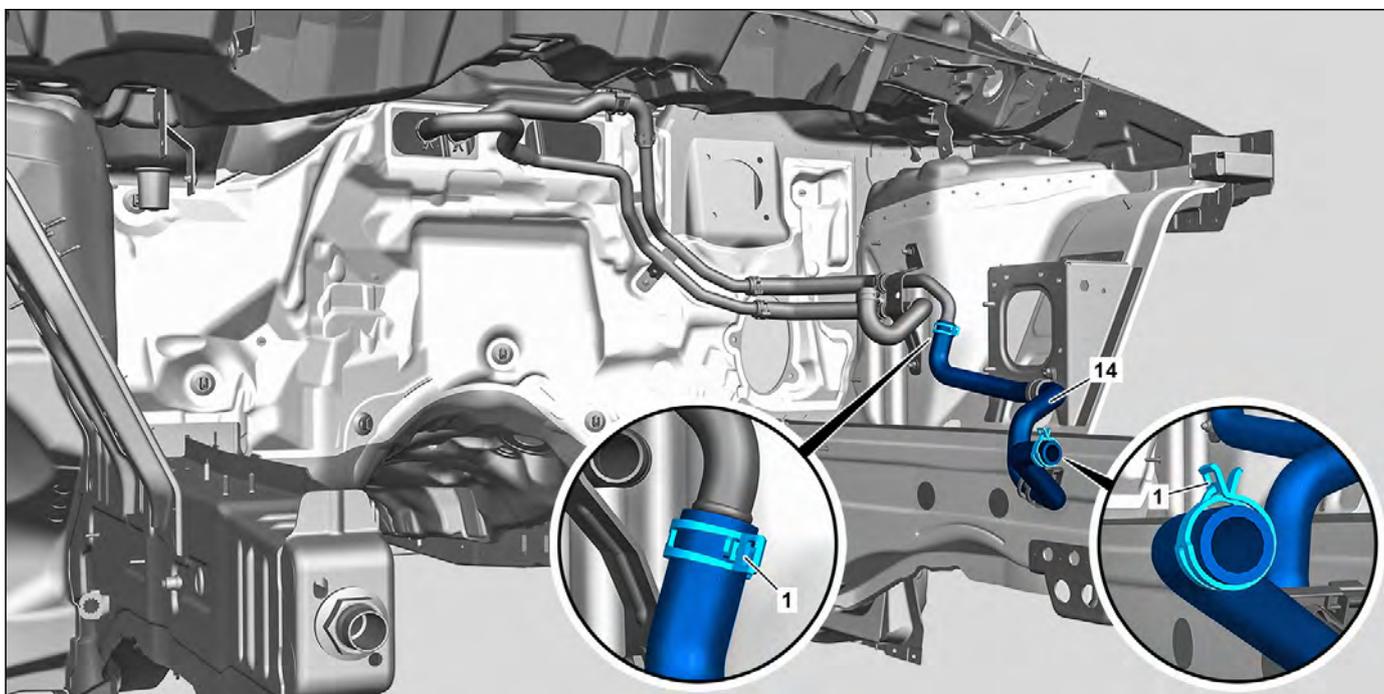
S83.20-A030-79

Model 447 with code MG3/MG4/MG7

1 Clip

14 Heating circuit molded hose in engine compartment at left wheel well

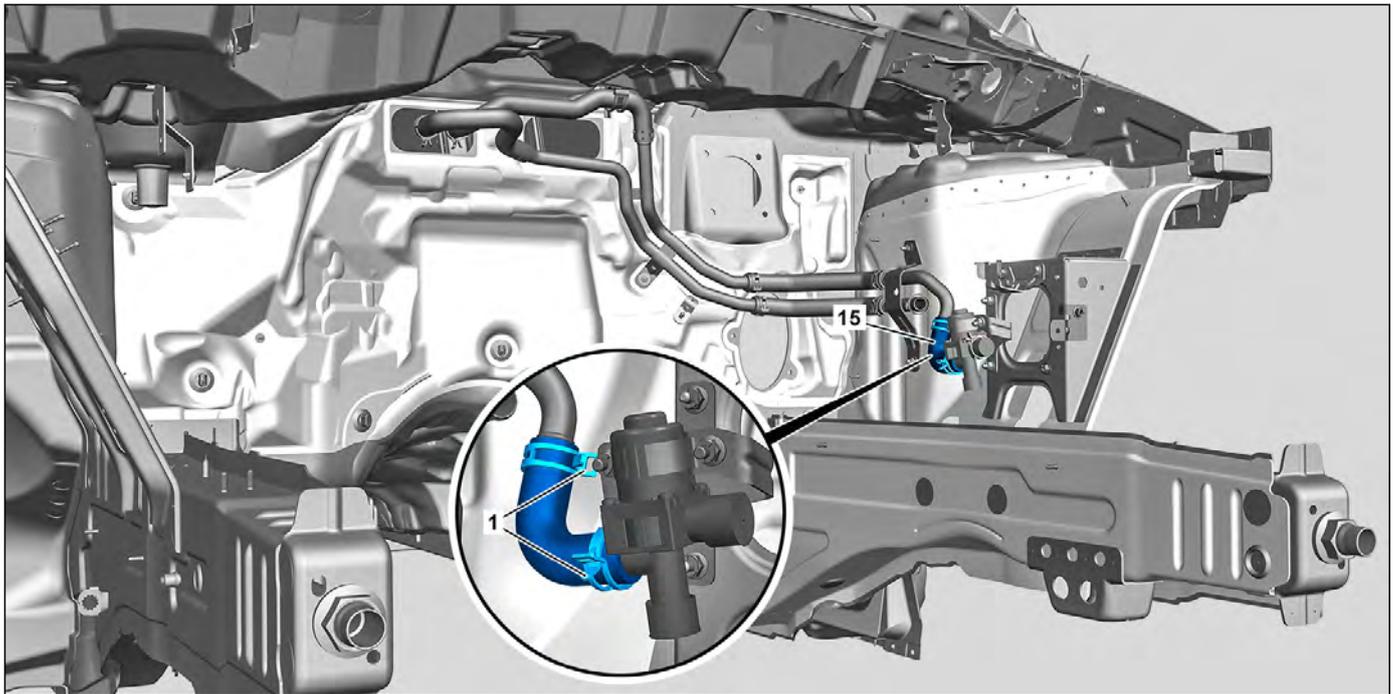
S83.20-A031-79

Model 447 with code H12 + (MX1/MX2/MX4/MX8/MG3/MG4/MG7/MM1/MU0/MU2/MU4/MU6/MU8), model 447 with code F48 + H12 + (MX1/MX2/MX4/MX8/MG3/MG4/MG7/MM1/MU0/MU2/MU4/MU6/MU8)

1 Clamps

15 Heating circuit molded hose in engine compartment at left wheel well

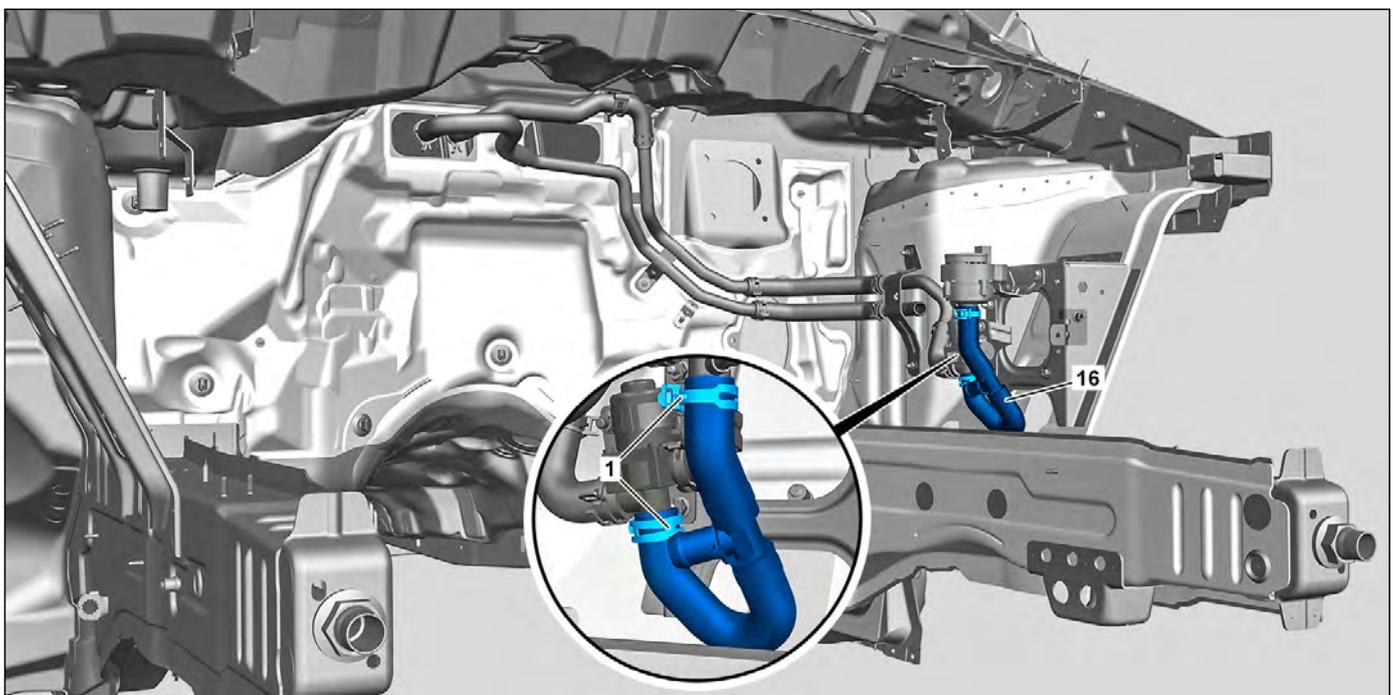
S83.20-A032-79

Model 447 with code H12, model 447 with code H12 + F48

1 Clamps

16 Heating circuit molded hose in engine compartment at left wheel well
