Campaign No. 2023080001, August 2023

SUBJECT: **Model CLA (118 platform)**
Model Year 2023

Inspect Tire Sidewall Stripe

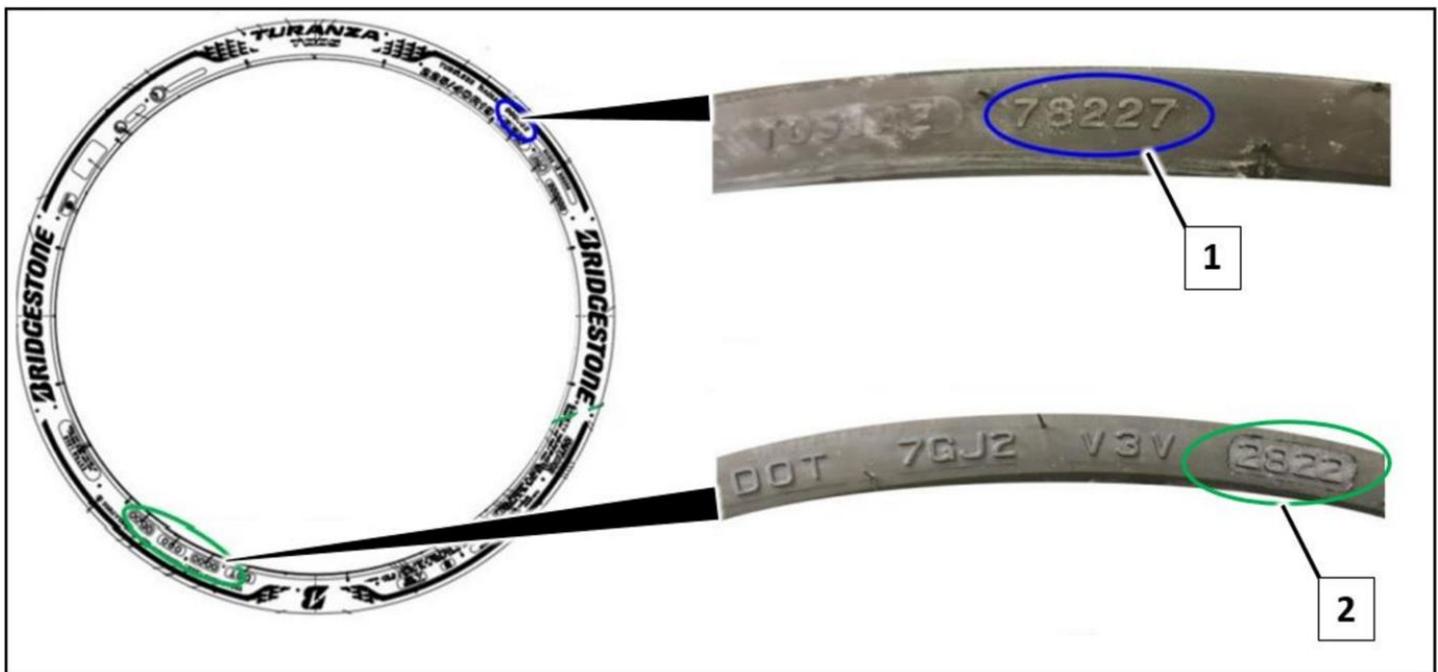
Figure 1

1. Check DOT number (2, Figure 1) and vulcanization mold number (1, Figure 1) of all 4 wheels:
 - a. In the case of tires with DOT number (2, Figure 1) 2822: Check vulcanization mold number (1, figure 1) of tires.
In the case of **all other** DOT numbers (2, Figure 1):
Do **not check** vulcanization mold number (1, Figure 1) of tires and do **not replace** tires, **end measure**.
 - b. In the case of DOT number (2, Figure 1) 2822 and vulcanization mold number (1, Figure 1) 78227 and 76425 of the tires: Perform **Work Procedure**.
All other vulcanization mold numbers (1, Figure 1): Do **not** replace tires.

- i** Vulcanization mold number (1, Figure 1): 78227 and 76425 are **not OK**
 DOT number (2, Figure 1): 2822 is **not OK**

1. Remove respective wheel and tire assembly.
i For basic information, see AR40.10-P-1102MFA.
2. Replace respective tire.
i For basic information, see AR40.10-P-1030MFA.
