WORK DESCRIPTION FOR FIELD MEASURE

Code: 23P4692601

Check steering column on steering wheel for end play, replace steering column tube if necessary

Model 223

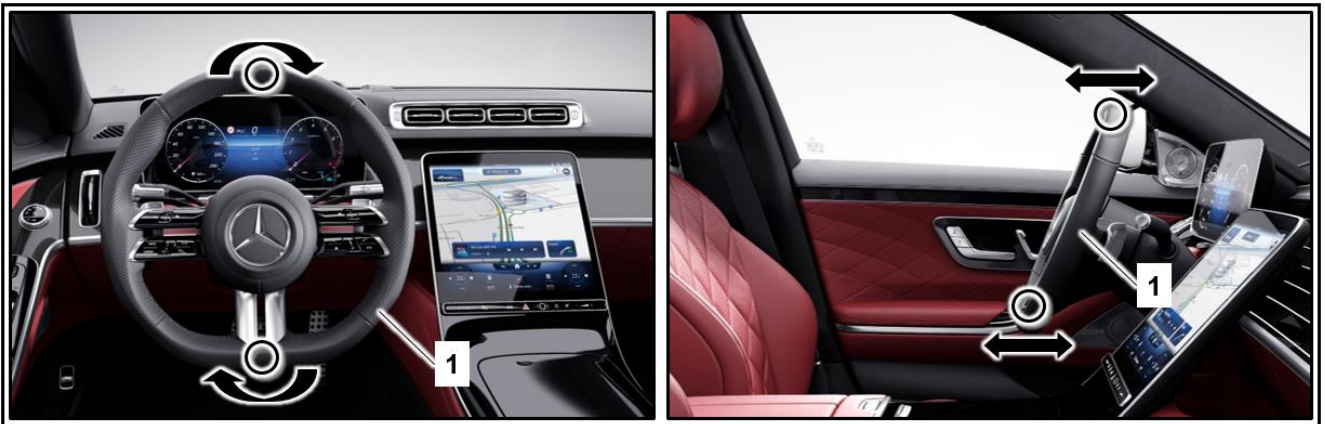
Figure 1

1. Align steering wheel (1, Figure 1) in straight-ahead position.
2. Grip steering wheel (1, Figure 1) at the marked positions and wiggle forwards and backwards (see Figure 1).

i The steering column on the steering wheel (1, Figure 1) must not have any end play.

- a. If the steering column on the steering wheel (1, Figure 1) has end play: Carry out **work procedure**.
- b. If steering column on the steering wheel (1, Figure 1) has **no** end play: **End measure**.

1. Replace steering column tube (steering column)
