# WORK DESCRIPTION FOR FIELD MEASURE

Code: 23P6892005

**Check additional cushions for leg rest in rear passenger compartment for soiling or discoloration and replace if necessary**

Model 223 Maybach Haute Voiture

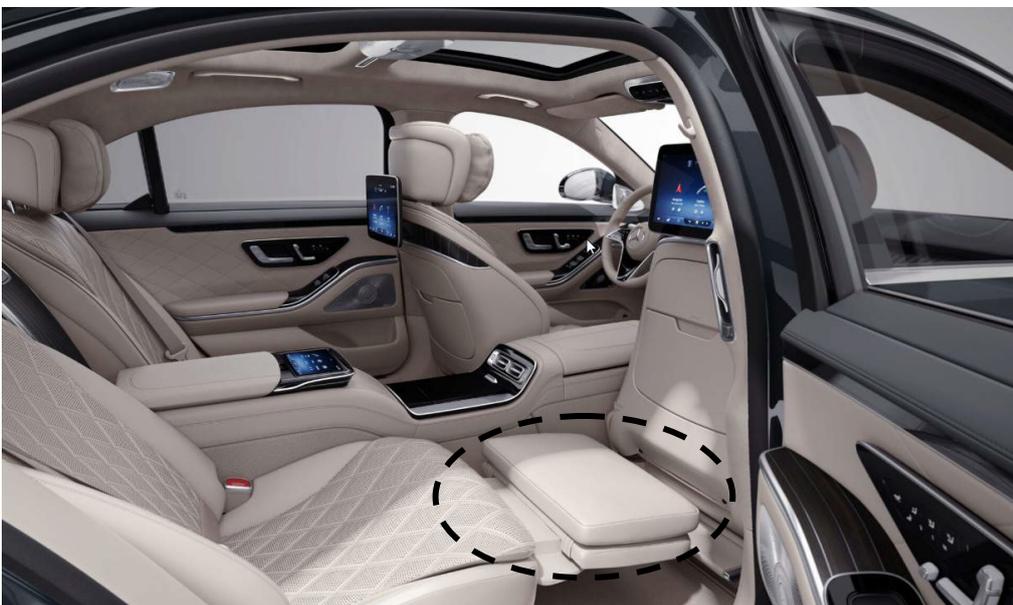
Figure 1

1. Check whether the additional cushions for the leg rest in the rear passenger compartment of the vehicle are soiled/discolored.

**i** The additional cushions for the leg rest in the rear passenger compartment can be installed or in the black transport bag in the trunk.

- a. Additional cushion(s) for leg rest in rear passenger compartment **is/are** soiled/discolored: Carry out **work procedure**.
- b. Additional cushion(s) for leg rest in rear passenger compartment **is/are not** soiled/discolored: **End measure**.

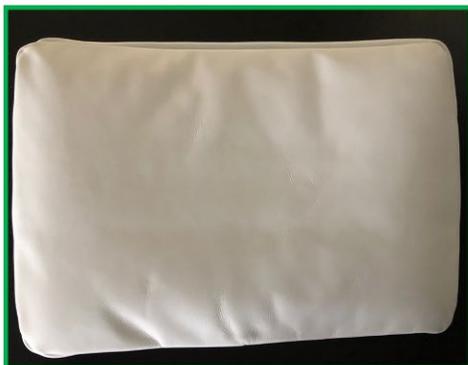
Figure 2, OK condition

i.o

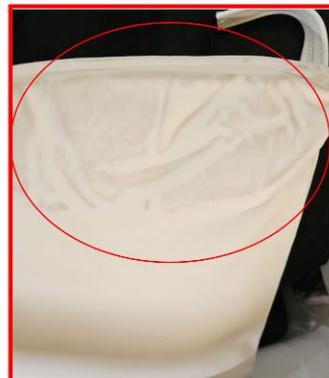
Figure 3, not OK condition

n.i.o

1. Enclose additional cushion(s) for leg rest in rear passenger compartment according to vehicle version.
