# News Channel Update | Vans Customer Service and Parts

TO: Mercedes-Benz Dealer Principals, General Managers, Sales Managers, Service Managers, Parts Managers	FROM: Anthony Washington, Department Manager, Regulations and Certifications
Re: Service Campaign Notification Model 907 (Sprinter) Model Year 2022 Retrofit PTC Heater	DATE: August, 2022

Campaign No. 2022070014 August, 2022

SUBJECT: Model 907 Model Year 2022 Retrofit PTC Heater

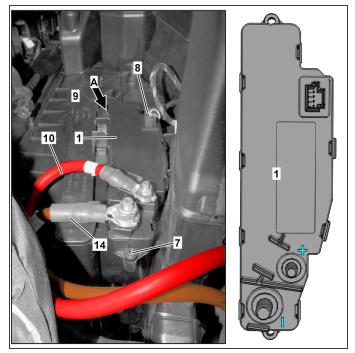
D83.70-A028-82

- 1 PTC heater booster
- 7 Screw
- 8 Connector
- Heater housing 9
- Positive line 10
- 14 Ground cable

4	Remove the cover (6).	iTo do so, unscrew screw (7) and release retaining tab (arrow A).iThe cover (6) is no longer required.	
5	Disconnect plug (8) from air conditioner box (9).	<b>i</b> The plug (8) must not be connected to the air conditioner box (9).	
6	Remove protective cover of positive line (10).	<b>i</b> To do so, separate cable tie. The protective cover is no longer required.	
7	Cut cable tie (20).		
8	Detach cover (17) from positive terminal of on-board electrical system battery.	Model 907	
9	Remove protective cover of positive line (10).	<b>i</b> To do so, separate cable tie. The protective cover is no longer required.	
	Retrofit PTC booster heater (1)		
10	Retrofit PTC booster heater (1).	<ul> <li>Install PTC booster heater (1) straight into air conditioner box (9).</li> <li>When installing, <b>do not tilt</b> the PTC booster heater (1).</li> <li>Otherwise damage at the PTC heater booster (1) could occur.</li> </ul>
