<p>TO: Freightliner Dealer Principals, General Managers, Sales Managers, Service Managers, Parts Managers</p>	<p>FROM: Anthony Washington, Senior Manager, Regulations and Certifications</p>
<p>Re: Launch Recall Campaign Notification Model Sprinter 907 Model Years 2021 Replace Fuel Delivery Module</p>	<p>DATE: October, 2023</p>

Campaign No. 2023090004 October, 2023

SUBJECT: **Model 907 Sprinter, Model Year 2021**
Replace Fuel Delivery Module

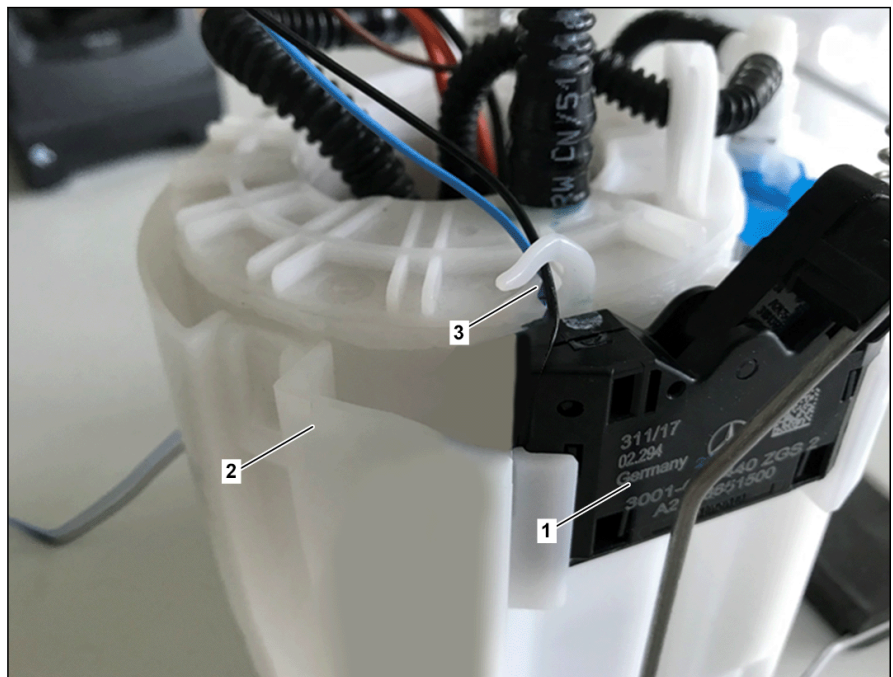
D47.20-A031-76

i Installation:
Check that the fill level sensor (1) is correctly locked.

- 4 Install in the reverse order.
