| RE: <b>Service Campaign Launch Notification</b><br><b>Check Top of Right and Left Fenders at A-Pillar Paneling</b><br><b>MY23 CLA (118 platform)</b> | DATE: May 10, 2024 |

Campaign No. 2024040014, May 2024

## **Check Top of Right and Left Fenders at A-pillar Paneling**

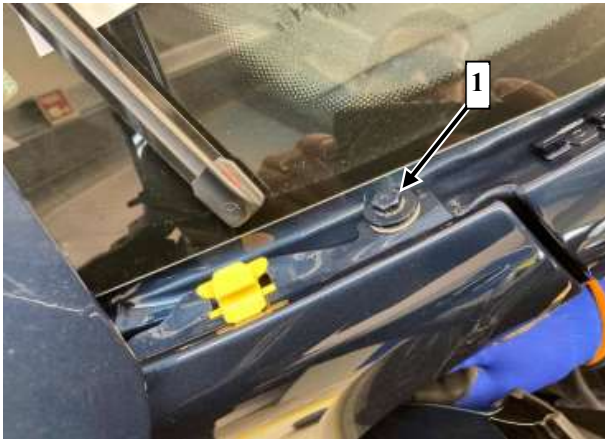
Figure 1

1. Remove drip rail on right and left of windshield.  
i For basic data, see **AR88.80-P-4000MFA**.
2. Unscrew screw (**Figure 1, 1**) on right and left side of vehicle.
3. Lift fender above and check A-pillar paneling (**Figure 2, arrows**) for paint damage (cracking/chipping, deformations or rubbing).
