SUBJECT: **Model 906 (Sprinter)**  
**Model Year 2014-2016**  
**Modification to the emissions control system**

**Campaign: 2021070034**

**Update control unit software (code: NC3ID182ND, acc. no.: 07 972 82)**

**Model 906**

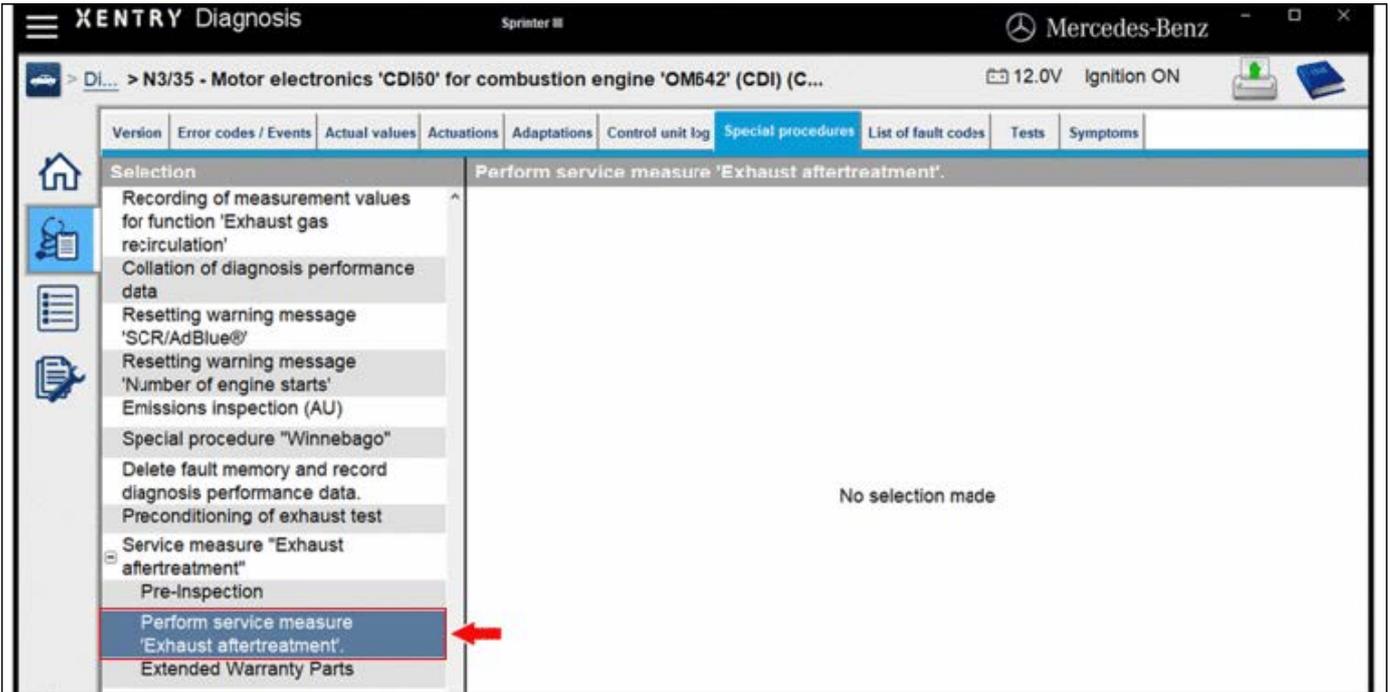
D54.00-A009-79

### OM642 engine: Exemplary screenshot of Exhaust Aftertreatment Service Measure

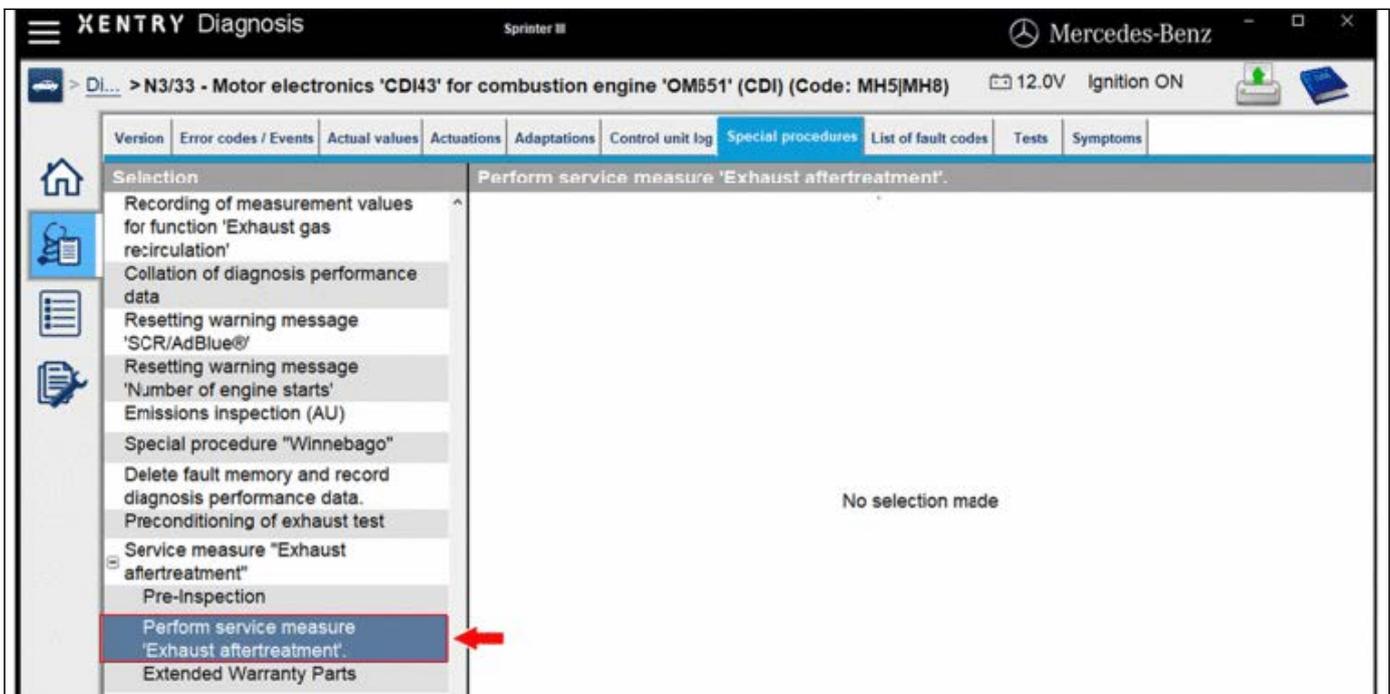
D54.00-A010-79

### OM651 engine: Exemplary screenshot of Exhaust Aftertreatment Service Measure
