SM91.60-D-0077SG 24.02.2022

Replace driver's airbag (code: NC3DABTKW2, acc. no.: 91 921 53)

Model 906

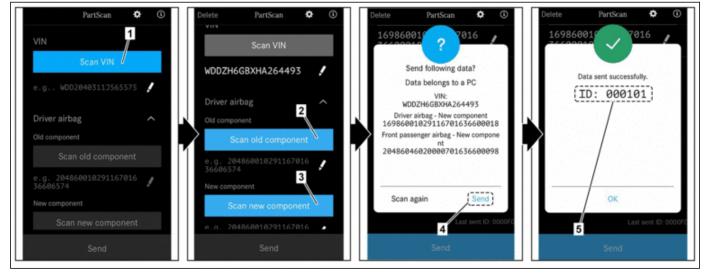
S91.60-A090-78

- 1 "Scan VIN" button
- 3 "Scan new component" button 5
- 2 "Scan old component" button 4 "Send" button

In order to simplify redocumentation and avoid input errors, the use of the "Mercedes-Benz PartScan" app is recommended. In the event of redocumentation with the "Mercedes-Benz PartScan" app, no additional documentation needs to be implemented in VeDoc.

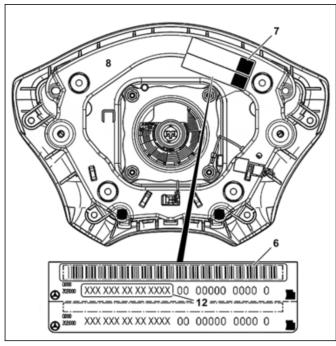
D91.60-A019-12

Scan ID

Shown on driver's airbag

- 6 Bar code
- 7 Adhesive label
- 8 Driver airbag
- 12 Part number

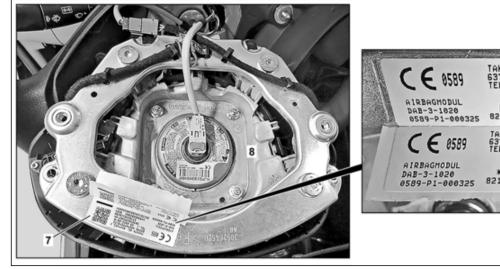
D91.60-A020-08

Shown on driver's airbag

- 7 Adhesive label
- 8 Driver airbag

12 Part number

13 QR code

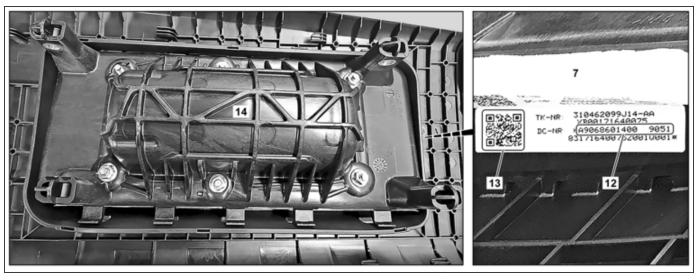
D91.60-A021-08

Shown on front passenger airbag
