Campaign No. 2021070027

SUBJECT: **Model 907 Sprinter, Model Year 2019
Software Update**

SM54.21-D-0228SG	Update software of control units (code: VS3MOGED19, acc. no.: 07 972 76)	12.12.2022
-------------------------	---	-------------------

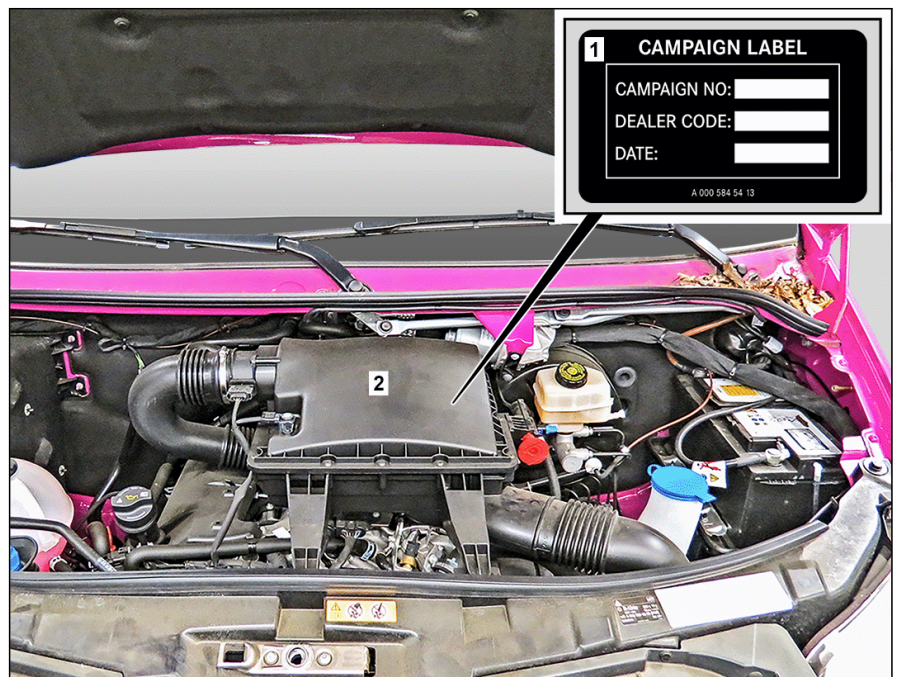
D54.21-A036-76

Shown on model 906 with engine 642

- 1 Campaign label
- 2 Air cleaner housing

8	Fill out certificate and hand over to customer.	<p>Only applies for vehicles in State of California.</p> <p>i Apply number from campaign label (1).</p>
