IMPORTANT EMISSION RECALL CAMPAIGN INFORMATION

Campaign No. 2021120007, January 2023

SUBJECT: Model ML-Class (166 platform)

Update Transmission Control Unit Software

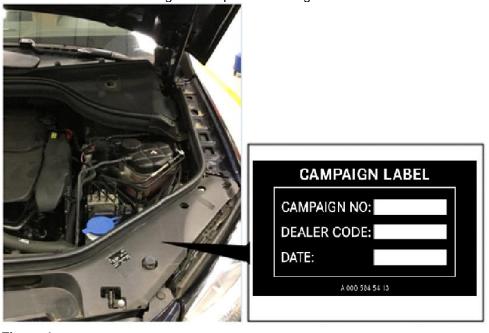
Figure 1

Apply Proof of Correction Label (A 000 584 54 13) to area identified in Figure 1. Fill in the blank areas of the label. The campaign number for the California Proof of Correction is unique and must be entered as such (211207), your dealer code, and the date of the repair, using a black permanent marker.

Note: Clean bonding surface prior to affixing label.
