TO: Mercedes-Benz Dealer Principals, General Managers, Sales Managers, Service Managers, Parts Managers	FROM: Anthony Washington, Senior Manager, Regulations and Certifications
<b>Re: Launch Recall Campaign Notification</b> <b>Model Sprinter 447</b> <b>Model Years 2021-2022</b> <b>Replace Fuel Delivery Module</b>	DATE: December, 2023

## IMPORTANT RECALL CAMPAIGN INFORMATION

Campaign No. :	Campaign Desc. :	Replace Fuel Delivery Module
2023100006	VS2KRAPUMP	
This is to notify you of a Recall Campaign Launch to replace the fuel delivery module on approximately 8,181 MY 2021-2022 Mercedes-Benz Metris vans. The recall campaign will be visible on the <a href="http://www.safercar.gov">www.safercar.gov</a> website and may generate questions from customers. All affected VINs will be flagged "OPEN" in VMI and cannot be sold until the recall has been remedied.		
Background		
Issue	Mercedes-Benz AG, the manufacturer of Metris vans, has determined that on certain Metris (447 platform) vehicles the fuel pump impeller might not meet specifications in regards to material characteristics. As a consequence, the impeller might deform and come into contact with the fuel pump housing, leading to a me

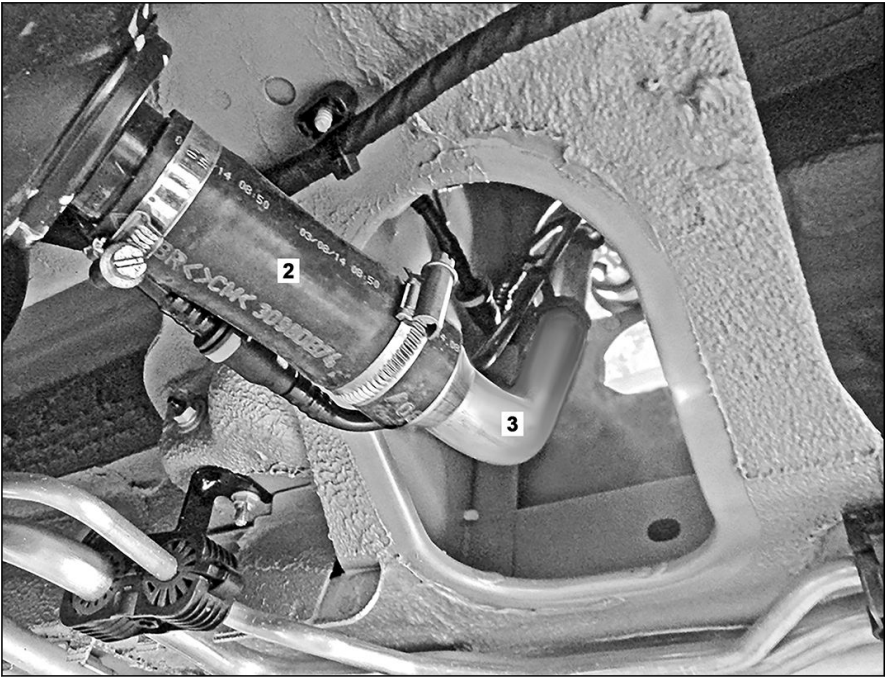
S47.20-A028-06

- 2 Fuel hose
- 3 Filler neck

Model 447 except code ZL3 (National version for Latin America)</p> <p>Contrary to the statement in the reference document on removal of the fuel tank, the <b>fuel hose (2) does not need to be removed</b>.</p> <p>The filler neck (3) is only detached from the body and remains on the fuel tank.</p> <p>
