TO: Mercedes-Benz Dealer Principals, General Managers, Sales Managers, Service Managers, Parts Managers	FROM: Anthony Washington, Senior Manager, Regulations and Certifications
<b>Re: Launch Recall Campaign Notification</b> <b>Model: Metris (447)</b> <b>Model Years: 2022-2023</b> <b>Replace Fuel Delivery Module</b>	DATE: April, 2024

**IMPORTANT RECALL CAMPAIGN INFORMATION**

<b>Campaign No. :</b>	<b>Campaign Desc. :</b>	<b>Replace Fuel Delivery Module(dealer inventory only)</b>
<b>2024040005</b>	<b>VS2KRAPUM2</b>	
<p>This is to notify you of a Recall Campaign Launch to replace the fuel delivery module on approximately <b>80</b> MY 2022-2023 Mercedes-Benz Metris vans. The recall campaign will be visible on the <a href="http://www.safercar.gov">www.safercar.gov</a> website and may generate questions from customers. All affected VINs will be flagged "<b>OPEN</b>" in VMI and cannot be sold until the recall has been remedied.</p>		
<b>Background</b>		
<b>Issue</b>	<p>Mercedes-Benz AG, the manufacturer of Metris vans, has determined that on certain Metris (447 platform) vehicles, the fuel pump impeller might not meet specifications in regards to material characteristics. As a consequenc

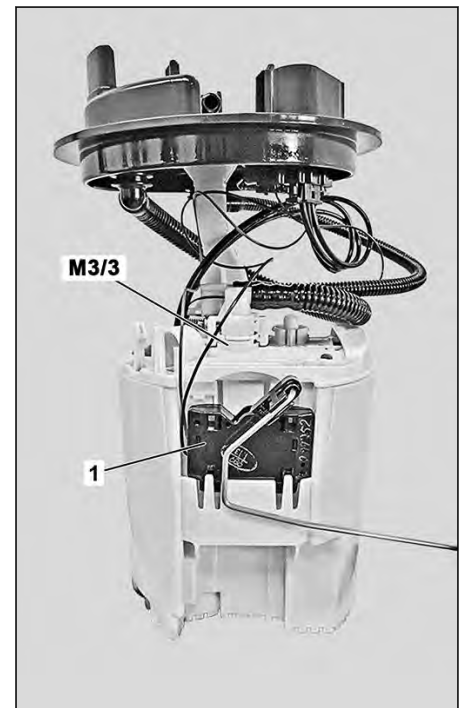
S47.20-A027-03

- 1      *Fuel tank fill level sensor*
- M3/3      *Fuel pump with fuel feed module*

<b>Remove</b>		
4	Remove fuel pump with fuel delivery module (M3/3).	<p>

The removed fuel pump with fuel delivery module (M3/3) is not reused.</p> <p>Dispose of removed component parts that are not reused properly. Observe the applicable legal requirements and specifications of the relevant country.</p>	AR47.20-S-7000E

<b>Modify</b>		
5	Transfer fuel tank fill level sensor (1) of removed fuel pump with fuel delivery module (M3/3) to new fuel pump with fuel delivery module (M3/3).	Only if new fuel pump with fuel delivery module (M3/3) was delivered without fuel tank fill level sensor (1).	AR47.50-S-0111E

<b>Install</b>		
6	Install new fuel pump with fuel delivery module (M3/3).		AR47.20-S-7000E

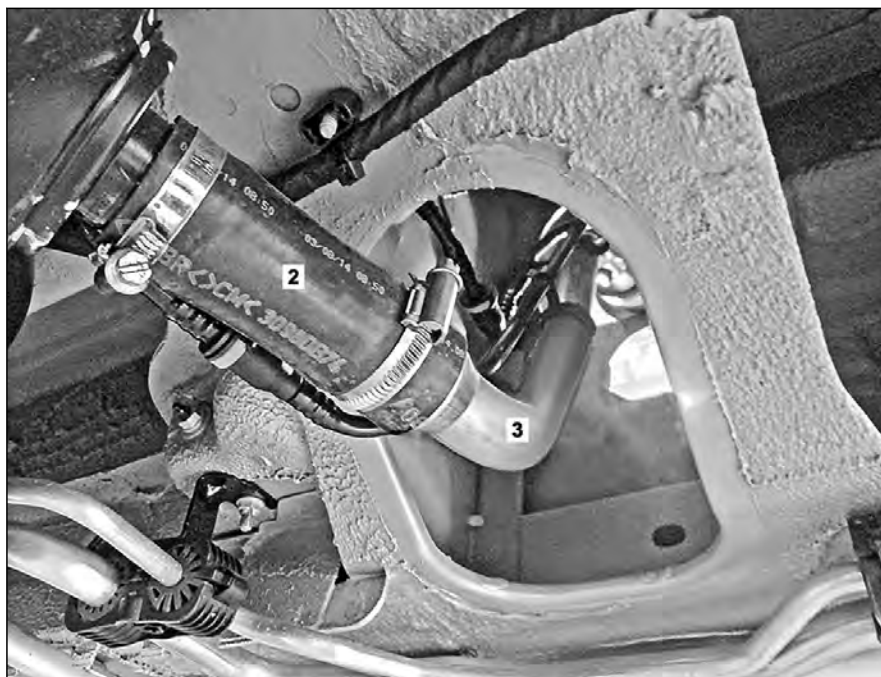
S47.20-A028-06

- 2 Fuel hose
- 3 Filler neck

Contrary to the statement in the reference document on removal of the fuel tank, the <b>fuel hose (2) does not need to be removed.</b></p> <p>The filler neck (3) is only detached from the body and remains on the fuel tank.</p> <p>
